Albatros
3.1.9

Operator's manual

Tecnologie e Prodotti per l'Automazione

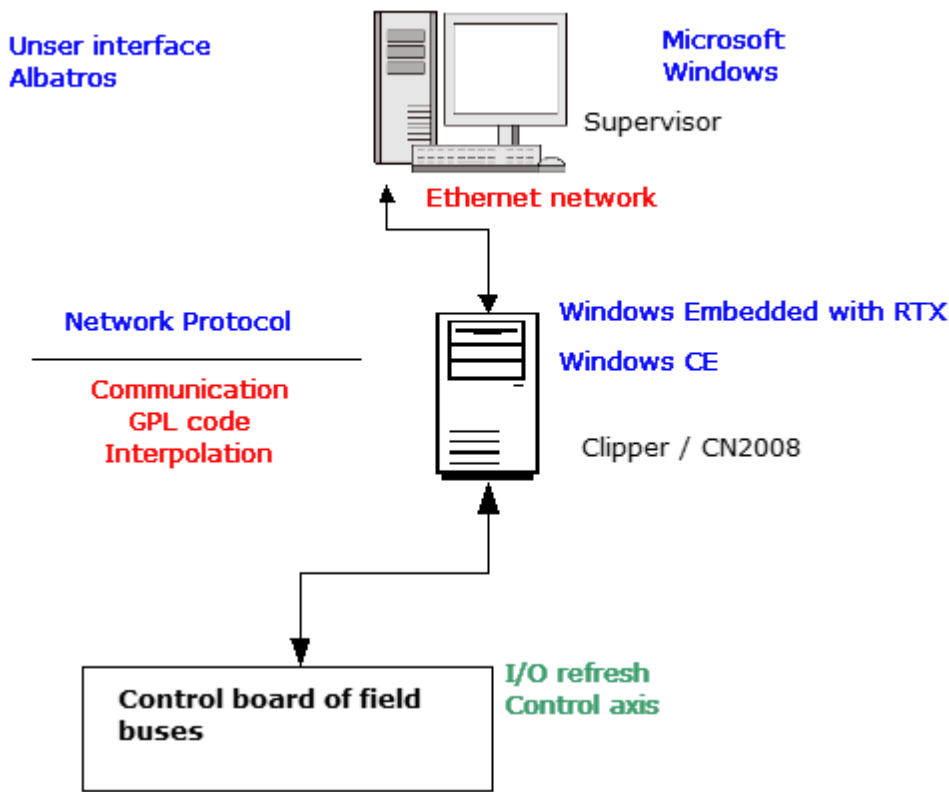
Connection diagram of a remote module

In the monomodule version, the axis cards are installed directly in the Supervisor PC, while in the multimodule version they are installed in an industrial PC (with or without screen and keyboard) connected to the Supervisor PC via Ethernet. The following figure shows the diagram of the connection between the Supervisor PC and the remote module (Clipper). The main activities of the single components are also described.

Intelligent remote devices pilot I/O devices and axes (TRS-AX remote) directly on the machine. These devices read the Digital Input (ON/ OFF) or Analog Input channels, refresh the Digital or Analog Output channels and are connected to the Modules by means of a Greenbus (serial bus RS485 - 1 Mbaud) and CAN bus and PowerLink II and Ethercat optionally. The profile machining of Albatros is protected by a USB hardware key, configured by T.P.A. S.p.A.

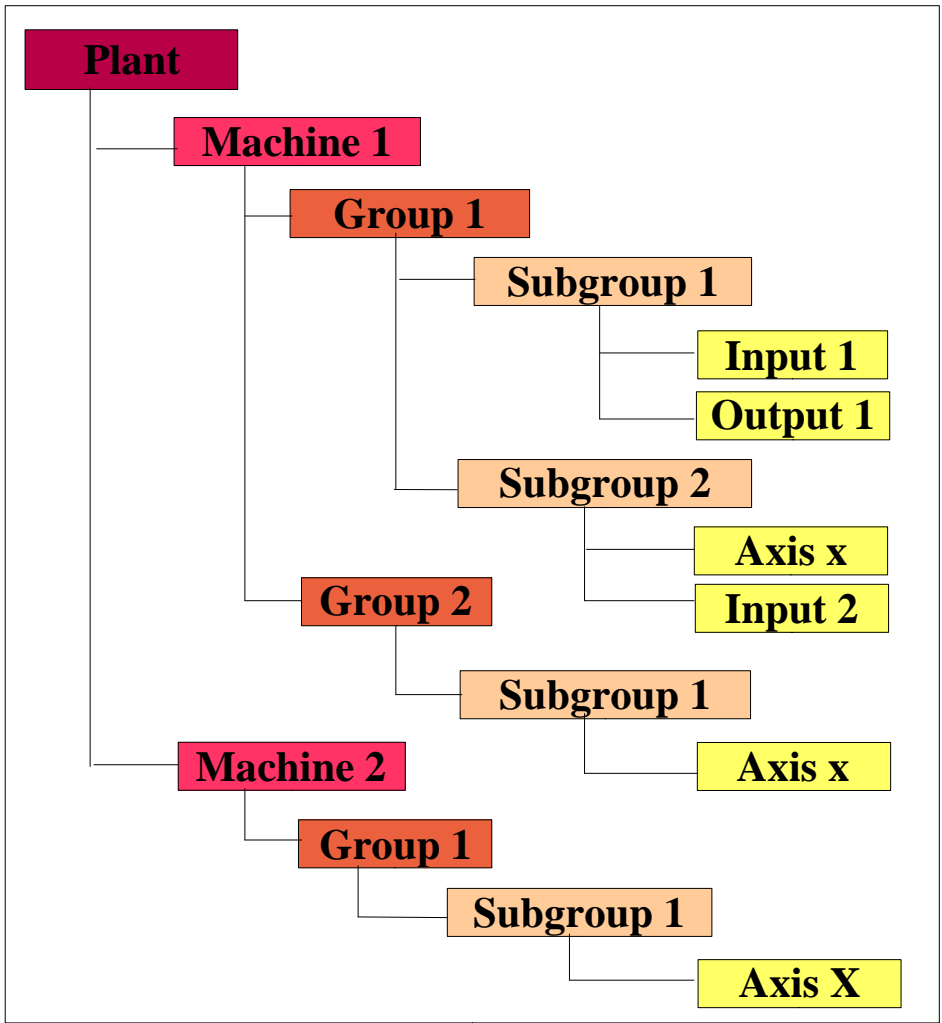
Example of hierarchical structure of a plant.

The following figure schematises the structure of a hypotheticalal plant composed by two machines:

NOTE: The Groups do not necessarily have to be divided into Subgroups, they can be made up directly of Devices.

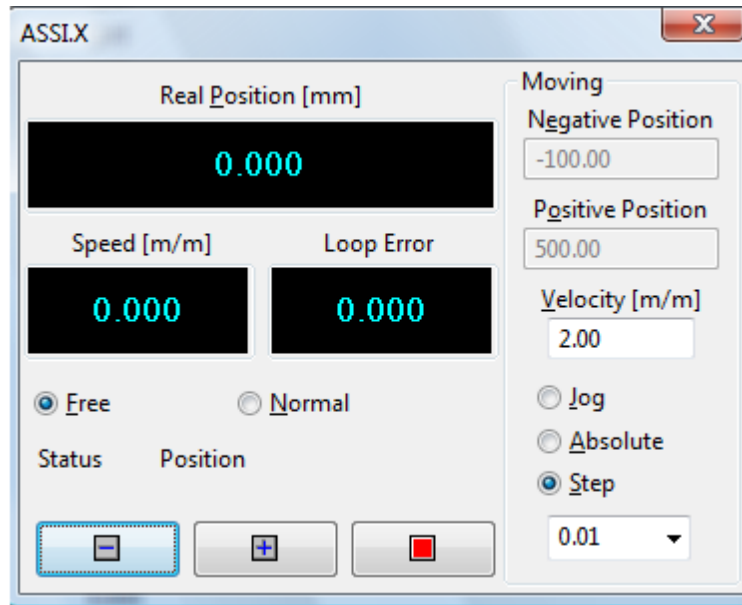
Manual axis movement window

To interact with an axis, simply *double click* with the mouse on the positions display field of the required axis. The dialog window in the figure below will open. In the case of Virtual, Stepping motor and Count axes, the dialog window contains less data. For example, in the case of a Count axis, only the Real Position and Speed values are displayed.

The window is composed of two areas, whose contents are described below.

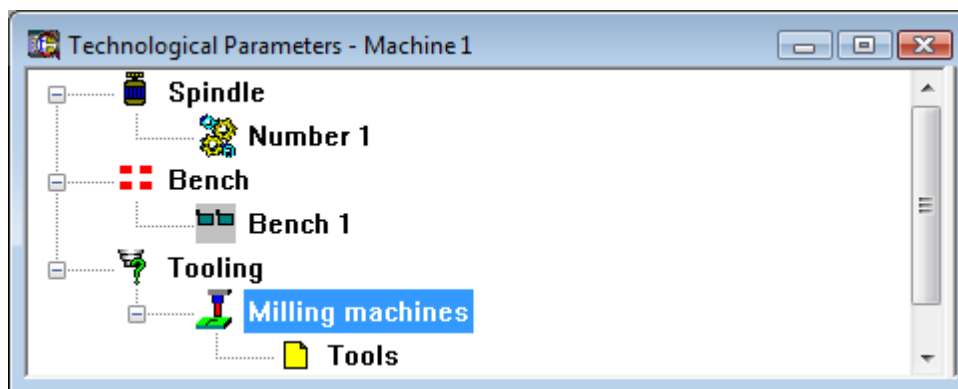
Structure of the Technological Parameter file.

The Technological Parameter window displays in a tree structure all the Groups and Subgroups of parameters that compose the file, as shown in the following figure.

The window contains Groups, displayed in a tree structure, with their relative Subgroups of parameters. The tree structure can be expanded or collapsed using the \oplus and \ominus buttons found at each node. The +, -, Right/Left arrows and **Enter** keys and the **Space Bar** can also be used to open and close parts of the tree.

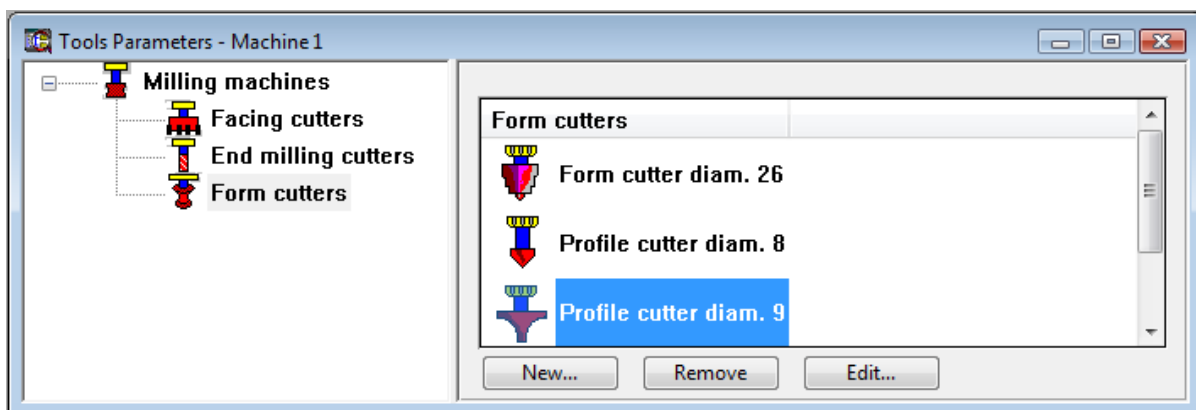
Example of a Tools Parameter Window.

The window of Tools Parameters can be opened in Menu **File->Open Tools Parameters**. Tools parameters, determined by the Manufacturer on the basis of the operations performed by the machine, are usually organised as shown in the figure below:

The Tools Parameter window is divided in two areas:

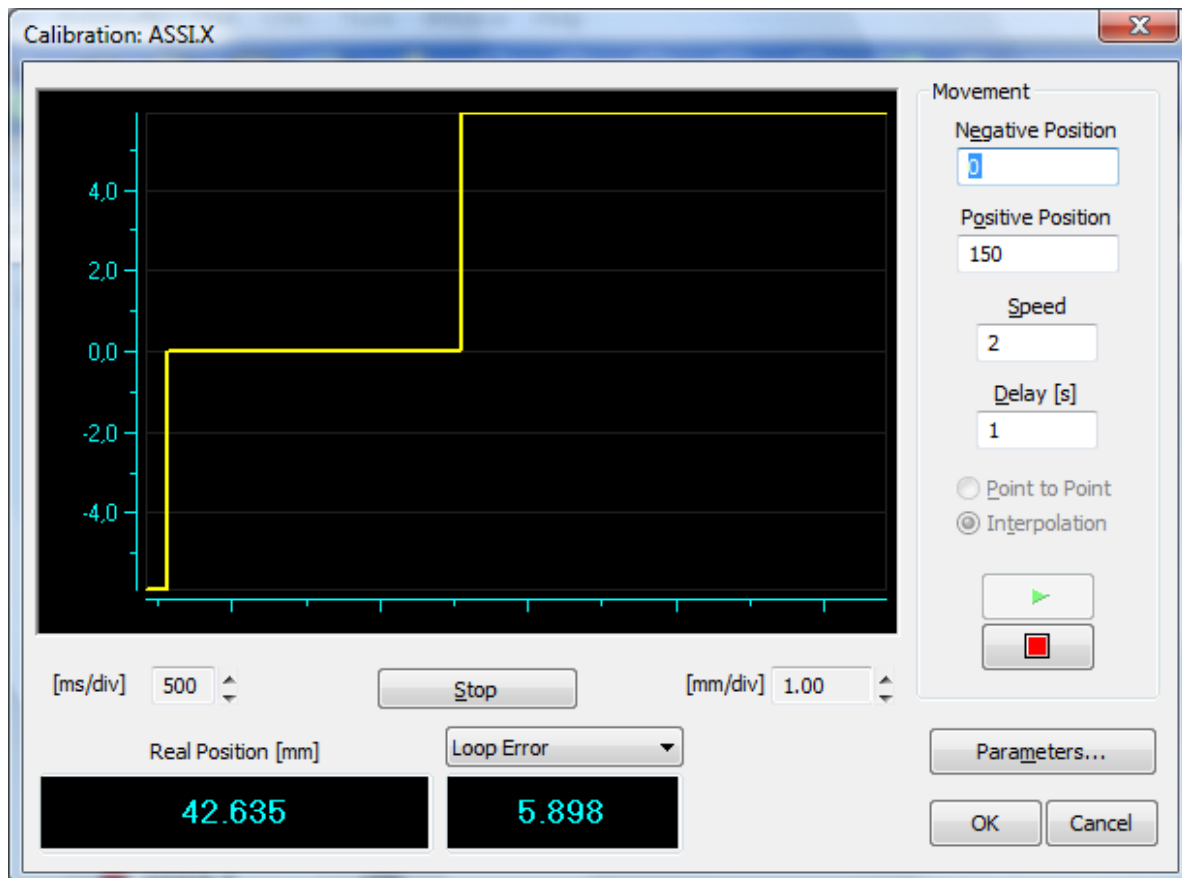
Axis calibration control board window

The calibration control board shown in the following figure will be displayed:

To verify axis behaviour as parameters change, the axis is moved continuously between two limit positions called **Positive Position** and **Negative Position**. As well as these parameters, axis movement **Speed** will also have to be set. In the early stages of calibration we suggest using a low speed value. A **Delay**, to be applied between movements, can also be fixed.

possible, as with bench oscilloscopes, to scale the graph to adapt it to the size of the window and to examine it in detail. By means of a mouse or control keys and buttons you can examine the last calibration minute again, display one or two cursors to measure and check on the sampled data, enlarge an area of the graph to analyse the details of the sampled data, change the offset and the scale both in the x and y-coordinates. Moreover graph scrolling can be interrupted by pressing the **Stop** button, to allow a careful study of the graph without having to stop the axis. Besides the graph, two boxes showing (on the left) the real position and (on the right) the size displayed graphically. This can be set using the combo box situated above the display box.

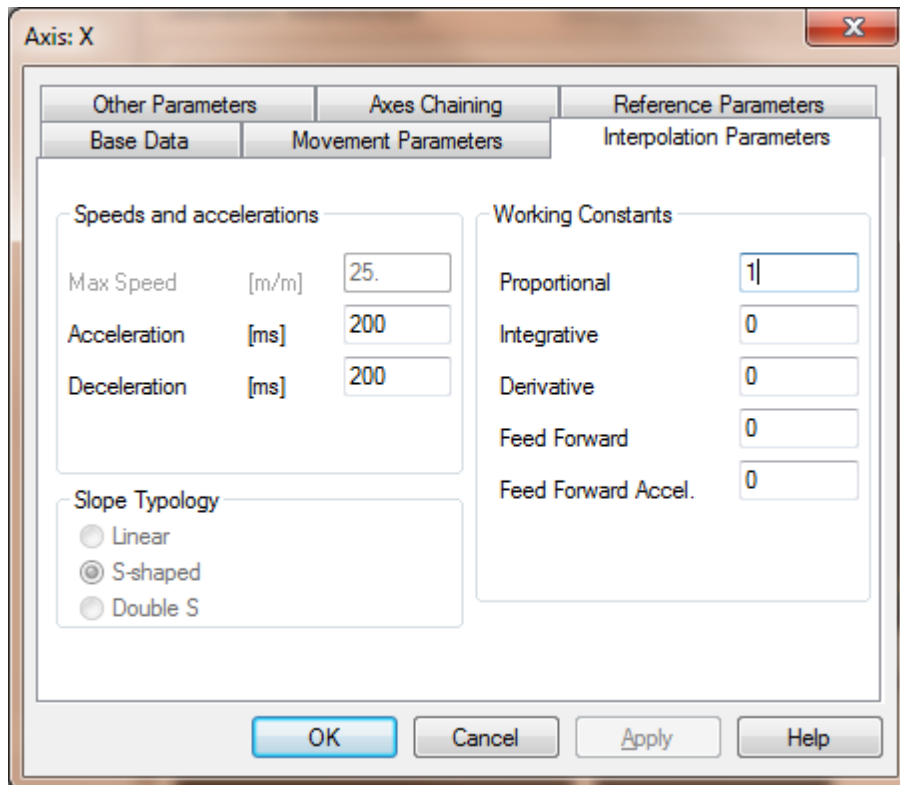
Parameter definition window for axis calibration

To change the parameters of the axes, press the **[Parameters...]** button, which activates the window shown in figure 6.2 where most axis parameters can be edited directly. Once a change has been made to one or more parameters it can be activated by pressing the **[Apply]** button. For such changes to be saved in the Configuration press the **[Ok]** button.

The principal parameters to be operated on are the following:
