Job No: 503550

Ref : VIPAC-ACS-6913-00

RE: Rain Noise Assessment of ASTEC EC-100 Paint

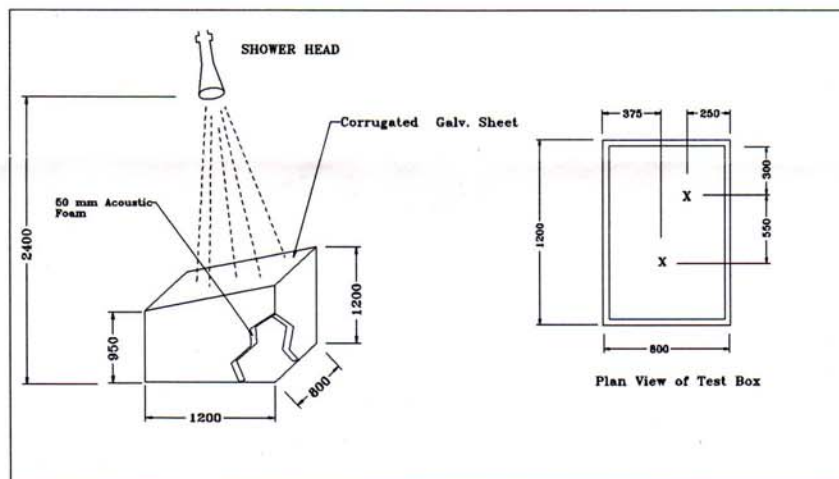
Figure 1-1 : Test Article Layout Showing the Test Box and Microphone Positions Marked X.

On, Wednesday, the 28th of May 1997, Vipac Engineers and Scientist measured the noise produced from 3 different flow rates of water as showered onto the test rig before and after the treatment of the 0.4 mm Corrugated Galv. Roof section surface with ASTEC EC-100 (as shown in Figure 1-1).

- The shower head was set up above the test box such that the area of the spray covered approximately 80% of roof surface. It was ensured that the shower head distributed the water as droplets and as evenly as possible.

- All interior surfaces of the test box (except the roof) was treated with 50 mm acoustic foam to reduce the internal acoustic reflections to a minimum.

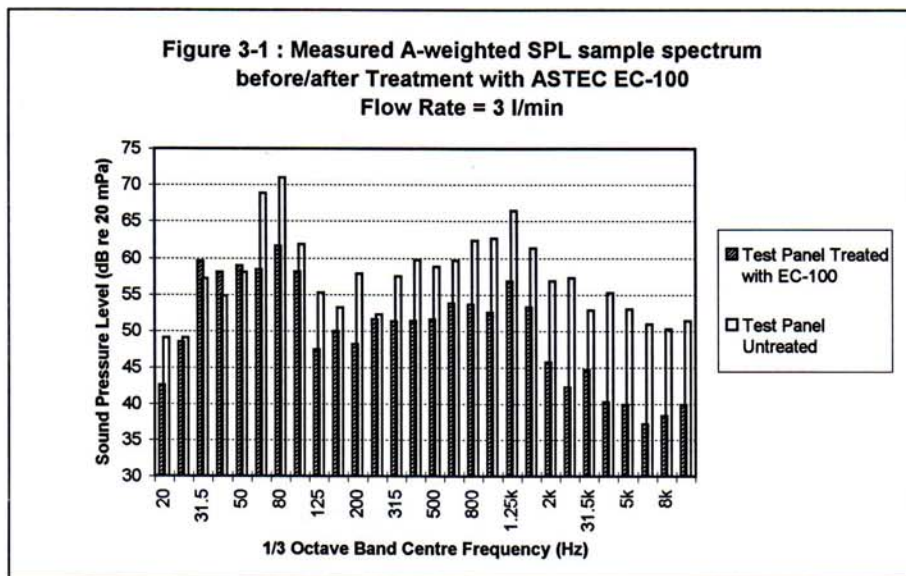
Figure 3-1 : Measured A-weighted SPL sample spectrum before/after treatment with ASTEC EC-100. Water sprayed onto test box roof at a Flow Rate of 3 l/min.

Typical frequency spectra as measured at 3 l/min can be seen in Figure 3-1.

- The sample coated with EC-100 showed a reduction in noise over the non-treated sample.
- The noise reduction occurred over most frequencies between 63 Hz and 10 kHz for all of the flow rates tested.
