3.0" THUREN/KING SHOCKS ADD ON INSTRUCTIONS FOR 2013+ RADIUS ARM TRUCKS

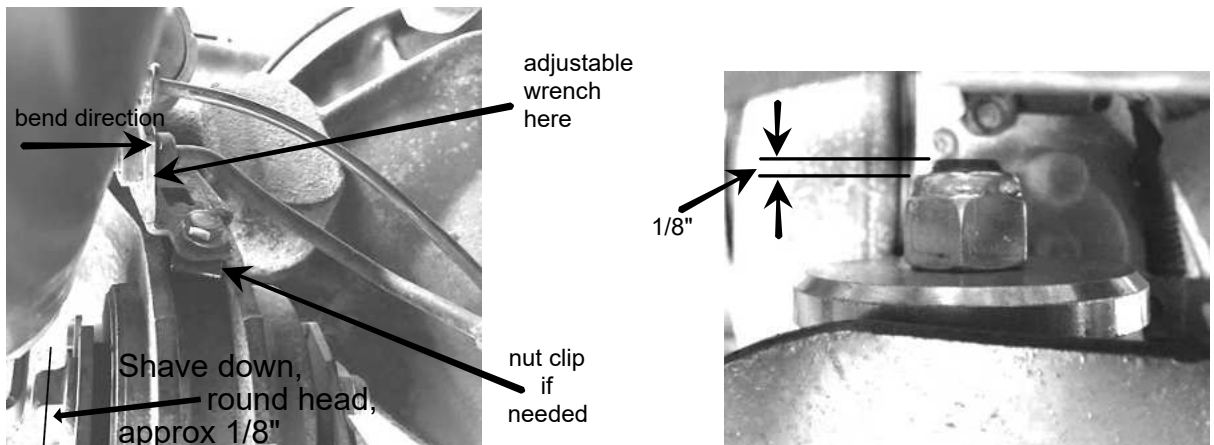
- 5) Not mandatory in most cases, but easy to do and smart in the long run, we suggest using a grinder and removing about 1/8" off the top of the upper radius arm bolt head. The reason for this is that under extreme off road conditions the 3.0 shock body can rub that bolt head. We have mostly seen this rub happen on Power Wagons, but even with a 2500/3500 it's smart to do.

- 4) Make sure that the upper radius arm bolt is installed, so the bolt head is on the same side as the shock. If that bolt was flipped for some reason, the protruding threads of the bolt would crash into the shock body during use, causing massive shock damage. The bolt comes from the factory in the correct direction, but you never know if the truck was worked on, if that bolt was put back the same way. Just check it...
