# **Prebona DuraClean™**

## **Fossilizing wood mechanism and effect**

## **Prebona report on formulations for fossilizing effect on wood (excerpt)**

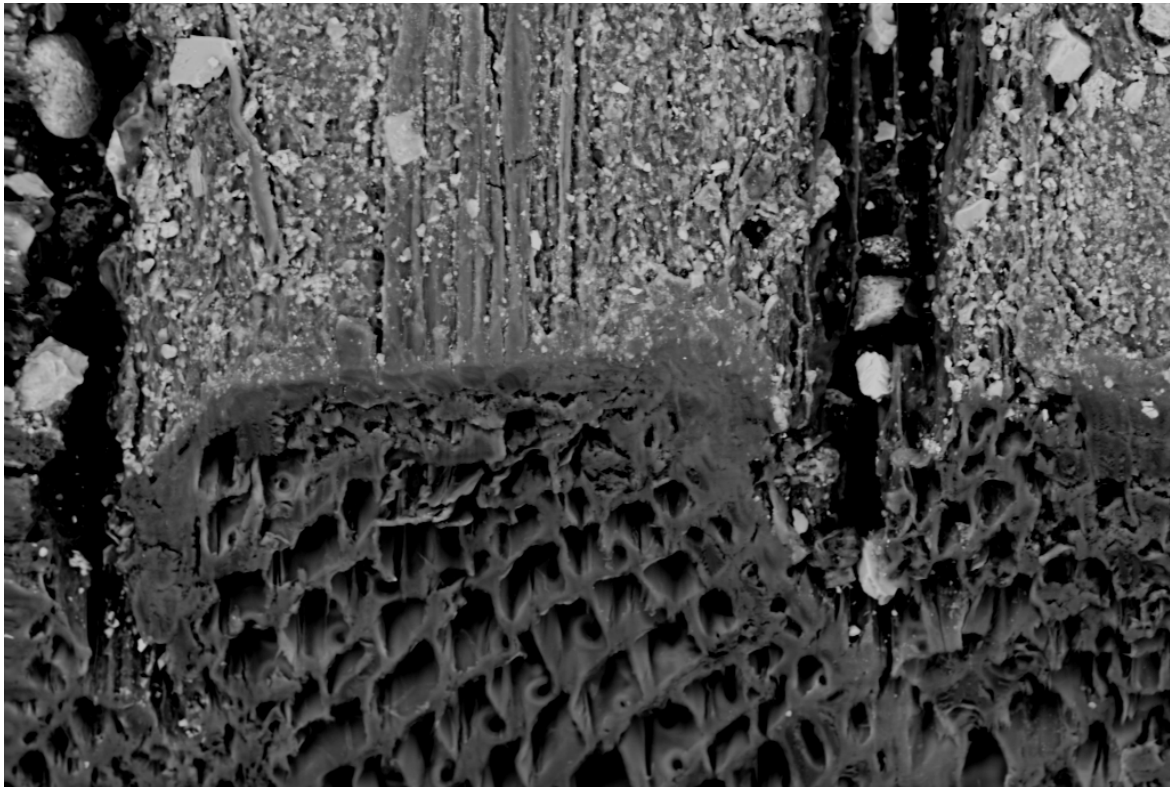
**Figure 2.b.** SEM images (500X) of old wood (1979) after 1 month outdoor exposure. Top: untreated sample. Bottom: sample treated with Prebona DuraClean.

Looking at the older wood from 1979 (see Figure 2.a, b and c), we can see that even the untreated samples have some inorganic material in the surface layer (naturally occurring fossilization), although not as much as the samples treated with Prebona DuraClean (instant or boosted fossilization). This difference is more striking when looking at the newer wood from 2000 seen in Figure 3.a, b and c, where very limited amount of inorganic material is seen on the surface of the untreated sample.

Interestingly, the pore structure further in to the wood also seems to have been impregnated with Prebona DuraClean. This is seen both in the older wood (Figure 2.a, b and c) and in the newer wood (Figure 3.a, b and c), where closeups at 1000x magnifications have been made roughly 100 µm below the surface. This suggests that Prebona DuraClean treatment has penetrated far beneath the surface and partly fossilized the fibers. We can also see some brighter spots in these images and in the 100x image (Figure 3.a) silica filled pores can be seen far below the surface. The results also suggest that Prebona DuraClean remains in the wood after outdoor exposure.
