# Greenhouse Coverings

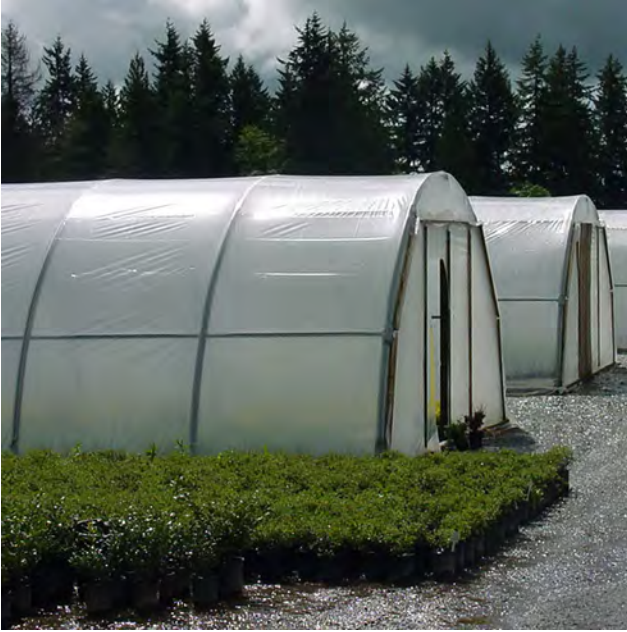
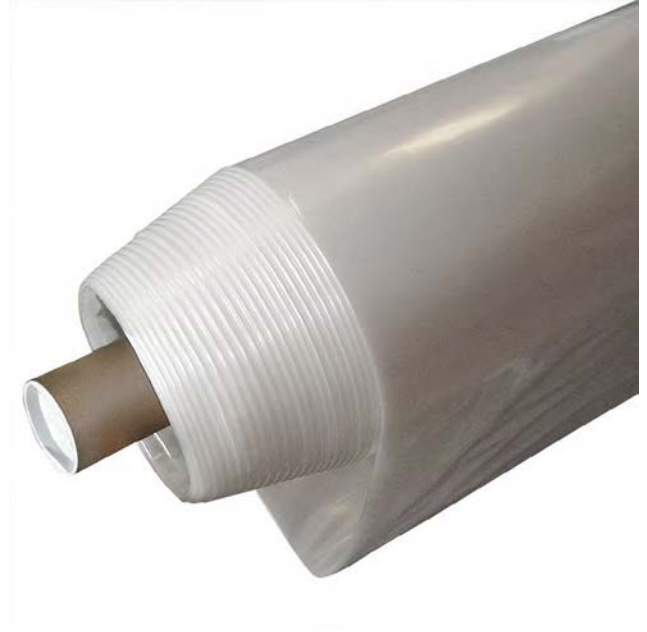
## Polyethylene Film

1. Can be applied in either single or double layer.
2. Double poly film requires the installation of an inflator fan to provide air between the two layers
3. Different grades are available and are rated as either one, two, three or four year film
4. All high quality greenhouse film has a UV inhibitor co-extruded into the film. This will give you extra life before replacement is necessary
5. Many films are also available with an anti-condensate coating to prevent condensate drip on the inside of the greenhouse during humid conditions

<b>Covering</b>	<b>Advantages</b>	<b>Disadvantages</b>	<b>Light Trans- mission</b>	<b>“U” Factor</b>	<b>Insulating Value “R”</b>	<b>Estimated Lifetime</b>
<b>Single Polyethylene Film</b>	<ul style="list-style-type: none"> <li>• Inexpensive</li> <li>• Easy to install</li> </ul>	Short Life	85%	1.2	.83	1 to 4 Years
<b>Double Polyethylene Film</b>	<ul style="list-style-type: none"> <li>• Inexpensive</li> <li>• Saves on heating costs</li> <li>• Easy to install</li> </ul>	Short Life	77%	.70	1.43	1 To 4 Years
<b>Corrugated Polycarbonate</b>	<ul style="list-style-type: none"> <li>• High Transmittance</li> <li>• High impact resistance</li> </ul>	Scratches easily	91%	1.2	.83	15 Years plus 10 Year warranty
<b>Glass Double Strength</b>	<ul style="list-style-type: none"> <li>• High Transmittance</li> <li>• High UV resistance</li> <li>• Resists scratching</li> </ul>	<ul style="list-style-type: none"> <li>• High cost</li> <li>• Difficult installation</li> <li>• Low impact resistance</li> <li>• High maintenance</li> </ul>	88%	1.1	.91	25 plus years

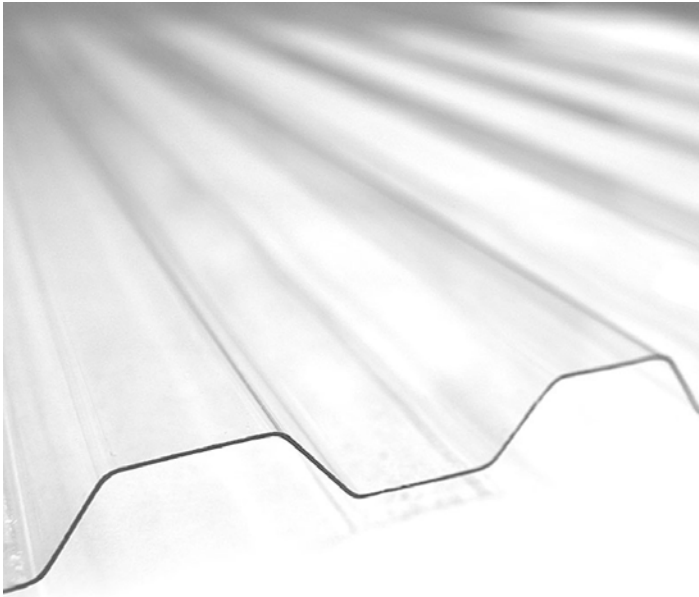
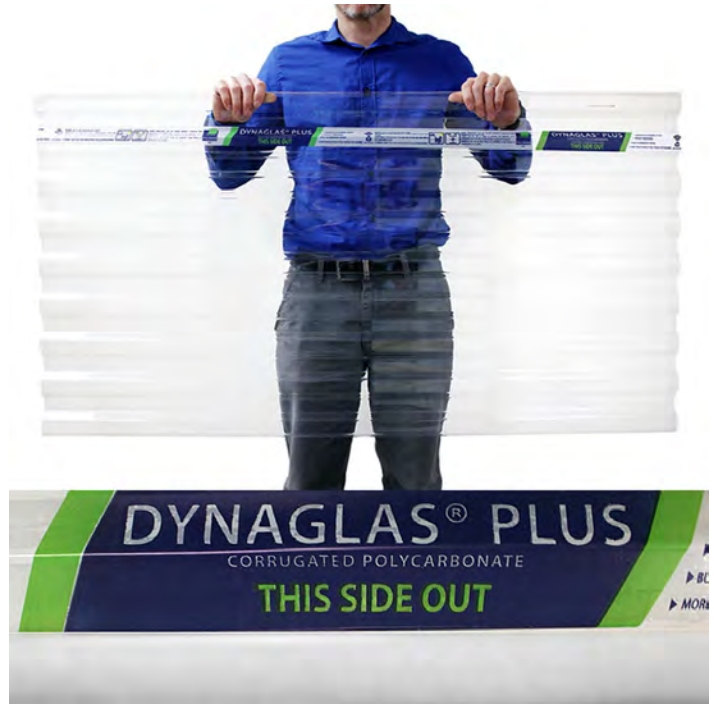
# Corrugated Polycarbonate

1. This is a hard plastic glazing material which approaches glass in its clarity and light properties. Transmission value of up to 92%.
2. Relatively inexpensive. Requires no special extrusions for attachment.
3. Easily installed. Lightweight and can be cut with utility knife or tin snips.
4. Available with anti-condensate coating on inside surface to reduce condensate dripping.
5. Virtually unbreakable which makes it extremely resistant to hail damage.
6. UV protected outer surface to provide long life under high sun conditions.

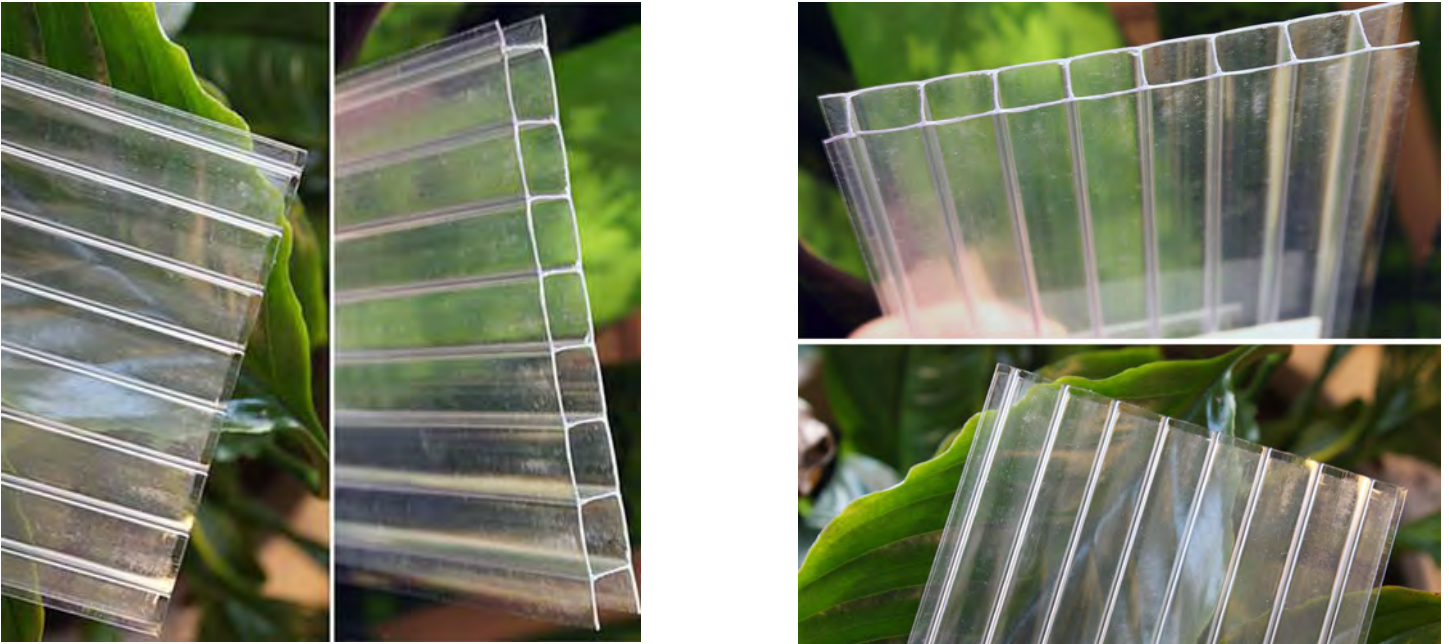
# Multi-Wall Polycarbonate

1. Tough impact strength for resistance to hail.
2. Provides insulation value similar to insulated glass. Reduces heating costs.
3. UV protected outer surface to provide long life under high light conditions.
4. 10 year warranty against yellowing and loss of light transmission.

<b>16mm Triple Wall Polycarbonate</b>	<ul style="list-style-type: none"> <li>• High Impact resistance</li> <li>• Saves on heating costs</li> </ul>	<ul style="list-style-type: none"> <li>• Requires glazing system to install</li> <li>• Scratches easily</li> </ul>	78%	.42	2.38	15 years plus 10 Year warranty
