INSTALLATION INSTRUCTIONS - INS031

1979 - 1998 MUSTANG
1999 - 2004 MUSTANG EXC. IRS

PERFORMANCE REAR CONTROL ARMS

Part# 2521, 25210, 2526 and 25260

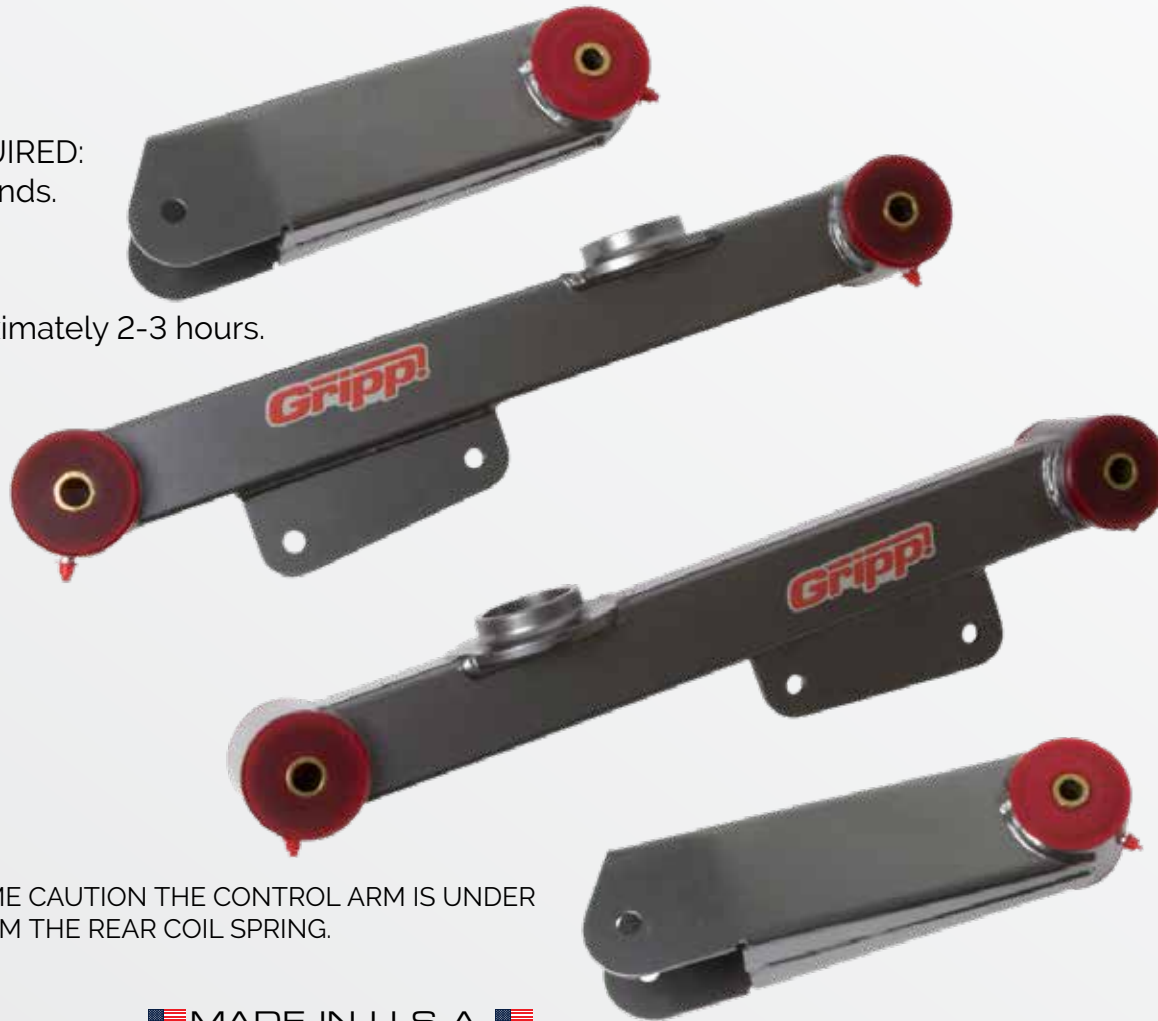
IMPORTANT! USE EXTREME CAUTION THE CONTROL ARM IS UNDER EXTREME PRESSURE FROM THE REAR COIL SPRING.

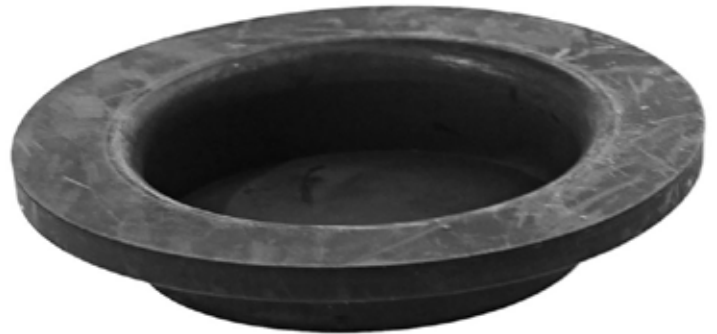
STEP 7

Upon removal of the factory coil spring, inspect the rubber insulators and replace with [BBK part # 2546](#) if necessary.
