SafetyPro Ribbon Loading

Improper loading of the SafetyPro ribbon can cause the ribbon to feed out and get cut with the vinyl, or other printing errors such as a red flashing light or no ink transfer. The most common ribbon loading issue is incorrect placement of the black ribbon spindle, and incorrect feeding of the ribbon between the supply and rewind sides. This issue is detailed below.

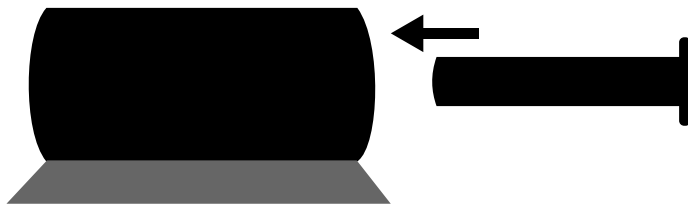
Figure 1

The rear spindle is for the full supply roll. The spindle must be inserted from the right-hand side, with the supply roll unwinding from under the roll, as shown in figures 1 and 2.

The ribbon is loaded on two black plastic spindles, with a lip/flange on one side. That lip must be on the right-hand side for both rolls when in the printer, in order to engage with the mechanism in the printer properly.

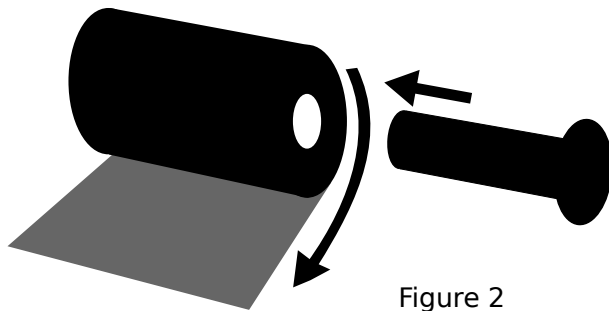
Figure 2

When inserting the spindle in the supply roll, make sure the ribbon is unwinding as shown in figure 2.
