PACSystems* RX7i

IC698CPE010/CPE020

Central Processing Unit

GFK-2244AG

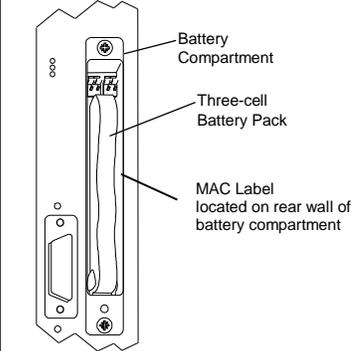
Subject	Description
<p>One TTL value configuration for all EGD groups</p>	<p>The system accepts only one TTL value configuration. If you configure separate TTL values for each EGD group, the minimum TTL value will be configured for all EGD groups.</p>
<p>Protection against attack on FTP and Web servers</p>	<p>When the FTP connection is not in use, the number of FTP servers should be set to 0. This protects against attack on FTP Server.</p> <p>Likewise, when Web pages are not in use, the number of Web servers should be set to 0.</p> <p>To set these parameters, Go to the Settings tab of the Ethernet Module configuration in Proficy Machine Edition. Set <i>Max Web Server Connections</i> and <i>Max FTPServer Connections</i> to 0.</p>
<p>MAC address</p>	<p>A label on the rear wall inside the CPU's battery compartment identifies the MAC address assigned to the CPU's embedded Ethernet Interface.</p>

<p>The diagram shows a vertical battery compartment. At the top is the 'Battery Compartment' label. Below it is a 'Three-cell Battery Pack'. At the bottom, on the rear wall, is a 'MAC Label located on rear wall of battery compartment'.</p>
