Demonstration and Evaluation of Lighting Technologies and Applications

MOGUL SCREW-BASE LED REPLACEMENT LAMPS FOR HIGH BAY ENVIRONMENTS

Field Test DELTA

Mogul Screw-base LED Replacement Lamps for High Bay Environments

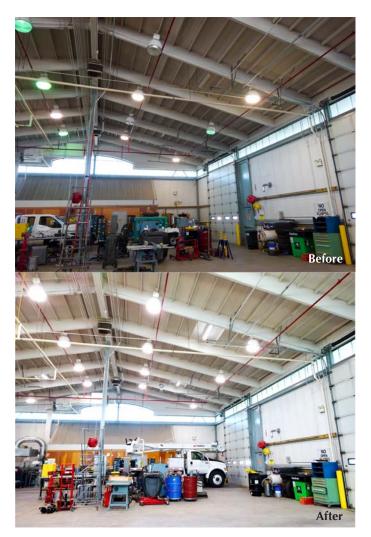
BPA Maintenance Facility before and after installation of LED replacement lamps

The existing 400 W (nominal) metal halide lamps were not new; out of 21, two were distinctly dim and green in color, four were not operating, and all the diffuser lenses were dirty. When the new LED replacement lamps were installed, the luminaires were also cleaned. For one circuit, lenses were not replaced; for the two other circuits, lenses were cleaned and re-installed, enabling comparisons with and without lenses.
