Advantec 75 Feed Gap Procedure

Feed gap adjustment of the unit is always performed before shipment. However, feed gap adjustments may be required periodically. The rubber components in the feeding mechanism will wear over time, causing the feed gap to get enlarged. This can lead to DBL, HLF or CHAIN errors.

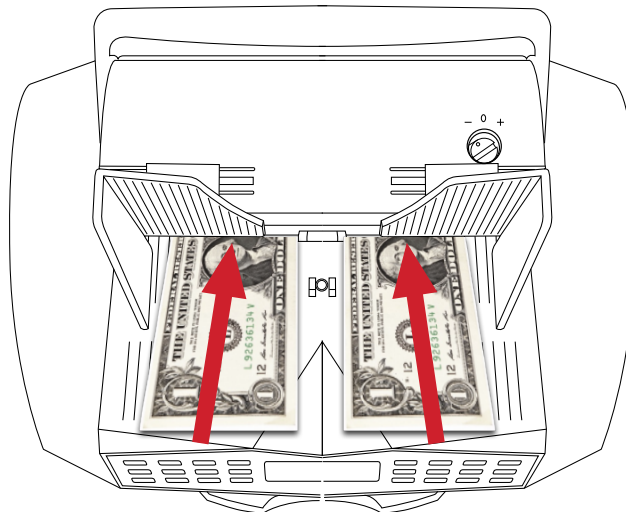
4. Place two of the most rigid bills onto the hopper platform length wise, centered and approximately one inch apart (See image below).
