TURBOCHARGER REPLACEMENT: DIAGNOSING INITIAL FAILURE & INSTALLATION

PRIOR TO FITMENT OF REPLACEMENT TURBOCHARGER THE FOLLOWING MUST BE OBSERVED

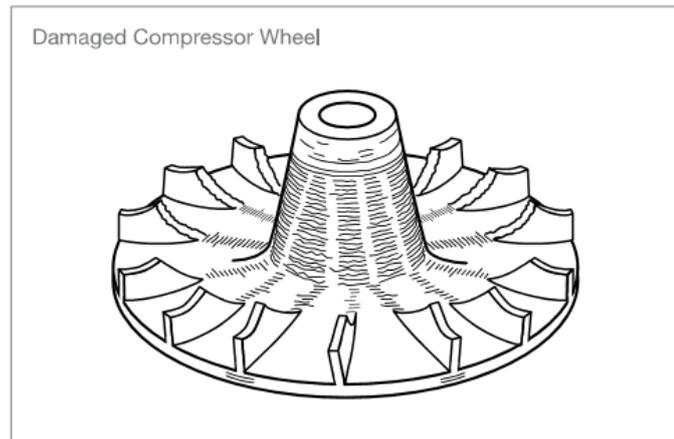
1. Foreign object damage

Check air cleaner assy to ensure the filter is sealing and is not blocked or restricted. Inspect all air induction piping ensuring the hoses are intact with no perforations.
