2 System Error Codes

Introduction

Understand System Error Codes

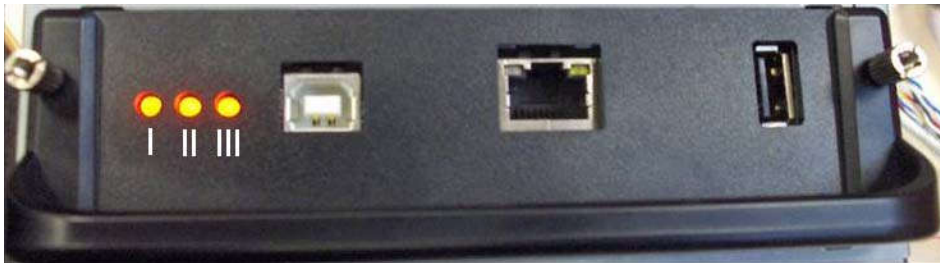
The following image shows the Formatter LEDs, which should be marked I, II and III.

Power supply LED	Formatter I LED	Formatter II LED	Formatter III LED	Touch Control Panel status	Part to change
1	Off	Off	Off	Off	Off	Power supply, see Power Supply Unit on page 466
2	On	Off	Off	Off	Off	Engine PCA, see EE Box on page 370 .
3	On	On	Off	Off	n/a	Reseat the Formatter, if this does not solve the issue, replace the Formatter, see Formatter on page 381 .

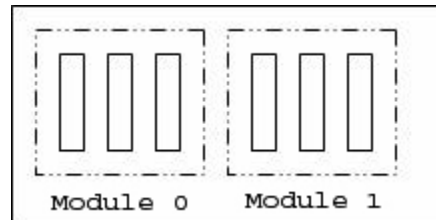
System Error: **22.0:YZ**

Problem Description: Left Ink Supply Station error, module 0.

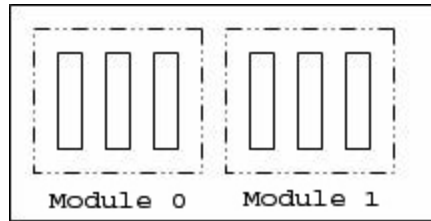
System Error: **22.1:YZ**

Problem Description: Left Ink Supply Station error, module 1

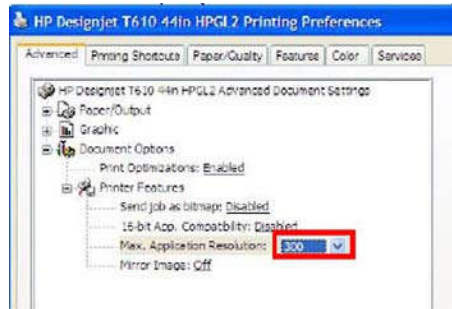
- The resolution required by the product to process the file is set by the print mode selected (Best, Normal, Fast). There is a setting available that enables you to decrease the resolution for each print mode to 300 dpi. If this setting is used, the rendering resolution will be reduced, but the output (printing) resolution will remain the default of the selected print mode. There could be an impact on Image Quality because of the reduction in the rendering resolution; this will be especially noticeable in circles and lines with very low inclination.

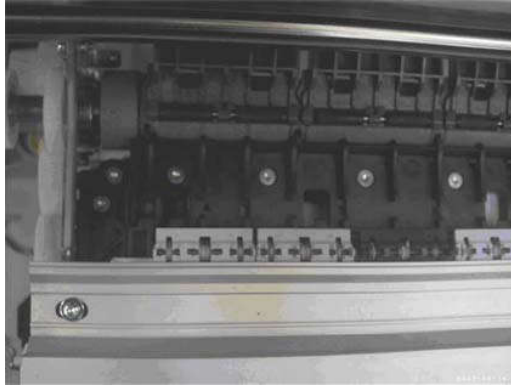
- Consistent 81:YZ error codes.
- Platen fingers rubbing on the roller surface, leaving black marks on the roller.

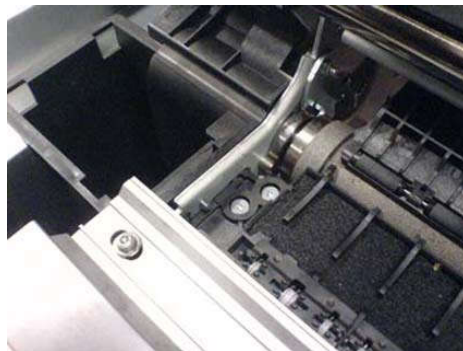
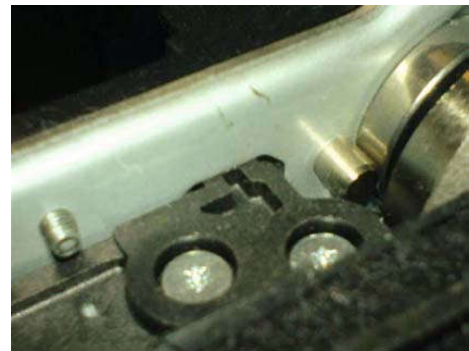
- A gap on the platen beam. If there's any gap in Z (vertical direction) between the plastic feature of the platen and the metal side plate, then the chassis is damaged and the unit cannot be repaired.
