## No. 1466298.5

Flooring Planks – Genuine Oak planks fixed to a perspex base using Mapei Ultrabond Eco 995. D3 PVA adhesive was applied in the joints before being assembled by the client.

### ISO 4760:2022(E) - LAMINATE FLOORING – TOPICAL MOISTURE RESISTANCE – ASSEMBLED JOINT (MODIFIED)

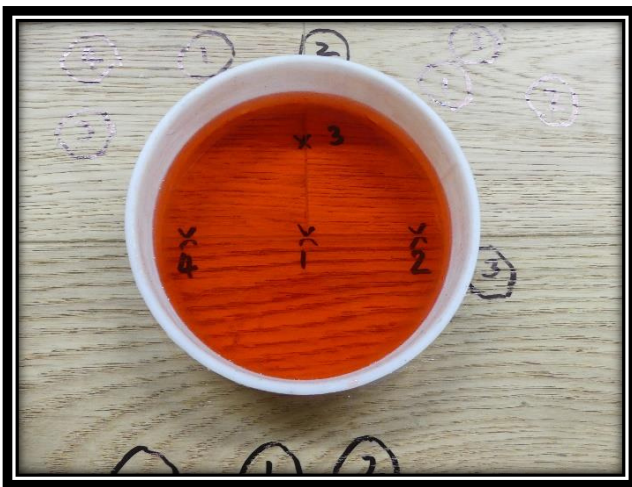
24hrs with water Wet Swell

100 mls of dye solution was applied onto the sample surface. It was poured into a cylinder 100mm diameter placed in the centre of the sample at the "T joint." Sealant was used at the plank/cylinder interface to avoid leakage.

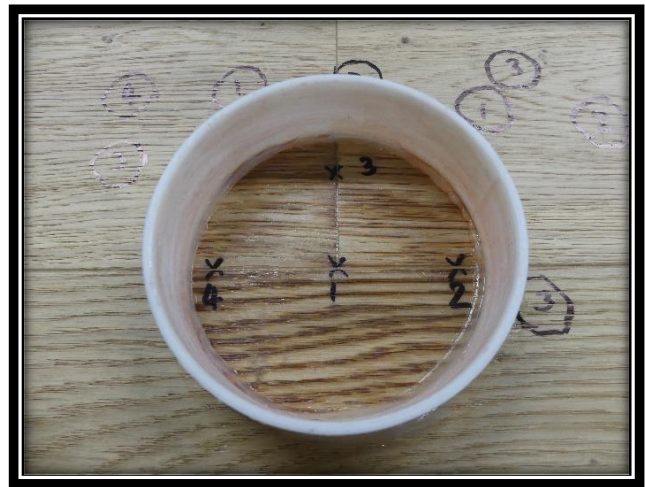
Wet Swell

Quantitative measurements are used to calculate surface swell in mm (within 15 minutes after water removal) and recovery swell (24 hours after removal of water).

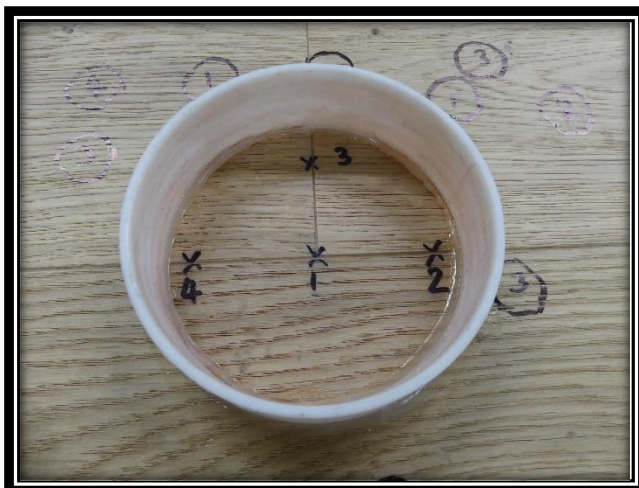
Wet Swell after recovery

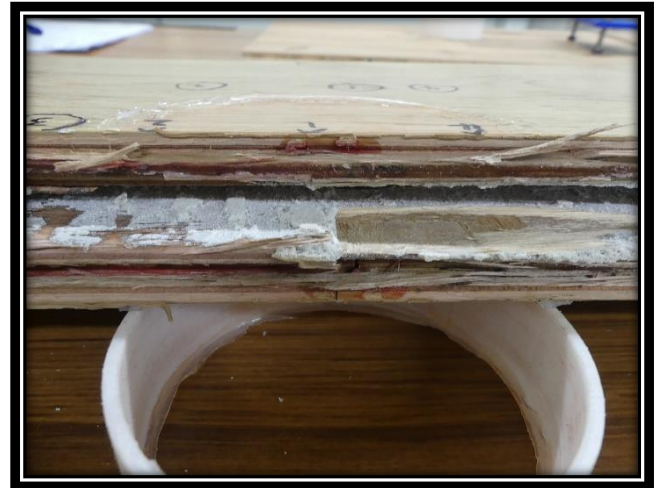
Disassembled after recovery
