ControlLogix Enhanced Redundancy System, Revision 20.058_kit2

Redundancy Module Catalog Numbers
1756-RM, 1756-RMXT, 1756-RM2, 1756-RM2XT

Controller Catalog Numbers
1756-L61, 1756-L62, 1756-L63, 1756-L63XT, 1756-L64, 1756-L65, 1756-L71, 1756-L72, 1756-L73, 1756-L73XT,
1756-L74, 1756-L75

Communication Module Catalog Numbers
1756-CN2/B, 1756-CN2/C, 1756-CN2R/B, 1756-CN2R/C, 1756-CN2RXT/B, 1756-CN2RXT/C, 1756-CN2RK/C, 1756-EN2T,
1756-EN2TR, 1756-EN2TXT, 1756-EN2TRXT, 1756-EN2TRK/C, 1756-EN2TK/D, 1756-EN2F/A, 1756-EN2F/B,
1756-EN2F/C

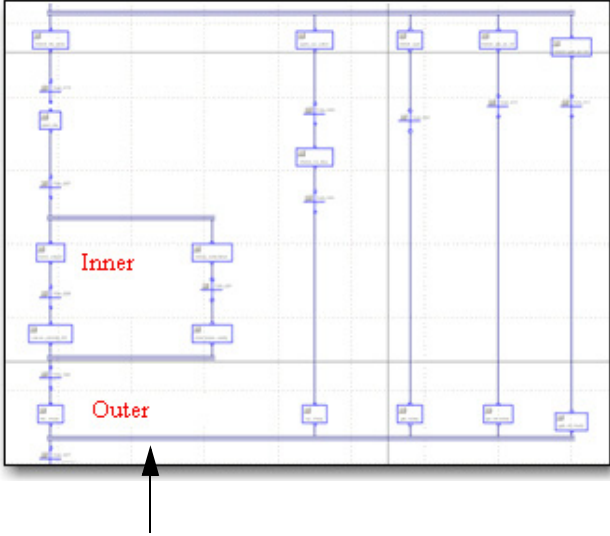
Cat. No./System Component	Enhanced Redundancy System Revision	Description
1756-L61 1756-L62 1756-L63 1756-L63XT 1756-L64 1756-L65 1756-L71 1756-L72 1756-L73 1756-L73XT 1756-L74 1756-L75	20.054	<p>CORRECTED: An anomaly can occur when you nest simultaneous branches in a sequential function chart (SFC) routine as shown in this graphic.</p>

<p style="text-align: center;">Bottom-most Steps</p> <p>During normal operations, the logic does not step out of a simultaneous branch until all incoming legs have reached their bottom-most step. In the example that is shown, the logic does not step out of the Outer simultaneous branch until the left-most leg has stepped out of the Inner simultaneous branch.</p> <p>The first time through the SFC routine, the application works as expected. On subsequent scans, however, the chart steps out of the Outer simultaneous branch even though the left leg has not reached the Inner simultaneous branch yet.</p> <p>This behavior occurs because the information in the bottom step, that is, the step next to the word Outer, remains from the previous scan. This stale information incorrectly causes the transition to move on as if the left leg is at the bottom step when it actually is not.</p> <p>To work around this anomaly, confirm that all incoming legs have reached their bottom steps in the transition. You can check the .x bits to make sure that the bottom-most step of each converging leg is active before allowing the chart to advance. This check can be added to the transition logic already present.</p> <p>For example, the steps in the following expression are the bottom steps (see the previous graphic) of the incoming legs. Each step has a timer. The transition does not move on until all step timers have reached their preset value.</p> <p>The expression can be modified to be sure that those steps are truly active. This expression is the original expression:</p> <pre>// Unit is ready to Transition Step1_ready.dn and Step2_ready.dn and Step3_ready.dn and Step4_ready.dn and Step5_ready.dn</pre> <p>This expression is the modified expression to work around this anomaly.</p> <pre>// Unit is ready to Transition Step1_ready.x and Step2_ready.x and Step3_ready.x and Step4_ready.x and Step5_ready.x and Step1_ready.dn and Step2_ready.dn and Step3_ready.dn and Step4_ready.dn and Step5_ready.dn</pre> <p>IMPORTANT: The x bit is cleared when the chart transitions out of a step.</p> <p>If you add this check to the condition, it forces the engine to wait until all of those steps are genuinely active before advancing out of the simultaneous branch.</p> <p style="text-align: right;">Lgx00118189, Lgx00116506</p>

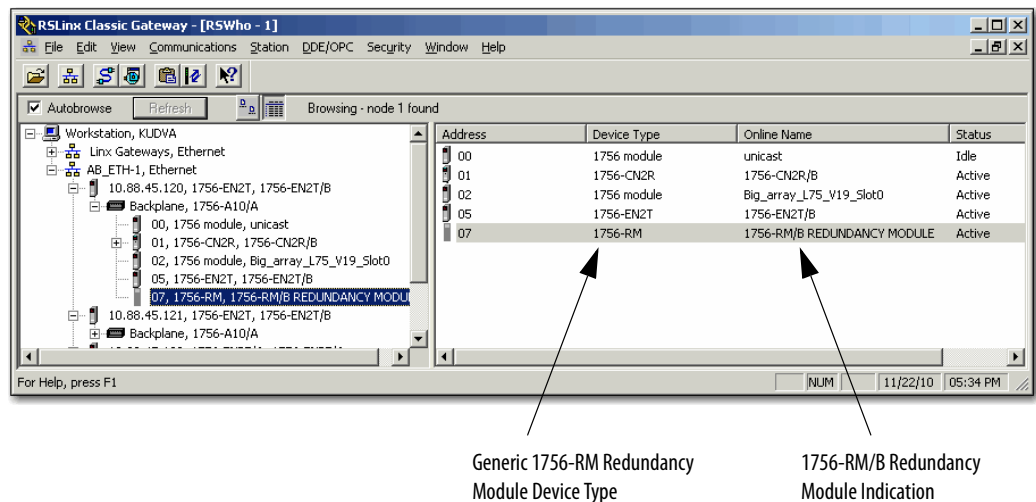
We recommend that you use the EDS file for redundancy modules that is included with the enhanced redundancy system, revision 20.054_kit1 firmware bundle. With the new EDS file, the RSWho software Device Type column shows a generic 1756-RM device type, as shown in this graphic.

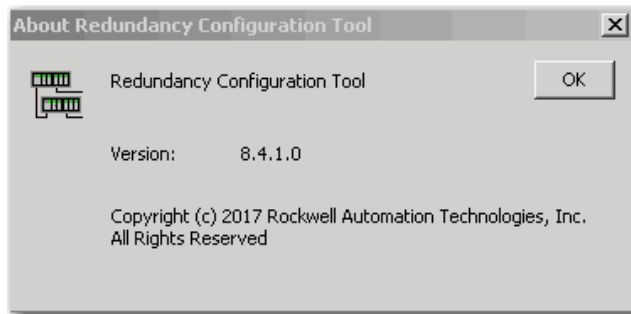
The About dialog box opens and indicates the RMCT version.

- TIP** The RMCT launches at the version that is compatible with the 1756-RM or 1756-RMXT redundancy module firmware that is installed.
- The About dialog box cannot reflect the new RMCT version. This condition occurs if you update your RMCT version but do not update your 1756-RM or 1756-RMXT redundancy module firmware revision compatible with the new RMCT version.

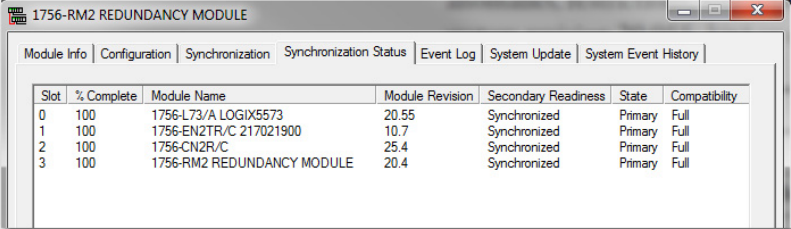
20. After the update completes, connect the Ethernet cable to the secondary Ethernet module, and wait for communication to resume on the network.
21. To verify that compatibility is Full for all communication modules in the chassis, check the Synchronization tab in the RMCT.

Slot	% Complete	Module Name	Module Revision	Secondary Readiness	State	Compatibility
0	100	1756-L73/A LOGIX5573	20.55	Synchronized	Primary	Full
1	100	1756-EN2TR/C 217021900	10.7	Synchronized	Primary	Full
2	100	1756-CN2R/C	25.4	Synchronized	Primary	Full
3	100	1756-RM2 REDUNDANCY MODULE	20.4	Synchronized	Primary	Full

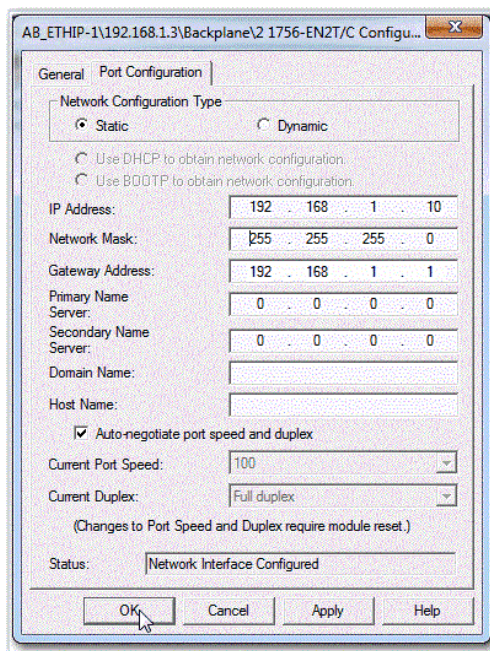
- b. On the Port Configuration tab, enter the desired IP address, Network Mask (if not entered automatically), and click OK.

This example uses the values in the following screen capture.

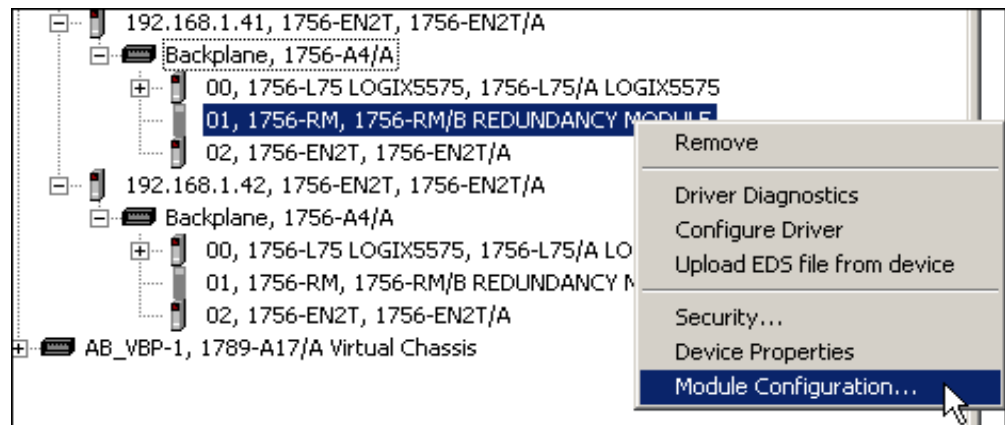
10. If you want to store the project to the nonvolatile memory card of the primary controller, execute a switchover as described in these steps.
- a. In RSLinx Classic software, right-click the 1756-RM module and choose Module Configuration to open the RMCT for the **primary** redundancy module.
