# **Exposure at Paint Removal with the Speedheater Infrared System**

**Richard Berglund**, M Sc  
Industrial researcher and Project manager

IVF Industrial Research and Development Corporation  
Argongatan 30  
SE-431 53 Mölndal, Sweden

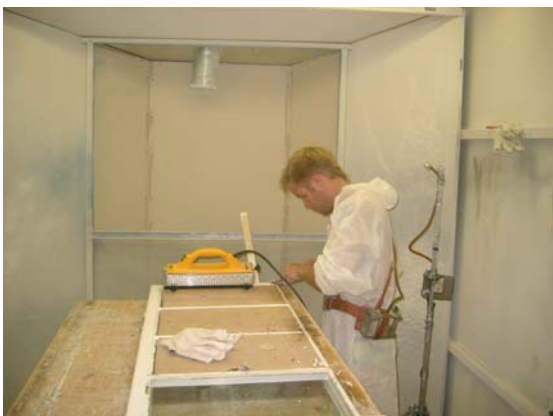
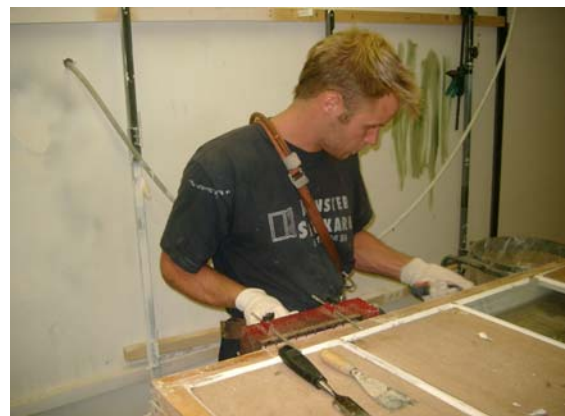
**Sampling:** Fumes and dust particles in the air were sampled on 25 mm filters. One sample was taken stationary in the room and one from the shoulder of the worker, who were using a Speedheater for paint removal throughout the sampling time. Sampling data is given in Appendix 1.

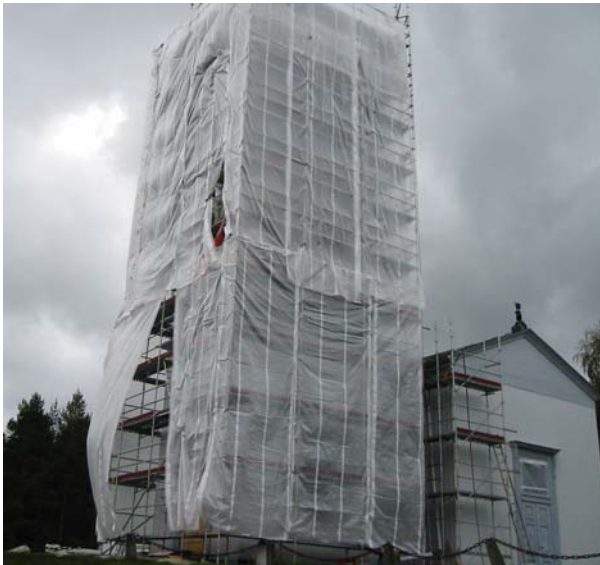
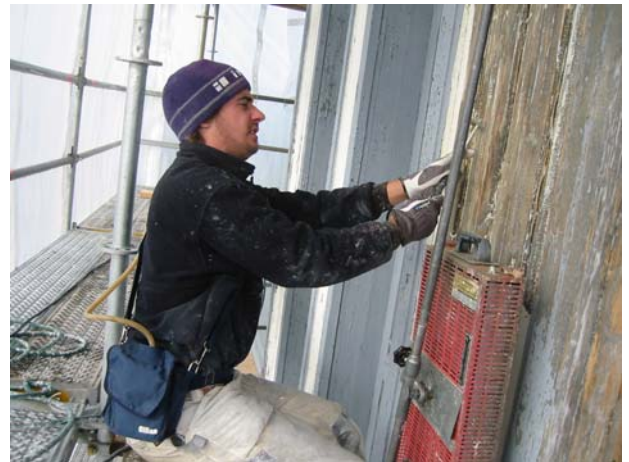
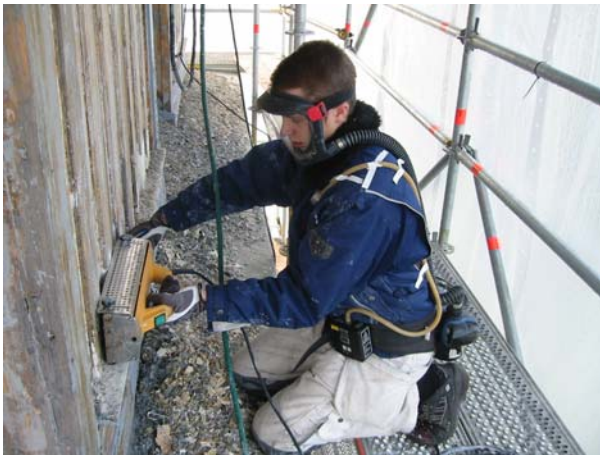
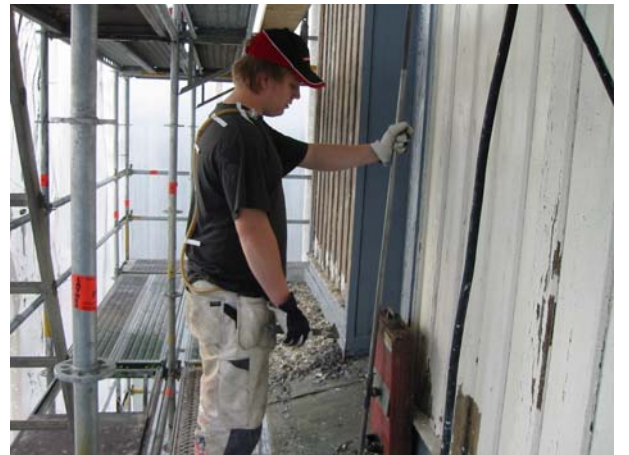
**Sampling:** Fumes and dust particles in the air were sampled on 25 mm filters. One sample was taken from the shoulders of each of the three workers, all using a Speedheater for paint removal throughout the sampling time. Recommended work procedures for the Speedheater System were followed. Sampling data is given in Appendix 1.

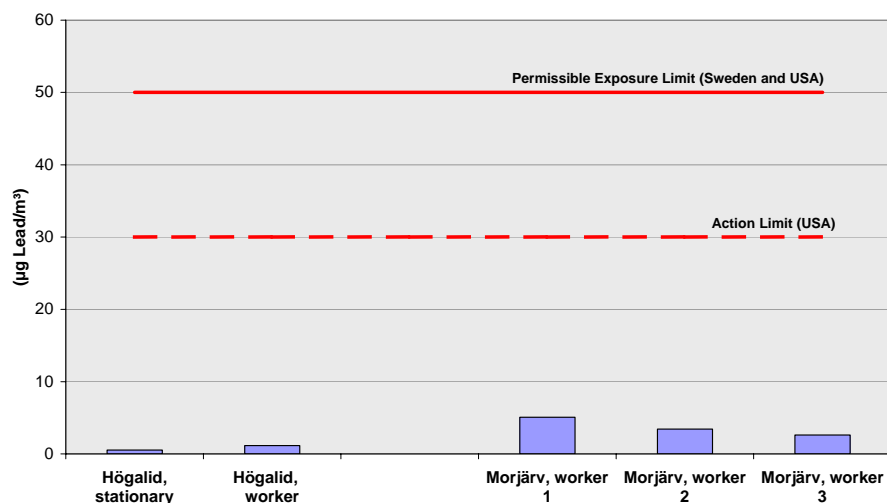
The limits apply to the total exposure during an 8-hour workday. Interpretation is made as if the work had continued in the same way during the complete workday, which is an overestimation of the exposure.
