## **ROTOR** power meter troubleshooting

Today's Tech News covers all common issues, tips and tricks from the development team, which are important for our 2INpower and INpower power meters.

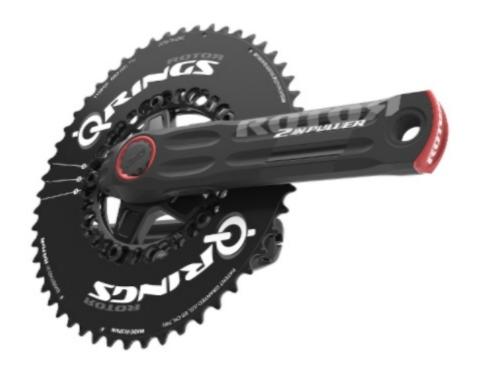
#### **2INPOWER PRODUCT FAMILY**

This section includes all points for addressing issues with 2INpower cranks
