| Subject: | 42-0010-011 Spin Motor Controller Obsolescence |
| Summary: | Information regarding the manufacturer obsolescence of the MAX-430 Spin Motor Controller (MC1) used to control Spin Motor in the Spin Rinse Dry Station in the OnTrak System. |

Technical Memo #013.1

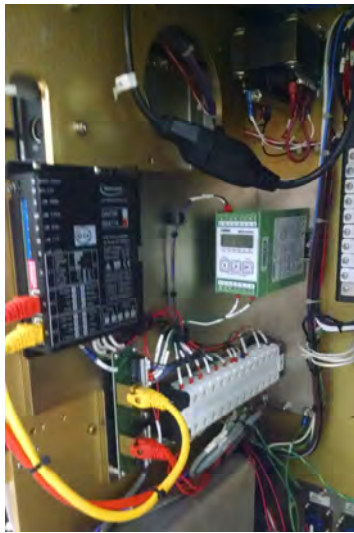
Spin Controller Retrofit

26-8875-904 Retrofit, Spin Mtr Cntrl

Uses the Entrepix Power Supply Retrofit. The Entrepix Power Supply modules can be replaced on failure as opposed to replacing the entire power supply.

A retrofit kit is required to replace the original controller. Depending on the type of power supply used, or desired, different retrofit kits are available.
