muss.dental

Quality Report

on the condition and function of handpieces and turbines from leading instrument manufacturers after more than one year of use and regular reprocessing in Careclave (4-in-1 Solution by MELAG Medizintechnik)

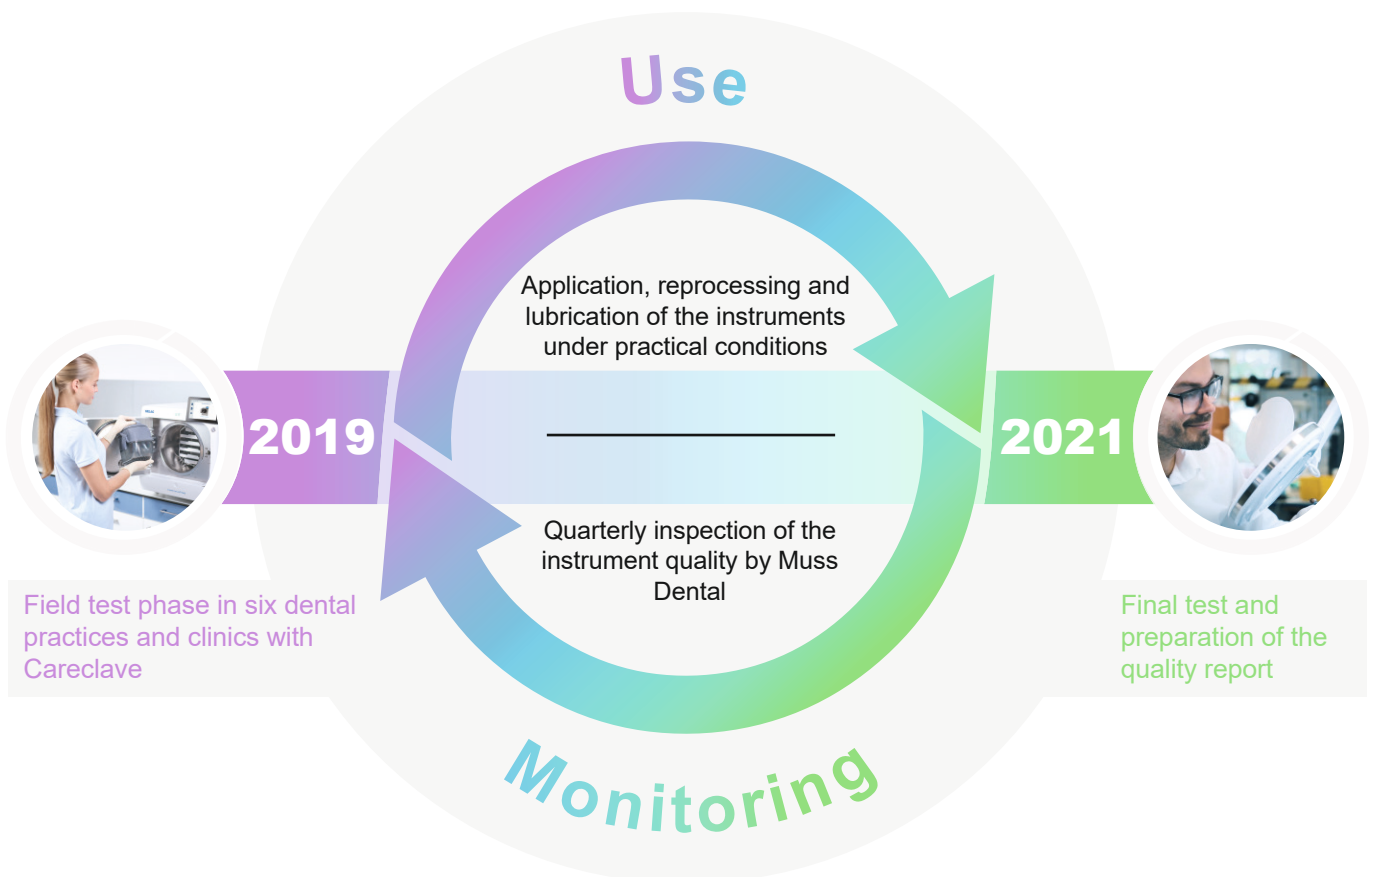
The following figure provides an overview of the test series procedure:

The test series extended from November 2019 to February 2021. At the beginning of this test series, brand-new instruments were used in six different dental practices and clinics for the daily treatment of patients. The instruments were checked by us at regular intervals and completely opened at the end of the test series.

At three-month intervals, the instruments were sent in again and tested. The interim and final results were each compared with the values initially determined.

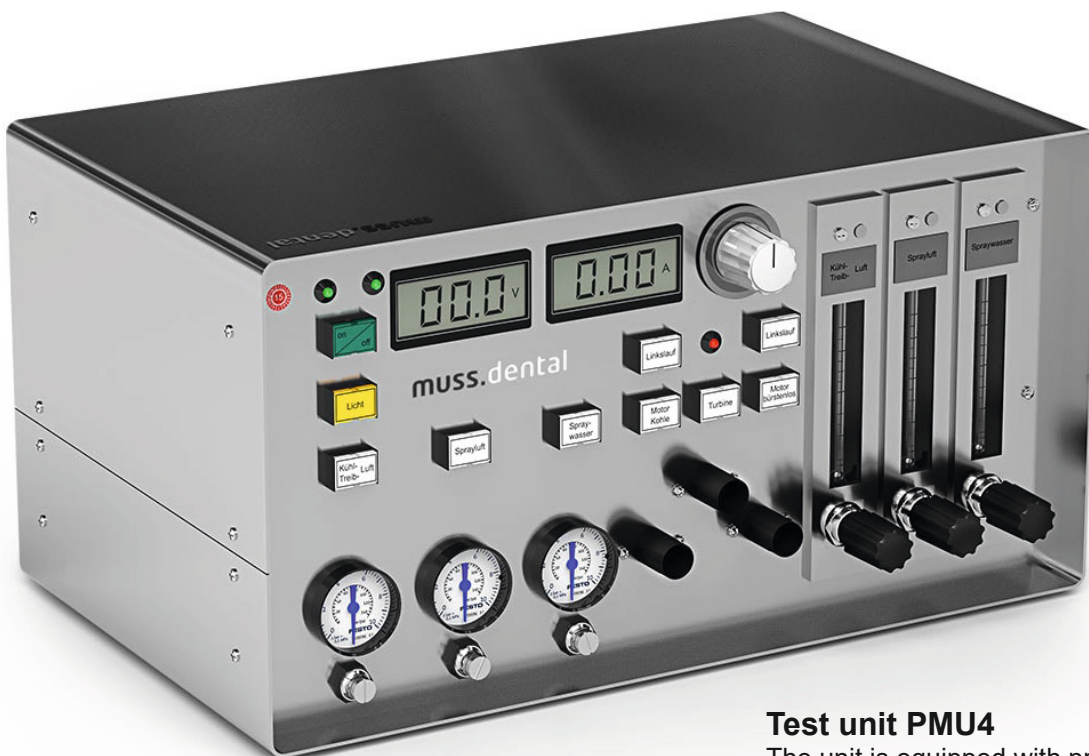
The unit is equipped with pressure gauges and flow meters for water, air and motive cooling air.

Manufacturer	Item number	Description
Muss Dental GmbH	MU 9406	Test unit PMU4
Sirona	6337518	Engine BL ISO C
Sirona	1894588	Quick coupling R
W&H	10403400	Clutch RQ-34
W&H	B2012000	Speed measuring device
W&H	C0063000	Holding force tester D=1,6 mm
W&H	C0029600	Test mandrel Ø2,35 mm
W&H	B2006000	Test mandrel Ø1,6 mm
KaVo	0.411.8731	Test manometer
KaVo	0.410.1933	Spray test drill
KaVo	0.411.4601 (3327793)	Holding force tester
