# **CERTIFICATION TEST REPORT**

#### TEST REPORT 16634-1 MECHANICAL STRENGTH TESTS ON SURFACE MOUNT FOLDING CLEATS WITH VISIBLE SCREW HOLES FOR ACCON MARINE, INC.

#### **REPORT NO. 16634-1**

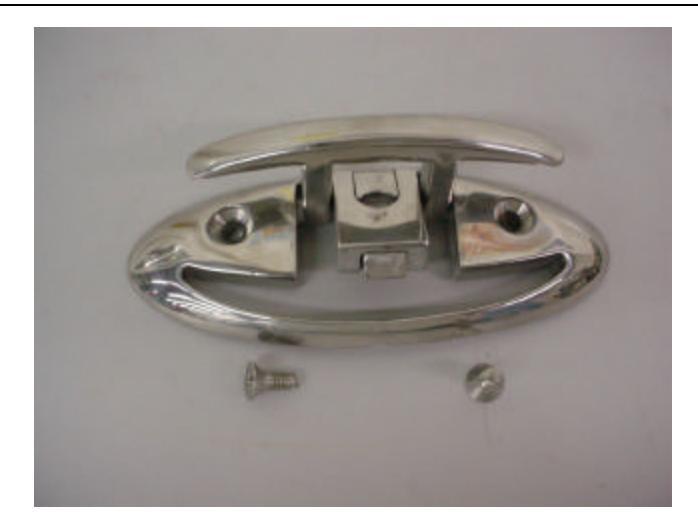
Figure 1. 4 <sup>1</sup>/<sub>2</sub>" Folding Cleat; typical failure mode (mounting bolt failure).

4 ½" Cleats		
SAMPLE #	MAX LOAD (lbs)	FAILURE MODE
1	4,000	MOUNTING BOLTS BROKE
2	3,700	MOUNTING BOLTS BROKE
3	3,600	MOUNTING BOLTS BROKE
AVERAGE	3,766	
6" Cleats		
SAMPLE #	MAX LOAD (lbs)	FAILURE MODE
1	9,450	MOUNTING BOLTS BROKE
2	9,150	MOUNTING BOLTS BROKE
3	9,250	MOUNTING BOLTS BROKE
AVERAGE	9,283

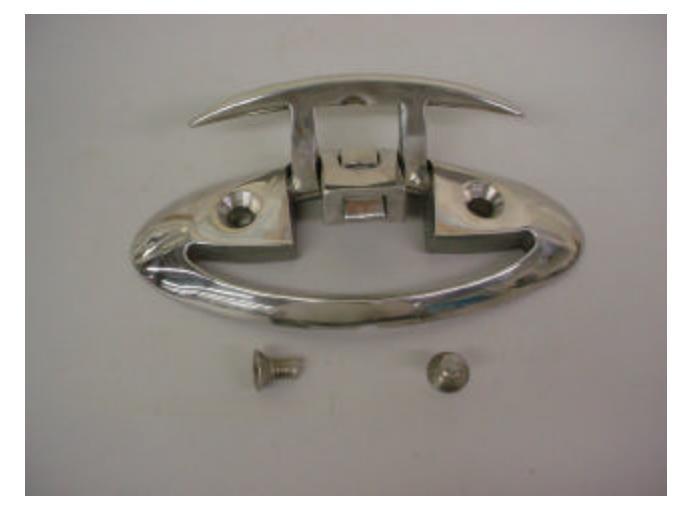
Figure 2. 6" Folding Cleat; typical failure mode (mounting bolt failure).

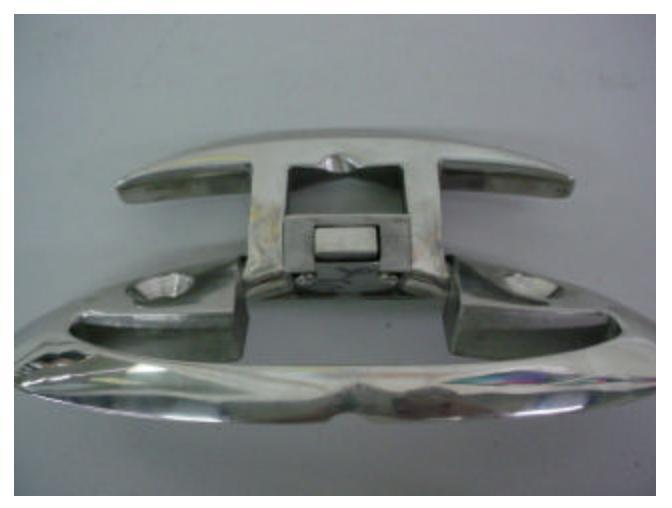
Figure 3. typical deformation experienced during tests

The following table contains the values obtained during the tests. In addition to the failures each of the tested samples also experienced some deformation as a result of the tests.
