Technical Tip

Beading Water

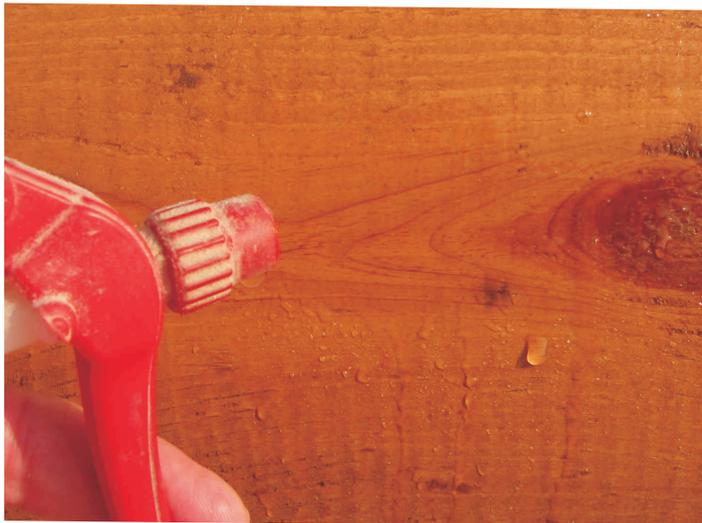
Water sheeting on LIFELINE Advance.

Every so often we get a call from a homeowner asking if they need to put another coat of Advance on their home since when water is sprayed on their finish the water does not bead up. Since none of our current finishes contain oil or paraffin wax they “sheet” water but do not “bead” water. Why don't we add wax to our finishes? Wax may contribute to water repellency for the short term but it weathers away fairly quickly, especially in those areas that are in direct sunlight. Once it is gone it leaves microscopic voids that may allow water penetration and since the finish is no longer smooth it is not as easy to keep clean. By maintaining a wax free smooth polymer film we've been able to significantly increase the long-term performance of our exterior finish systems. The other feature imparted by the presence of wax in a finish is the difficulty of applying additional coats of a water-based finish on top of it.

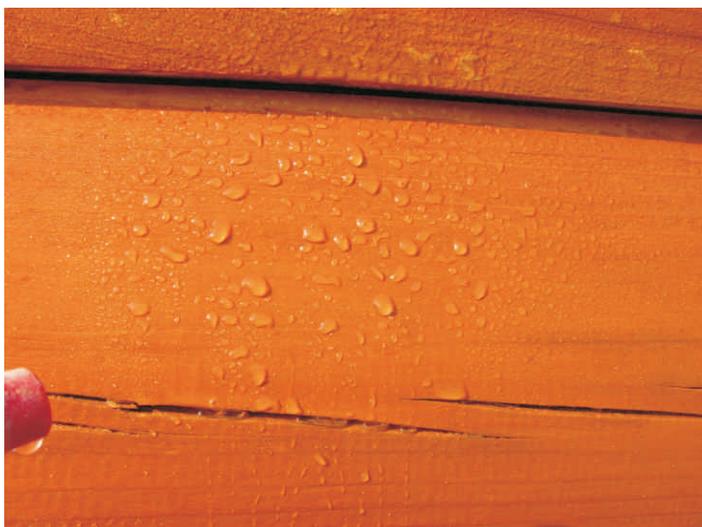
Water beading on a finish that contains wax.

A fallacy that many people have accepted as fact is that water beading on the surface of wood is the only sign that a finish is repelling water and that beading water is an attribute of a quality finish. Nothing could be further from the truth. Beading water is only an indication of the presence of oil or more commonly, paraffin wax. In addition, there is no correlation between beading water and protecting wood from sun (UV) damage.

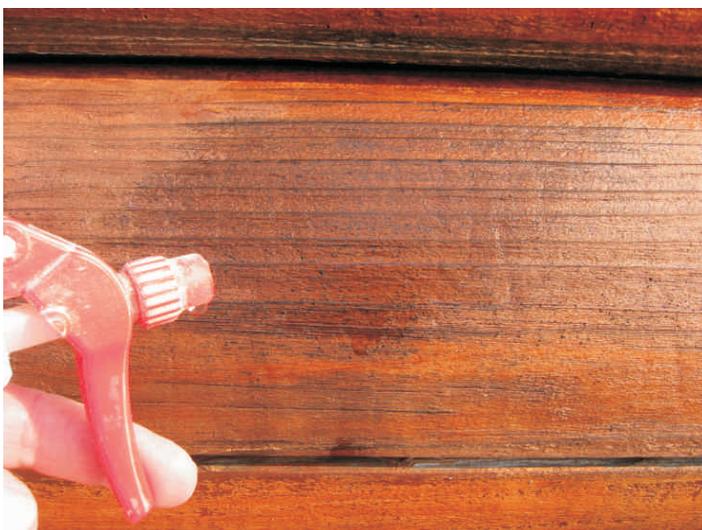
Water absorbing into wood through a finish that is no longer water repellent.

So how can you tell if a finish no longer repels water? If the wood is dry it is pretty easy. When dry wood is sprayed with water and there is no change in color it is a sign that the wood is not getting wet. On the other hand if the wood turns dark it's an indication that the wood fibers are getting wet and the finish is no longer water repellent.
