ATS or BD.....you decide.

The products that I'll be discussing are two competing sets of compound turbos, both installed on 2006 Dodge Ram's with Cummins Turbo Diesel engines. One set was from ATS, which included the Aurora 3000 and Aurora 5000 turbos and the other was from BD Power, which included the SuperB and R700 turbos. Both are advertised as towing / race setups.

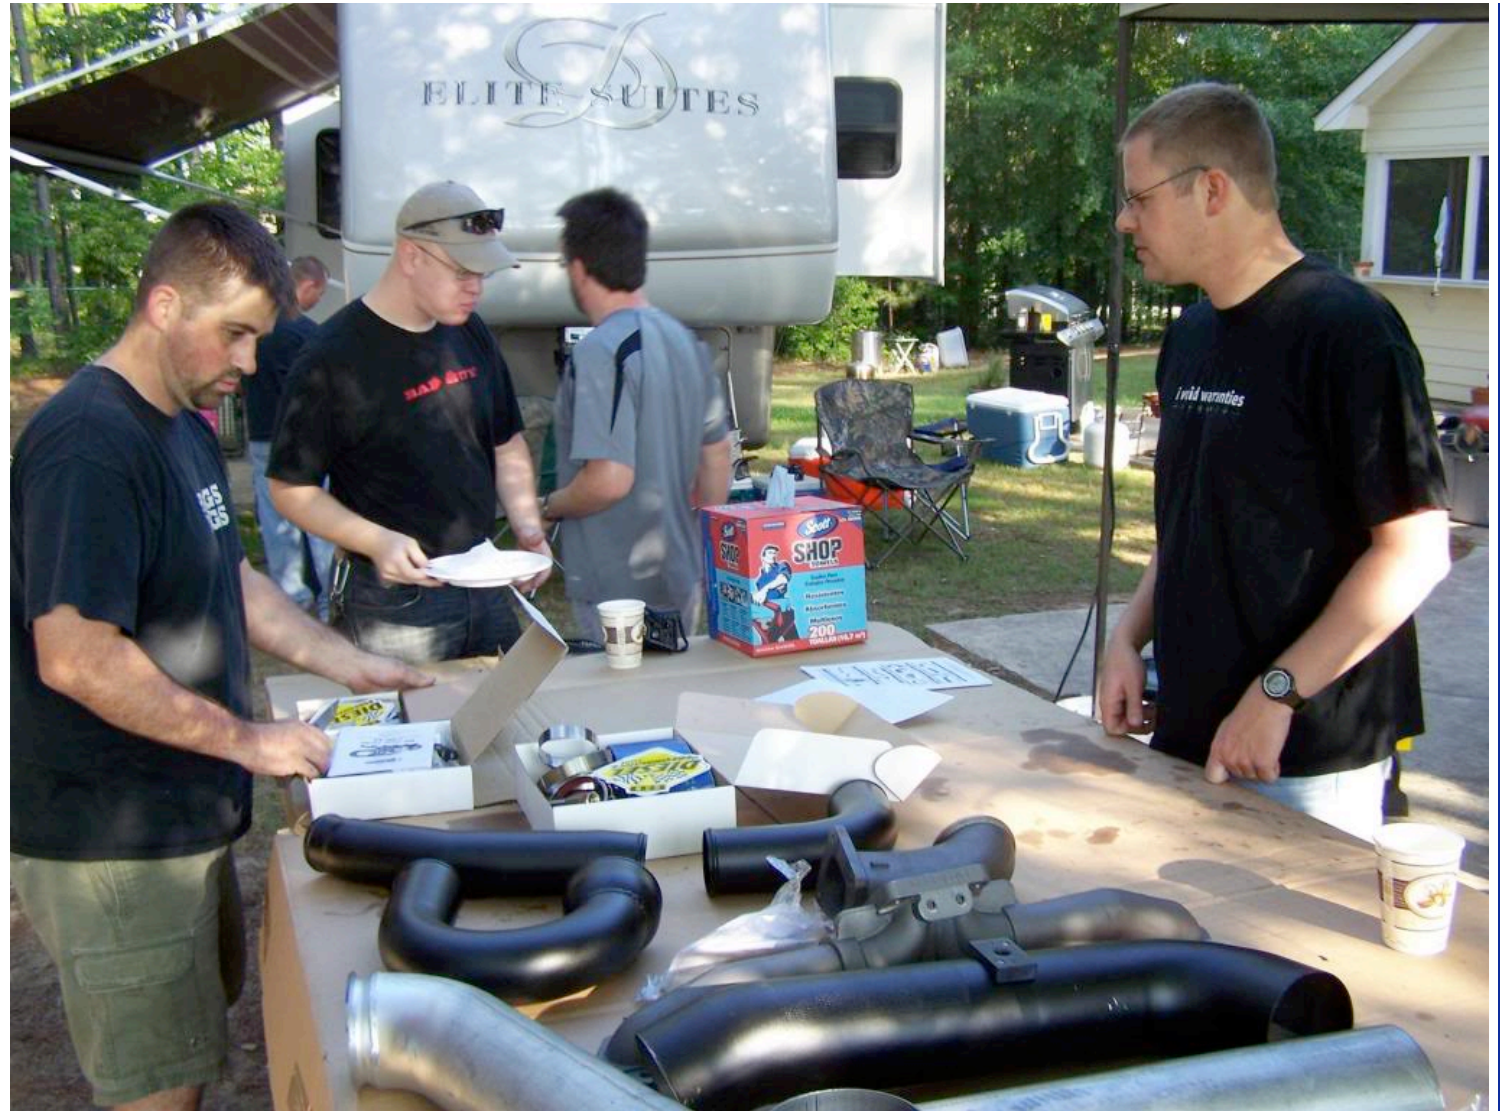
The BD kit arrived in multiple boxes and unassembled. Upon initial inspection, there were numerous parts missing (as noted previously) and there was considerable rust and corrosion on and in the turbine housing.

- 10 - air box bracket to radiator was poorly fit
- 11 - v-band clamp for secondary to elbow did not fit correctly and had to be tweaked
- 12 - no rust preventative applied to parts (there was rust on many of the cast parts, including the turbine housing, including the insides.

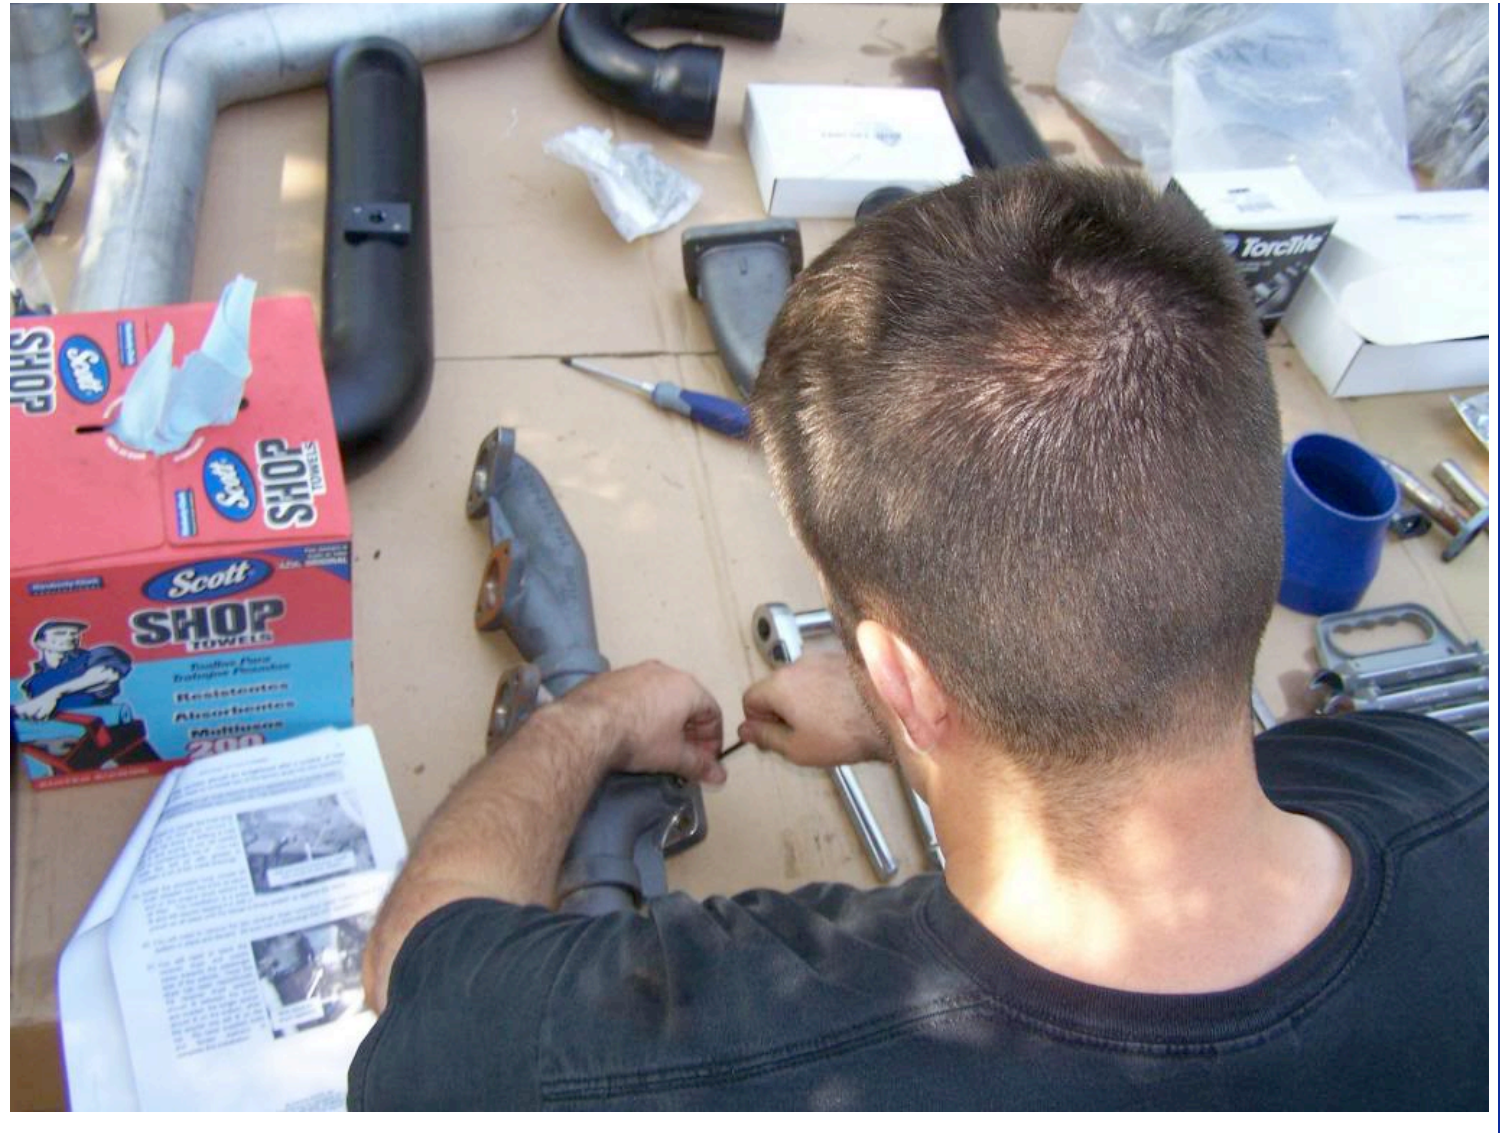
Once this was done, we installed the EGT probes and found another problem. The location of the ports on the bottom of the BD manifold did not allow enough clearance for straight type EGT probes. The probes ran directly into the side of the SuperB compressor housing. We ended up taking two 90* probes off of another truck to make them fit.

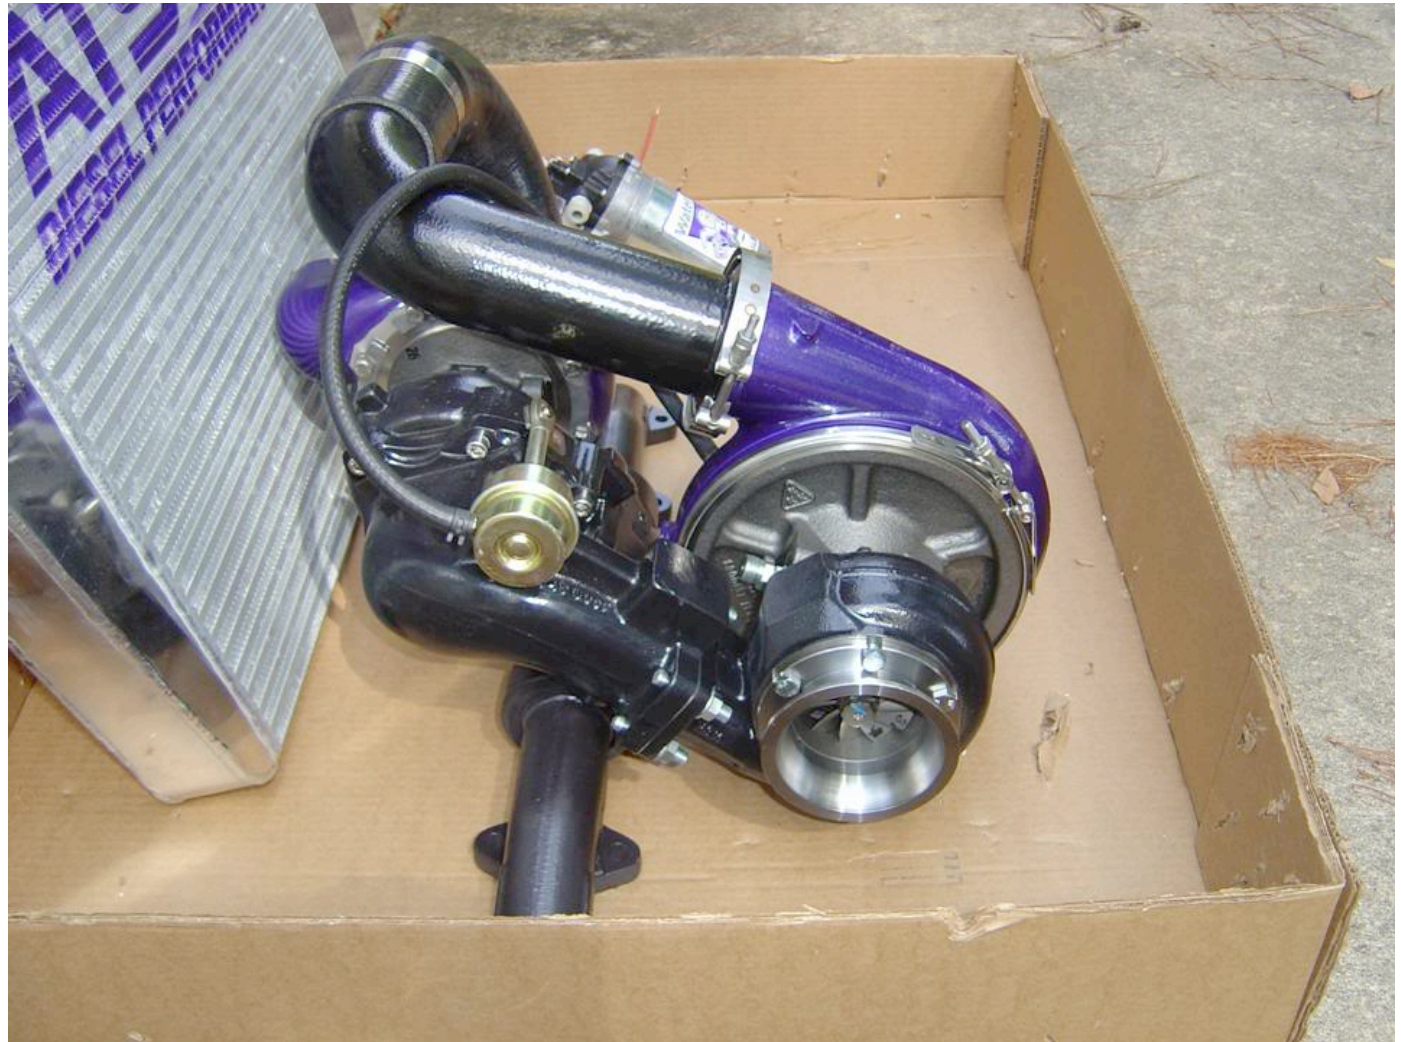
From here, the ATS kit requires attaching the exhaust adapter to the turbine housing of the secondary. This was simply a matter of lining up the holes and attaching the bolts. Using a ratchet wrench is essential here, otherwise you'll be making minute turns on two of the hard to reach bolts. The picture below shows the ATS exhaust adapter and where it fits to the secondary.
