TECHNICAL BULLETIN

Description: XTX Ratchet Feature

Product Effected: XTX 200 Tungsten, XTX 200, XTX 100, XTX 50

Serial # Effected: 9050001 and Onward

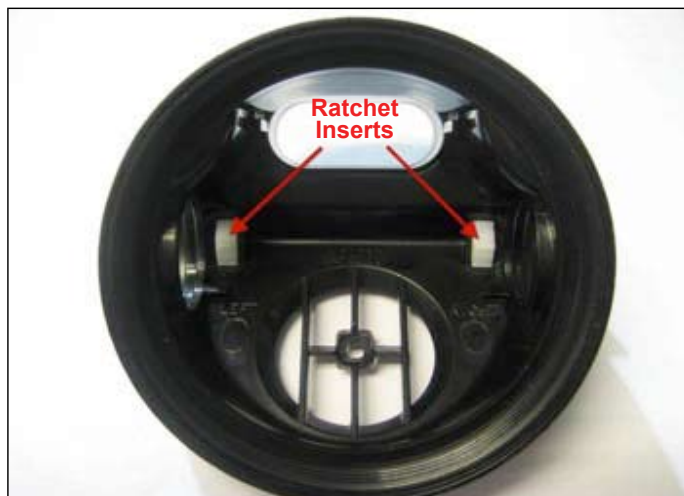
This has been achieved by removing the two ratchet inserts, in the 2nd stage case.

Regulator models which are affected are the XTX200 Tungsten, XTX200, XTX100 and the XTX50. The serial numbers of the new non-ratchet models are 9050001 and onwards. All regulators prior to this serial number will have the ratchet feature assembled as normal. There is no need to remove any ratchet inserts from in service regulators, as there are no technical issues. All XTX regulator maintenance manuals will remain unchanged showing the picture of the ratchet inserts fitted.
