TIT-202 PRO
THERMAL IMAGING CAMERA

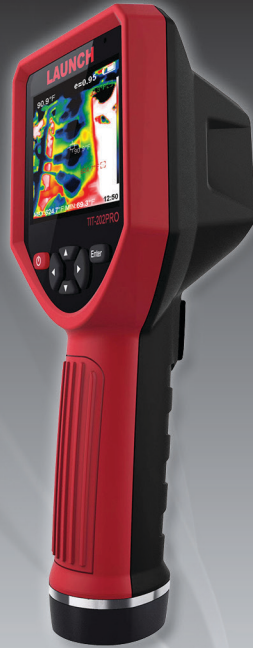
Using the advanced infrared technology, TIT-202 PRO can convert the radiation information into image, and clearly displays on the color screen. It reflects the slight defect as small temperature difference while the diagnostic device cannot detect them.
