MODELLI / MODELS : ECAM26.455
OGGETTO : Visualizzazione messaggi errati
SUBJECT : Wrong display indication
GENNAIO / JANUARY 2012

MACCHINE DEL CAFFE' / COFFEE MAKERS

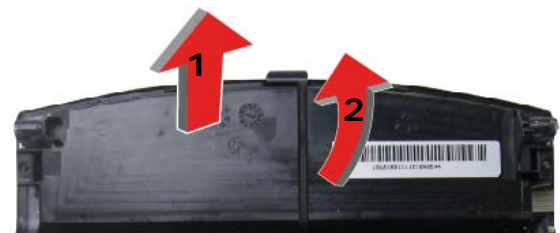
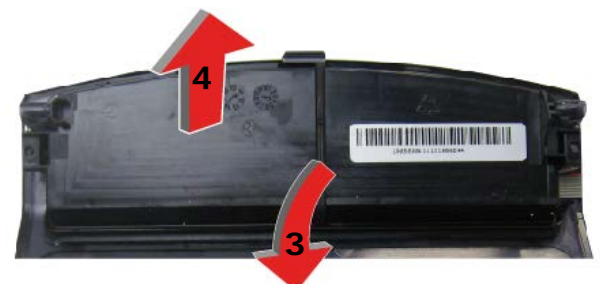
1. Spingere in avanti il coperchio
2. Una volta sganciato dal gancio frontale, sollevare leggermente il bordo superiore
3. Spingere delicatamente indietro il coperchio, per liberarlo dai due ganci posteriori
4. Togliere il coperchio sollevandolo.

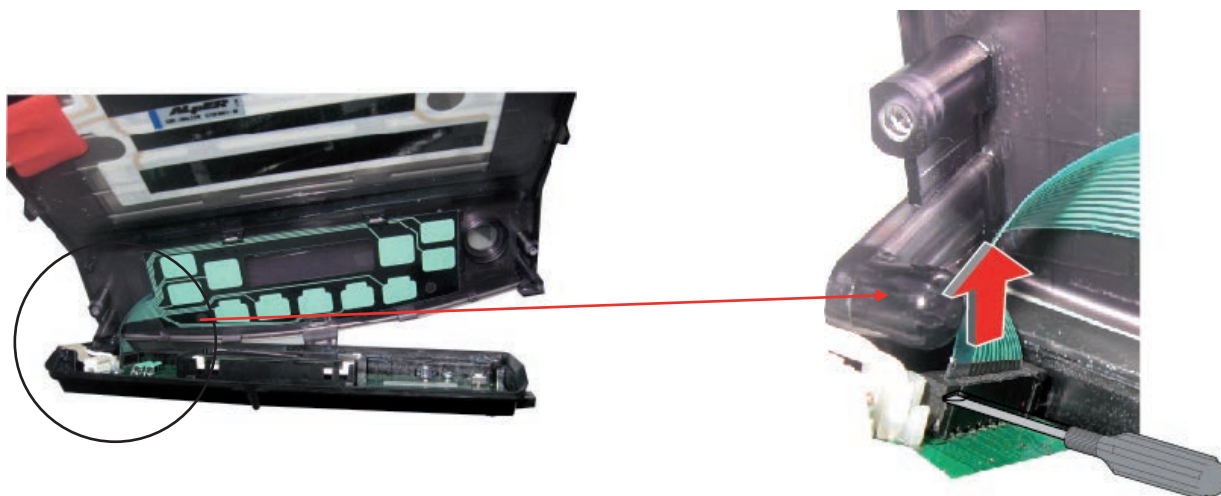
5. Take off with care the connector using a screwdriver.
