# Spill Cleanup of Fuel Contaminated Soils After Roadway Accidents Using In Situ Bioremediation.

### **Case Study 1. Restoration of Vegetation Affected By Diesel Spill**

### **Case Study 2: Diesel Fuel Release After a Vehicle Accident**

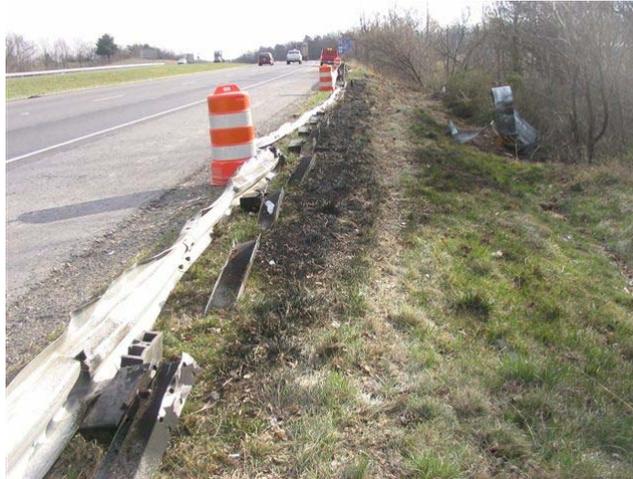
A tractor/trailer was involved in a highway accident releasing approximately 100 gallons of diesel fuel from a ruptured saddle tank and ten gallons of motor oil from the truck engine. Wreckage ended at the bottom of the embankment, immediately adjacent the

opening of the subsurface storm piping. Diesel fuel, released from the truck, flowed into soil near the wreckage and near the open ditch. Several hundred feet of guardrail was destroyed in the accident, causing engine oil to disperse over approximately 100' of vegetation at the pavement edge. GEC Environmental Contracting Corp. (GEC) was contacted to provide clean up of the release. Accident site is seen in Figure 1.

**Figure 1. The accident site and the release of fuel from the truck.**

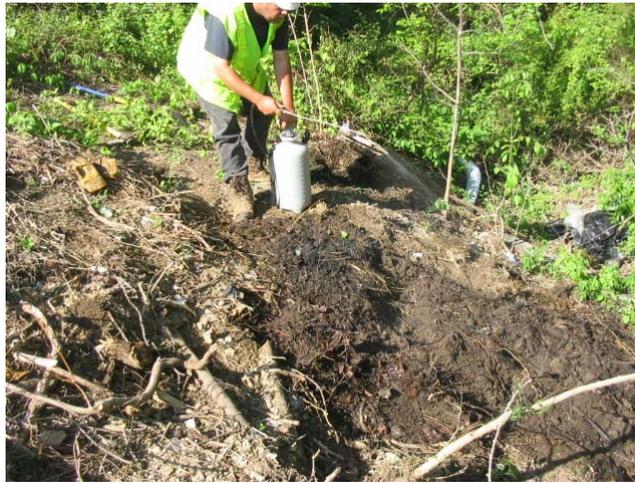
**Figure 2. Application of AgroRemed to impacted soils**

A soil sample was collected from the center of the diesel staining, approximately 2” below the surface showed a concentration of 65,000 parts per million (ppm). Impacted soil saturated with diesel was manually turned/tilled to allow natural oxygenation before application of AgroRemed as seen in Figure 2.

A soil sample was collected after 20 days of application from this location and analyzed for TPH/DRO values and the results of hydrocarbon range C-5 to C-30 showed a value of 26,000 ppm or more than 40% reduction in the value. Application of AgroRemed was continued at regular intervals but the reduction in TPH/DRO was not appreciable and was reduced from 26,000 ppm to 11,800 ppm that is attributed to prevailing drought condition and the soil was very dry. Hence in September before the final application, the soil was sprayed with water from a tanker before application of AgroRemed and the surface of the soil was also covered with straw mulch to prevent excessive evaporation. The TPH of the soil was examined after 15 days and the levels of TPH were reduced to 650 ppm with no signs of tainting of the grass and interestingly no diesel odor. Further, the area was found to support healthy growth of grass and other vegetation indicating no residual toxicity in the soil and AgroRemed helped restoration of the soil to its condition before the spill. The DEQ agreed that there was no further action required. The total time

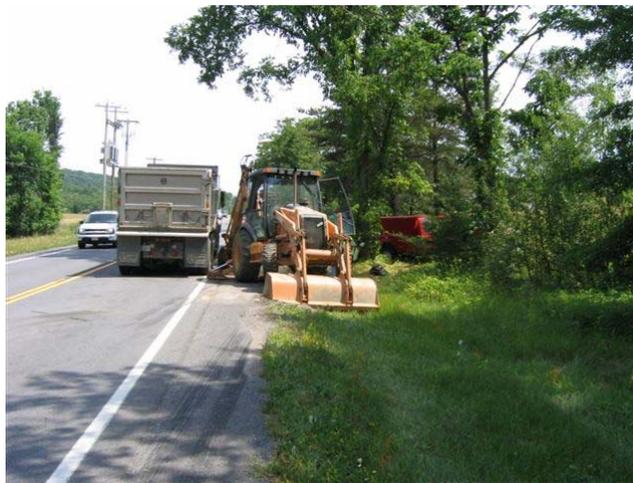
**Figure 3. Accident site showing the asphalted road affected by spill.**

Diesel fuel had released on the pavement edge and gravel shoulder causing surface staining. Debris on the pavement was pushed to the gravel to allow normal traffic patterns for evening hours. Petroleum absorbent booms were placed along the down-gradient edges of the spill area to prevent further migration during anticipated storm events. Anti-slip absorbent media was applied to the impacted pavement and scrubbed to remove residual phase petroleum. As this material was spent, it was removed and the process repeated until practical recovery was achieved. An additional application was then made as a slip preventative measure for traffic.

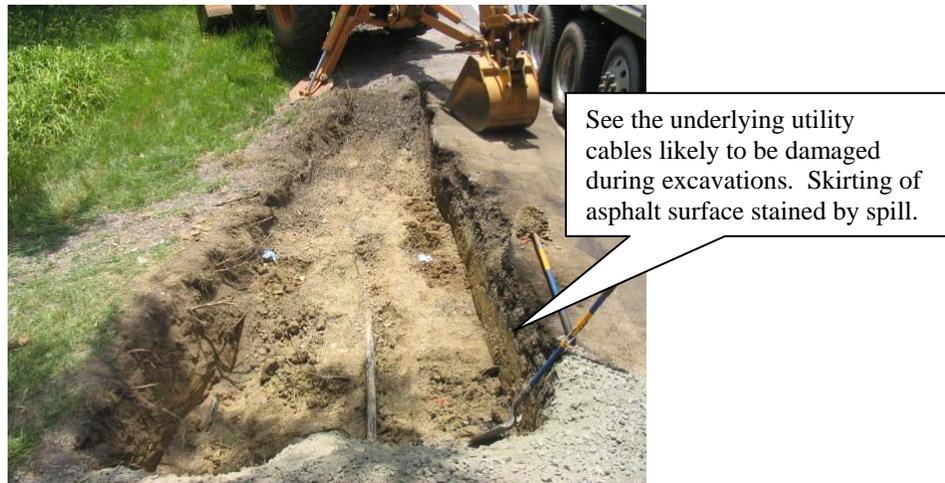
**Figure 4. Showing underlying cables and stained skirting of pavement.**

As the excavation continued along the embankment towards the open side ditch, depth was increased once equipment progressed beyond the exposed cable (Figure 4). At the east side of the excavation, a depth of 48" was achieved when a third unknown communication cable was damaged by the backhoe. Awaiting repair technicians, it was agreed that further soil removal is not practical or even possible by conventional means due to the position of buried cables. Underlying cables thus significantly reduced the area of excavation, accessibility and time constraints of two-way traffic closure, decision to apply AgroRemed was made by WV DEP.

*In situ* bioremediation using AgroRemed was considered a less disruptive and safe method for cleanup. Repair technicians had not arrived at this time and AgroRemed was readily available on site. Four locations were identified to record changes in TPH in soil and samples of soil from these locations were monitored several times to record any decrease of petroleum concentrations during bioremediation. Two pine trees located along the east bank of the right-of-way were identified as bench marks for future sampling events. Soil samples were collected from these two west locations at the pit bottom showed 2,500 ppm and 4,000 ppm respectively after 20 days of treatment.
