3" Bull Bar License Plt Kit

Part No. B0007-RELOCATE

Fits: **All Years** - **Universal License Plate Relocation Kit - Bull Bars**

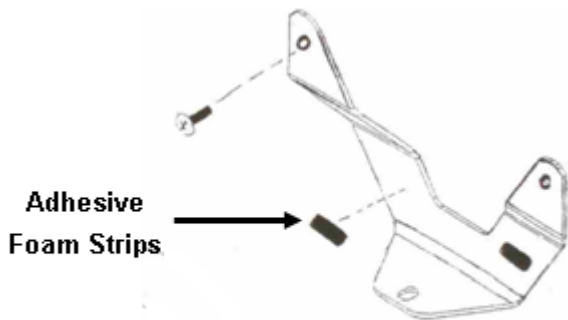
Figure 1

1. Attach two Adhesive Foam Strips on the Relocation Bracket as shown in Figure 1.
2. Remove center skid plate bolt from Bull Bar. Position Relocation Bracket against cross tube and on top of skid plate. Attach Relocation Bracket to bull bar using the skid plate bolt removed in this step (Figure 2). Tighten at this time
