This guide shows the location of the fuse for the Supercharger Coolant Pump (V188)

This pump fuse may need to be updated to a 20A/25A fuse for CWA100/150 upgrades

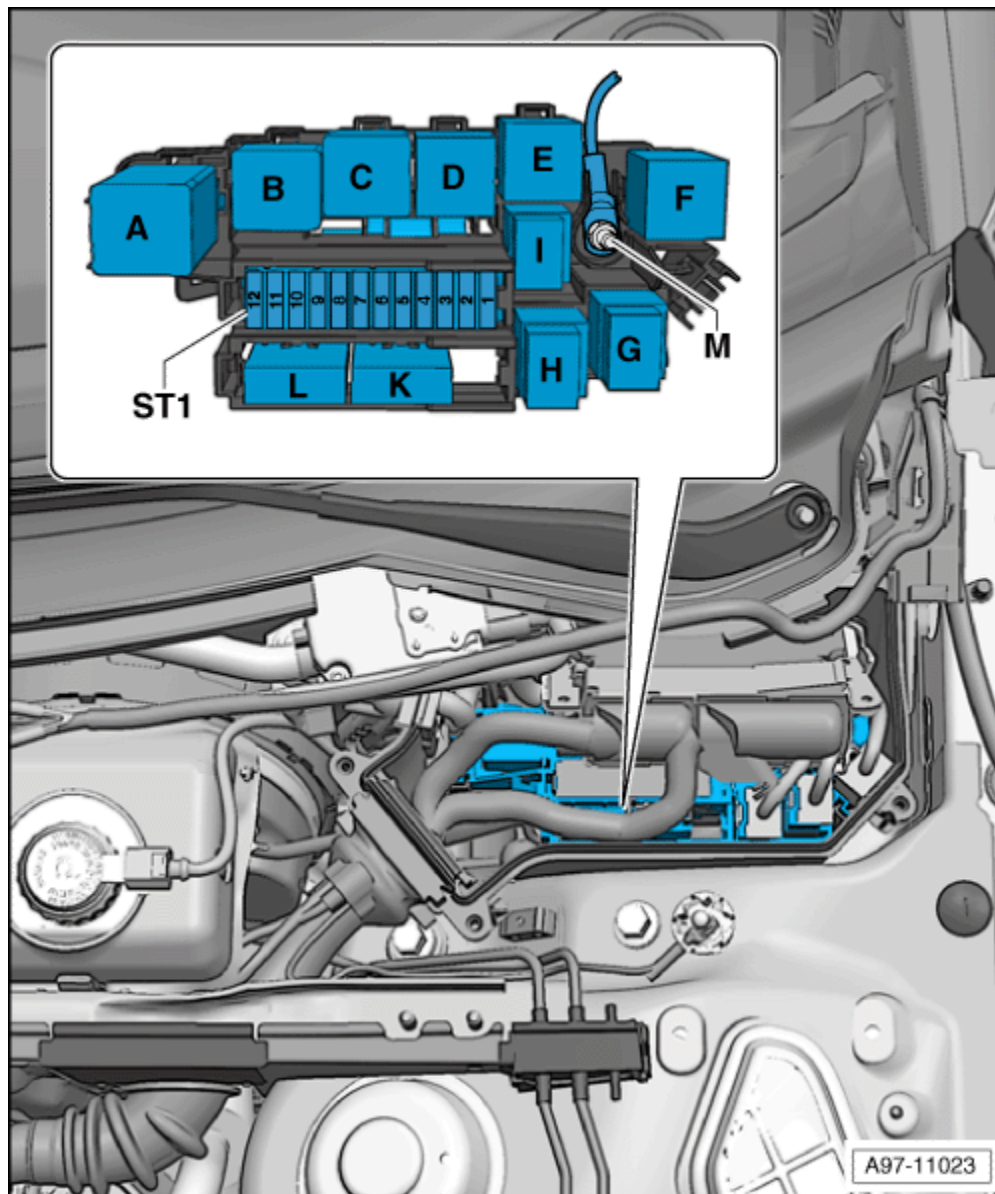
B8 S4/S5 (2009-2012)

SB10 - Fuse #10 in carrier ST1 in the underhood fuse panel SB

Location: Under washer fluid filler neck

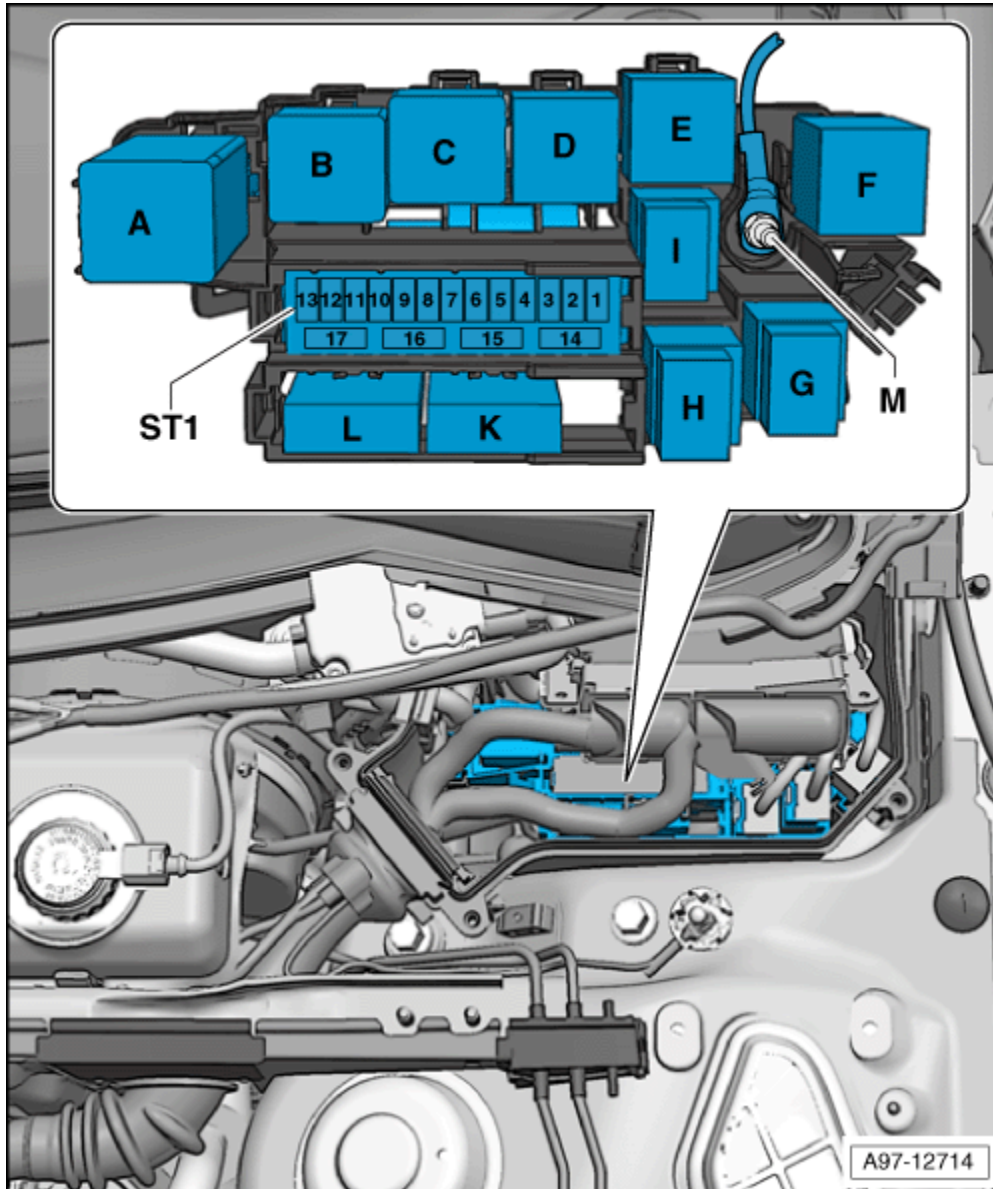
B8.5 S4/S5 (2012-2017)

SB16 - Fuse #16 in carrier ST1 in the underhood fuse panel SB

Location: Under washer fluid filler neck

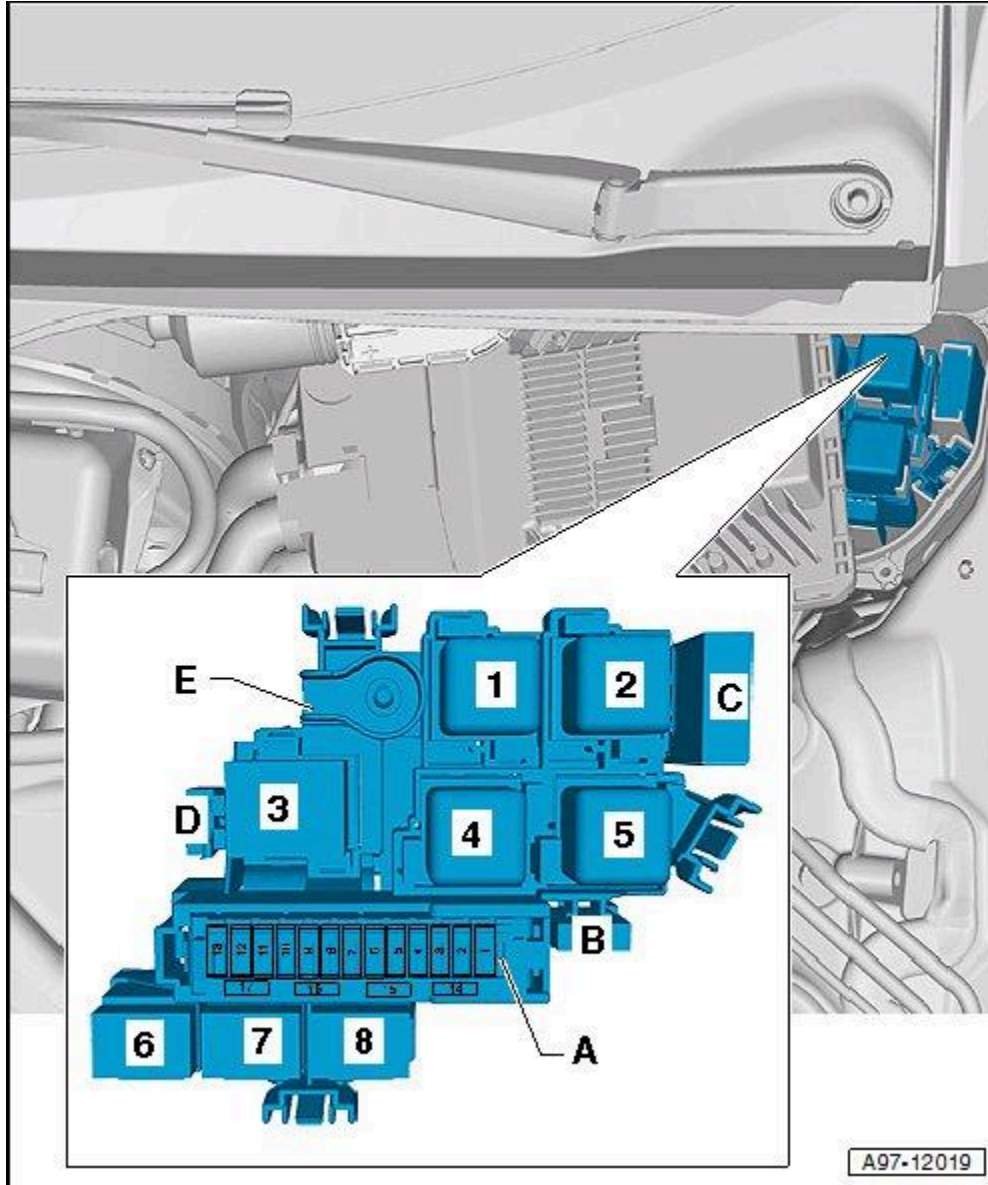
C7 A6/A7 (2012-2014)

SA16 - Fuse #16 in carrier ST1 (**A**) in the underhood fuse panel SA
Location: Under washer fluid filler neck

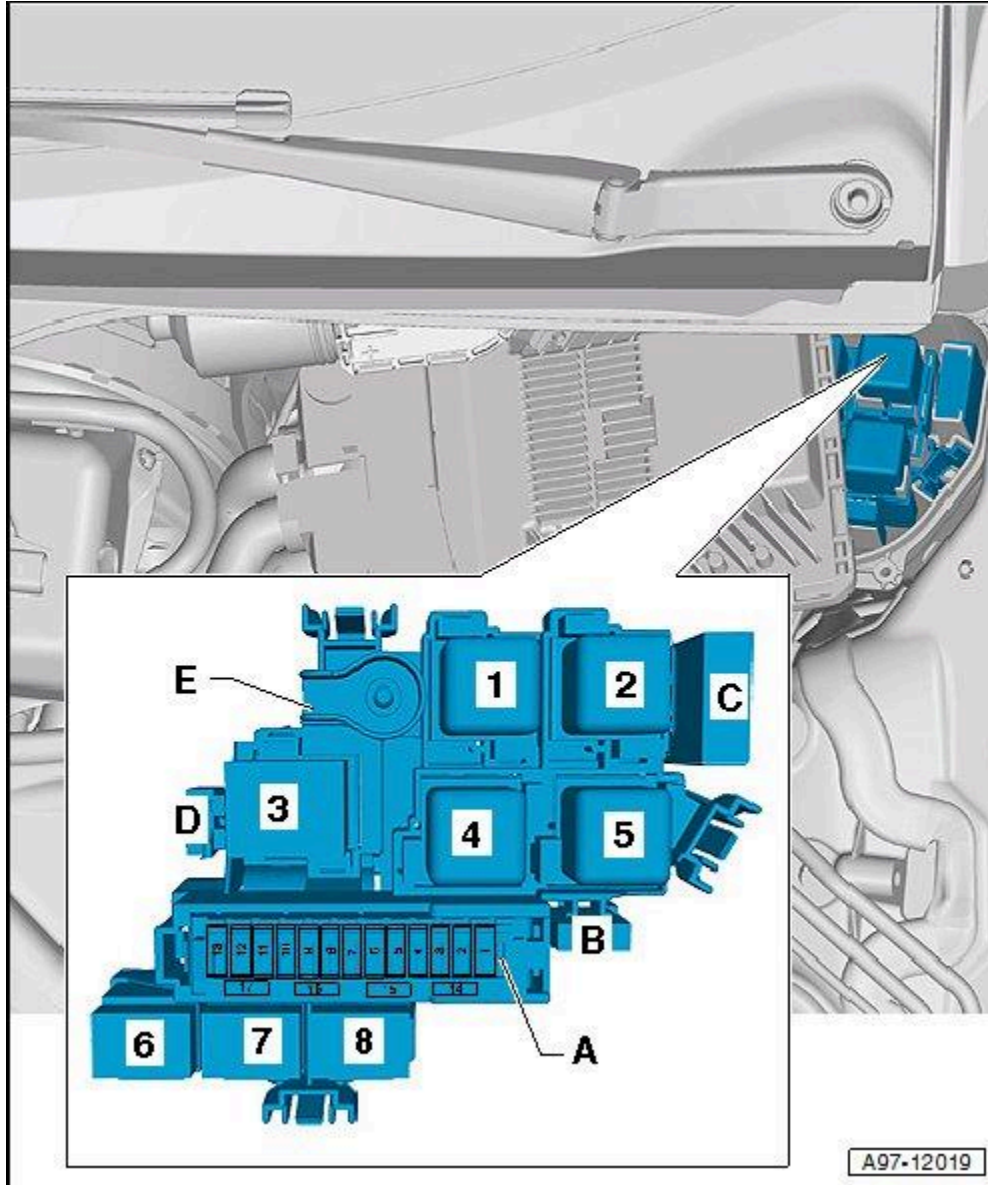
C7.5 A6/A7 (2015-2018)

SA10 - Fuse #10 in carrier ST1 (**A**) in the underhood fuse panel SA
Location: Under washer fluid filler neck

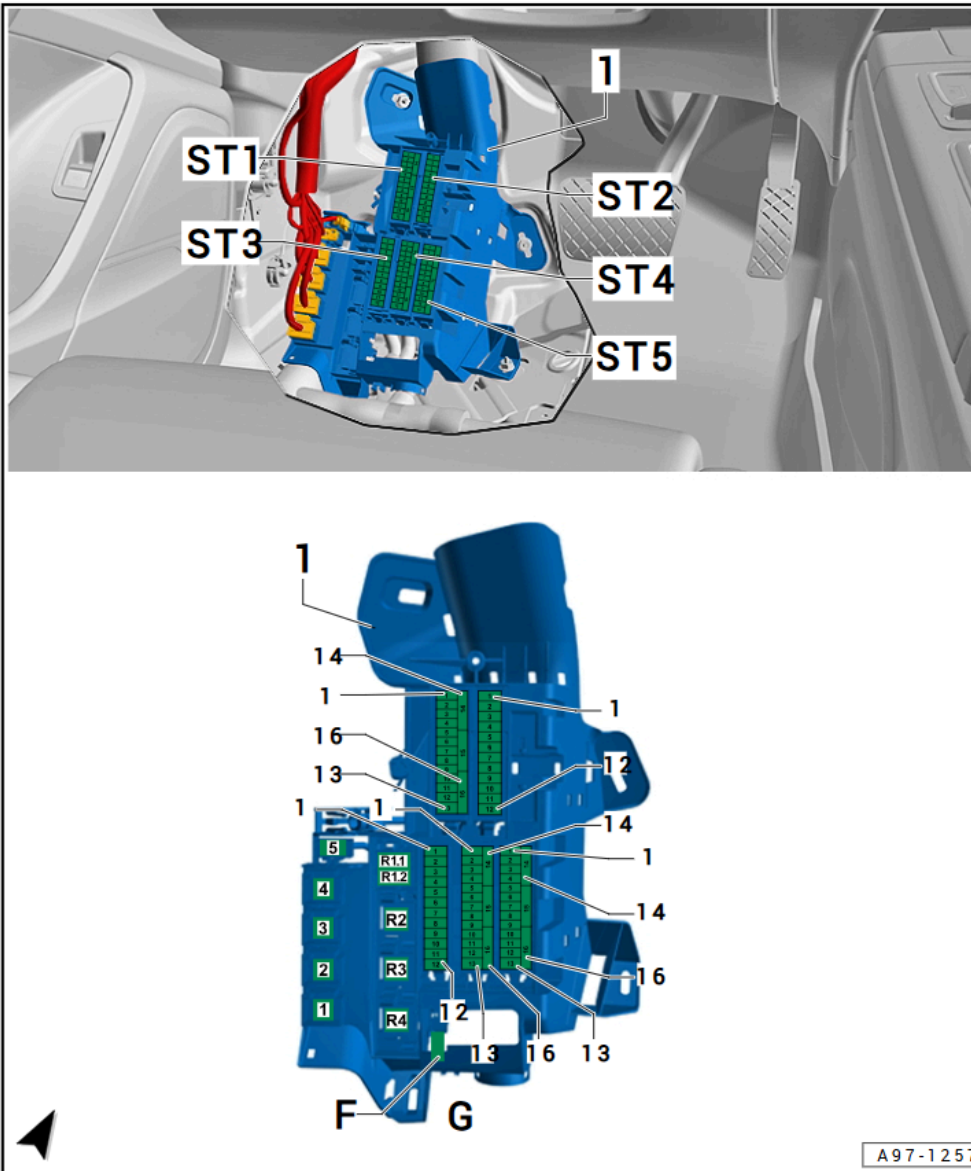
4M Q7 (2015-2019) EA837 only

SB8 - Fuse #8 in carrier ST1 (brown) in the interior fuse panel SB

Location: Under dead pedal/footrest
