CAP® - CLOSED END BLIND RIVETS

THE STRUCTURE

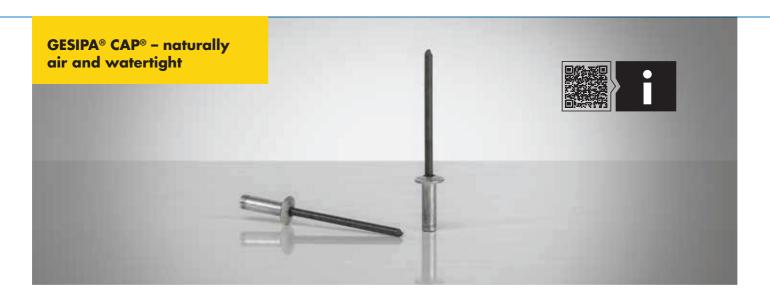
For technical reasons, the rivet mandrel of the GESIPA® CAP® blind rivet must be fixed in the rivet body. However this means that the rivet body can only deform slightly during the setting process. As a result, the cap blind rivet only has marginal hole filling capability. However this is necessary to be able to compensate large borehole tolerances.

The above-mentioned technical situations make careful preparation of the application imperative. The hole diameter should be as tight as possible to ensure a flawless function in the application for a long period.

If the GESIPA® CAP® blind rivet is processed carefully, it forms the basis for a reliably "tight" connection.
