# REPLACING WIND SCULPTURE CWS-01,-02,-03,-01L,&-02L BEARINGS

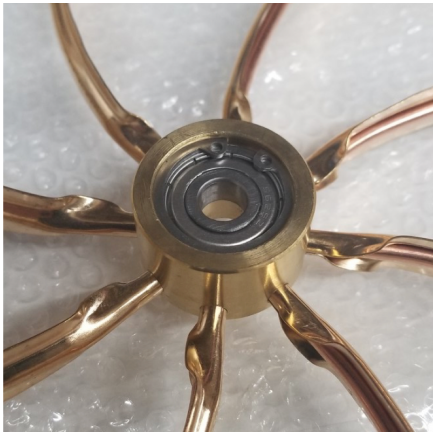
## STEP 1.

Disassemble the blade with the faulty bearing.

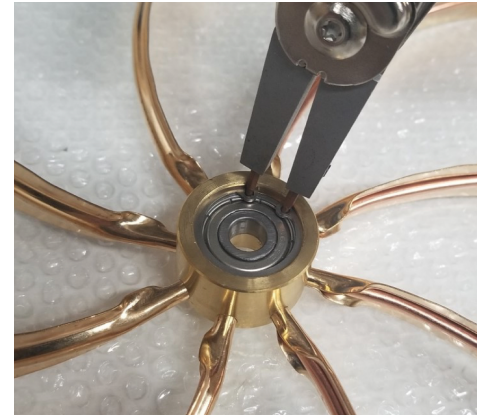
## STEP 2.

Use a retaining ring plier to remove the C-shaped retainer.

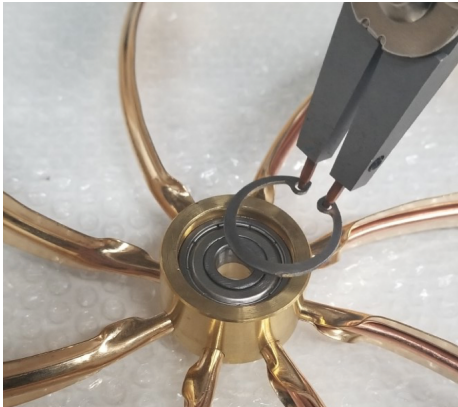
## STEP 3.

Remove retainer.

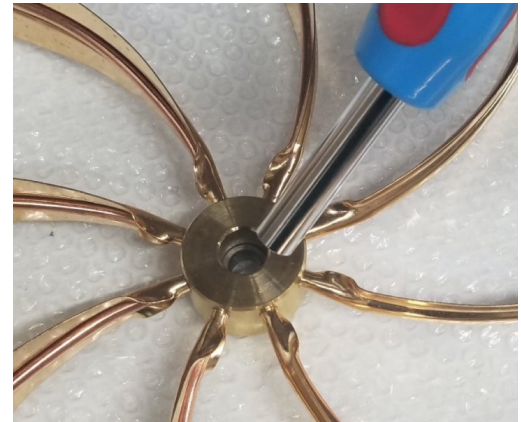
## STEP 4.

Flip the blade over to the other side.

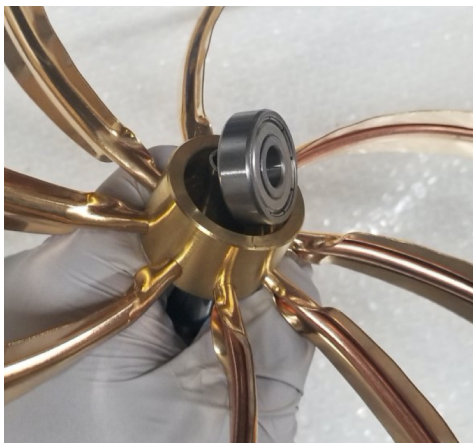
## STEP 5.

**Lightly** tap out the bearing with a screw driver, preferably with the screw bit and a hammer.

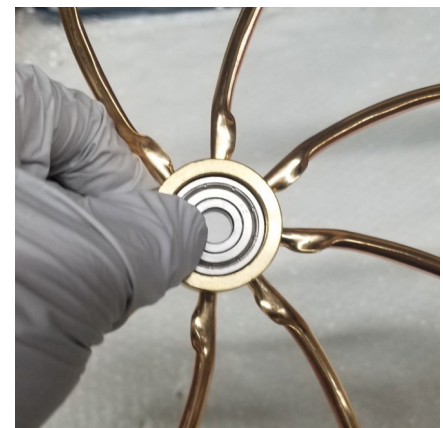
## STEP 6.

Push the new bearing into place using both thumbs on opposite sides. Put the retainer back with **Steps 3 & 2**, respectively.
