## HOW TO ...

# Service and/or fit a replacement diaphragm to the Alfons Haar type SF1 inflation valve

### Servicing the Alfons Haar SF1 Inflation Valve

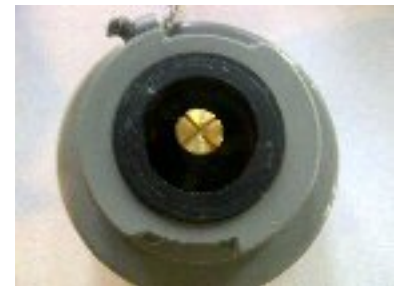
Remove the cap. Deflate the tube or collar by twisting the brass diaphragm spindle anti-clockwise a ¼ turn and depress the spindle down until it is in the locked open position. Remove and keep safe the black rubber seal (do not unscrew the upper valve body as the lower valve body may be lost inside the collar/tube).

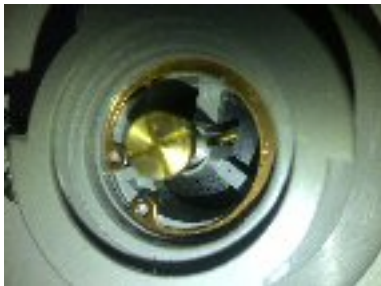
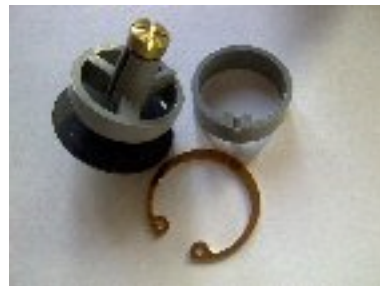
Using a pair of circlip pliers, remove the large gold coloured circlip from the body of the valve. Slide the complete spindle/diaphragm assembly up and out from inside the valve body.

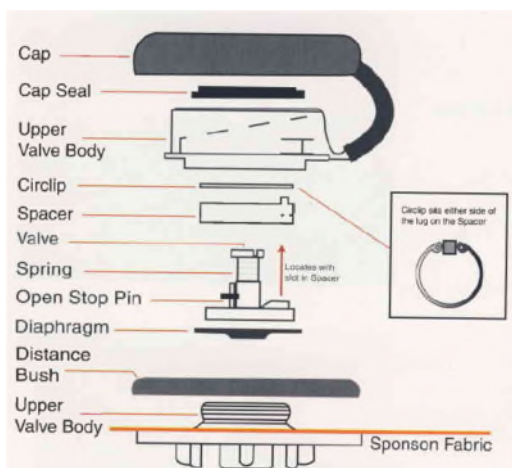
Inspect the rubber diaphragm for any damage, dirt and/or grit, or for any hardening of the rubber that prevents a good seating of the valve. Ensure that the spindle is in the closed valve position and depress the brass spindle to check the free operation of the spring. Inspect for any damage of the brass spindle, spring and plastic fittings. If any damage or failure to freely operate, replace the diaphragm assembly (service kit available at <https://www.ribstore.co.uk/shop-online>). Otherwise clean the diaphragm assembly with soapy water and when dry reassemble the valve. Ensure that the spindle is in the closed position before re-inflating and replacing the cap.
