Side Flange Modification Reference for TOYOTA Supra JZA80 2JZ-GTE Before Minor Change 6MT

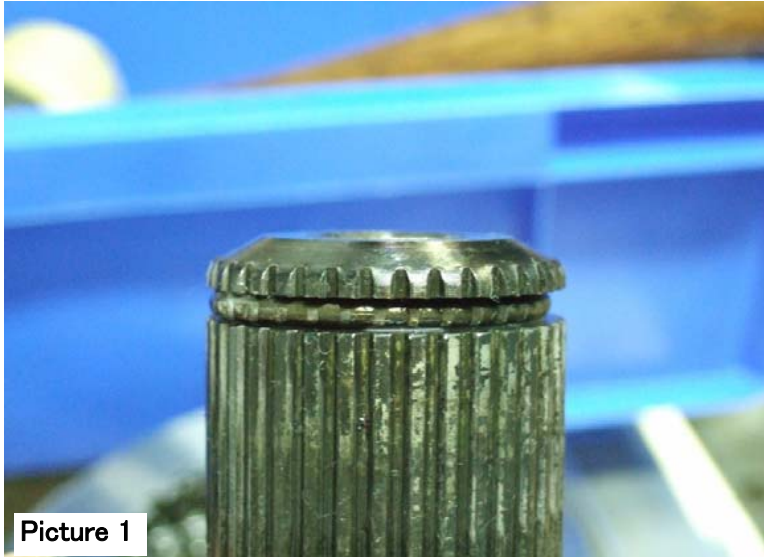
Picture 1

On the top of TOYOTA OEM side flanges for JZA80 2JZ-GTE Before Minor Change 6MT have a protruding area (trapezoid seen from the side) shown as Picture 1.

The protruding area interferes with the OS GIKEN Super Lock LSD inside parts.

Please shave the protruding area flat shown as Picture 2 and 3.
