2013+ Nissan Sentra Radio Removal Nissan Connect Factory Radio Upgrade

Dash Disassembly

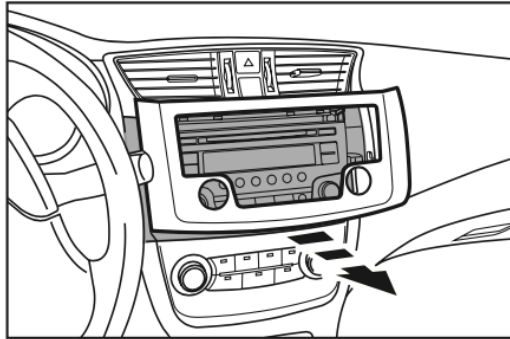
1. Unclip and remove the trim panel surrounding the radio. (Figure A)
Continue to kit assembly
2. Remove (4) Phillips screws securing the radio. (Figure B)
