DRISCOLL CHILDREN'S HOSPITAL RELIES ON NON-TOXIC COATING FOR SHOWER STALL REPAIRS

Armorguard System delivers acrylic urethane surface hardness

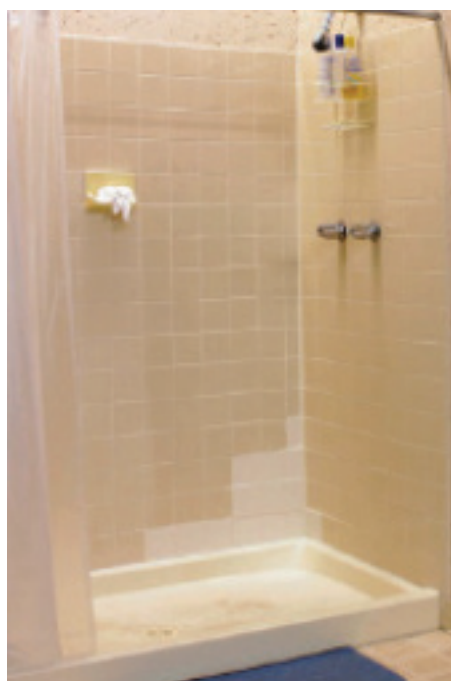
Before

The shower stalls in 30 patient rooms were in desperate need of repair as water was leaking through grout lines, dated and discolored. Grout was chipped and missing in some instances. It was apparent that a makeover was much needed.

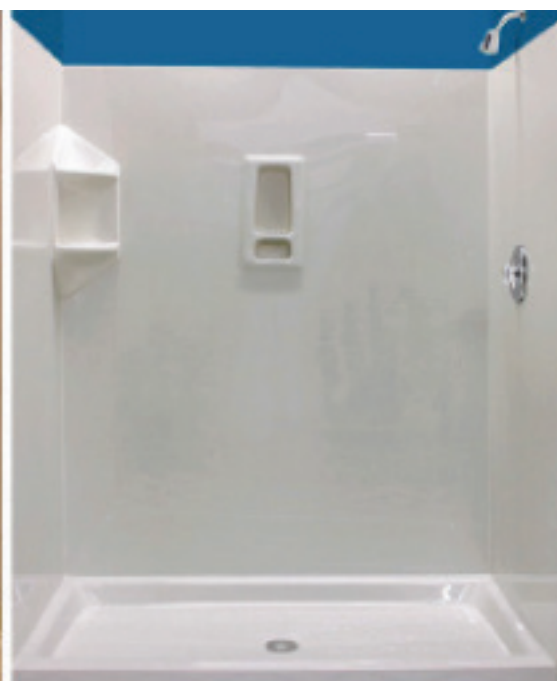
After

process," Naro explained. "The walls needed to be thoroughly cleaned, we had to regrout the tiles to make it even and filled. Now it looks like brand new tile."

The process begins with an Armorguard® primer color. Then Miracle Method's exclusive Mira-Stone gives it color and, finally, an Armorguard clear coat on top of that to seal it.

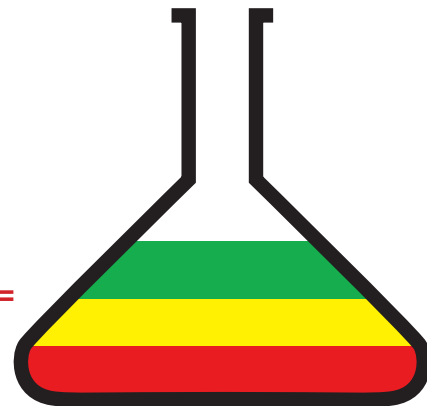
The shower stalls in 30 patient rooms were in desperate need of repair as water was leaking through grout lines, dated and discolored. Grout was chipped and missing in some instances. It was apparent that a makeover was much needed.

The process begins with an Armorguard® primer color. Then Miracle Method's exclusive Mira-Stone gives it color and, finally, an Armorguard clear coat on top of that to seal it. The shower area can be down anywhere from 24-48 hours depending on necessity.
