2019 Chevrolet Silverado 1500
2019 GMC Sierra 1500
PART NUMBER: DG-53-07-G3

PLEASE READ COMPLETE INSTRUCTIONS BEFORE INSTALLING THIS VSM G3

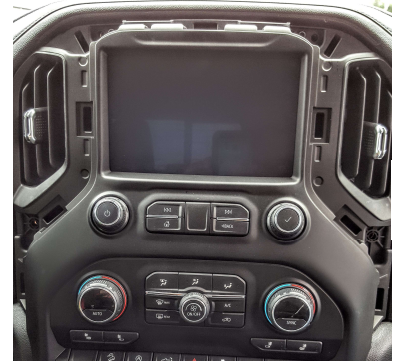
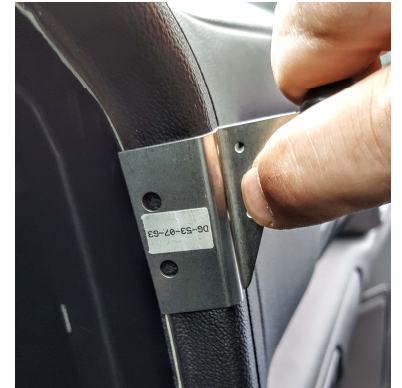
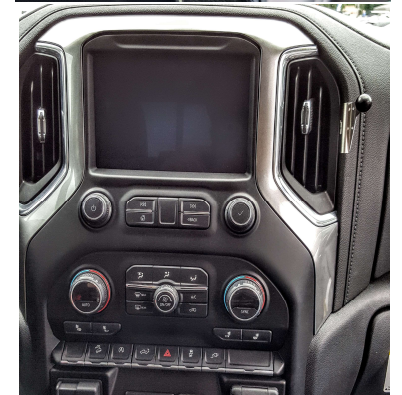
Step 1: Using the DTRT remove silver bezel around the radio (held with retainer clips) and set aside. Then remove the four T15 torque screws attached to the radio and climate control.

Step 2: Pop loose the radio, starting at the top of the radio using your hands (also held with retainer clips). Do not remove all the way. Only loose enough for room to attach mount.

Step 3: On the right side of the right vent, just below where the opening starts to angle up to the left.

Place the mount and mark the holes for the mount. Either pre-drill pilot holes or attach using your cordless drill.
