## Thermal Imaging Tests on Generator Set Systems

## Information Sheet # 31

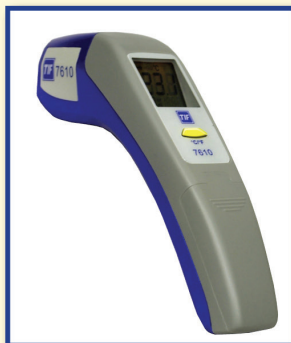
Infrared Ray Gun

Many service technicians use infrared guns, which show any such hot spots but these are unable to provide a hard copy for the record. Today's thermal imagers have ability to view live images of heat emitted from equipment and are becoming ever more affordable, making them highly practical and cost-effective.

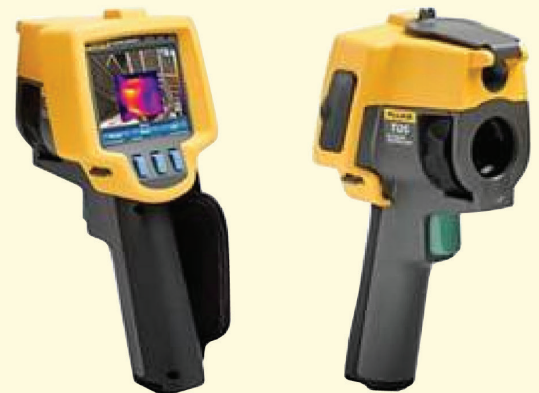
Images of an Actual Infrared Camera
