PERMAFYX L271 CASE STUDY

CHESHIRE EAST COUNTY COUNCIL

Cheshire East Council, Green Lane, Wardle, Nantwich, CW5 6DB

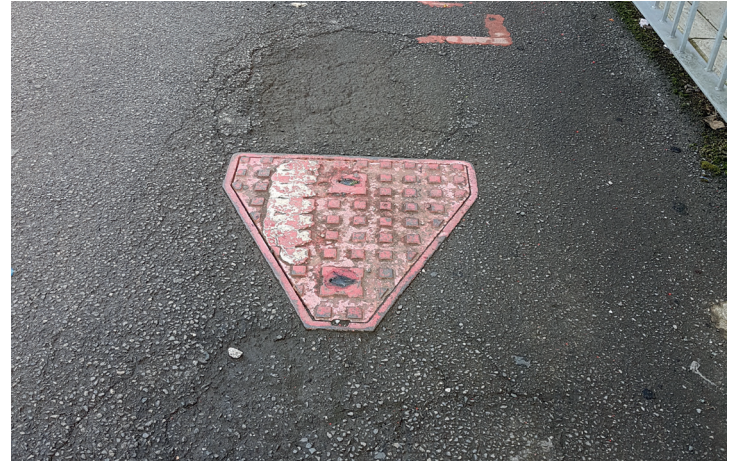
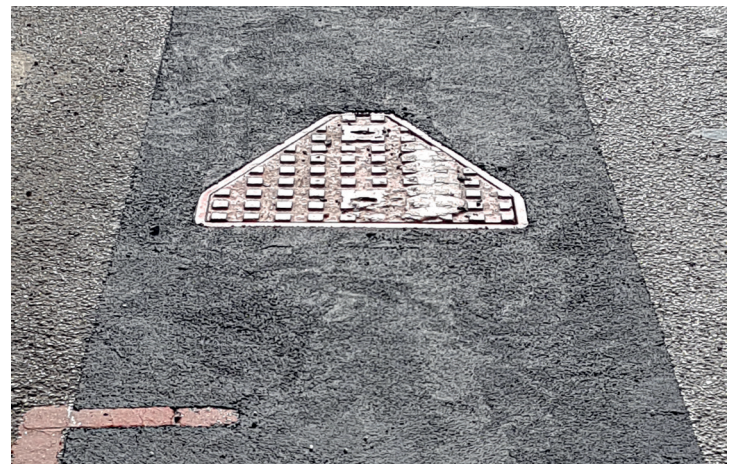
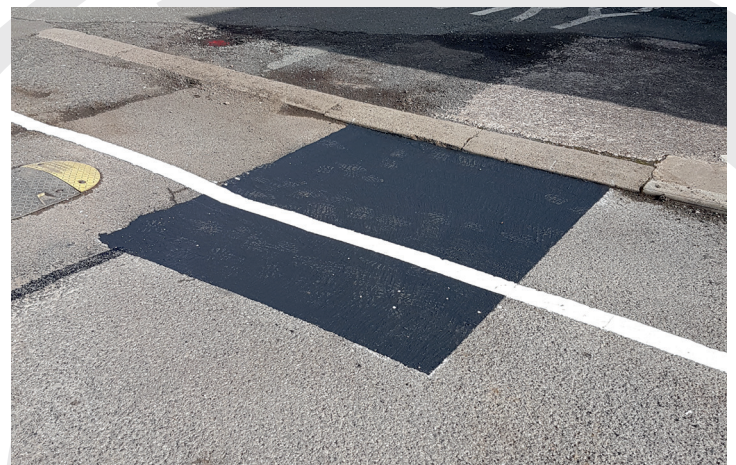
Cheshire East Council highways depot is a developing facility with increasing traffic movements and an aging entrance roadway. The office block is in constant use and a section of the adjacent access road surrounding a drainage cover had subsided. A repair system that did not involve noise, vibration or dust pollution was needed to ensure staff disturbance was minimised. Part of the access roadway had a walkway segregation white line that also required reinstatement and refreshing.

The Cheshire East team identified PermaFyx L271 as a natural solution to the situation. The system could be applied with minimal preparation, noise and dust, and without any material wastage or requirement for hot material being used within close proximity to the depot main entrance. The area was swept, dried using safe gas equipment, deep filled using a 2-6mm aggregate and then overcoated to a taped edge using the 2.5mm mix. Sections of the white line were subsequently reinstated without disturbing anyone on site and the repair was trafficable by the maintenance vehicles when they returned from their daily duties.

PermaFyx L271 MMA Surface Repair with 2-6mm aggregate. Overcoated with a surface layer of base resin, which has 1.4-2.5mm aggregate in.

Line reinstated with UltraLine L210.
