PERMAFYX L271 CASE STUDY

PORTSMOUTH COUNCIL LAKESIDE CAR PARK

Portsmouth Council, Lakeside Office Park, Northarbour, PO6 3EZ

Applied on 7th May 2020

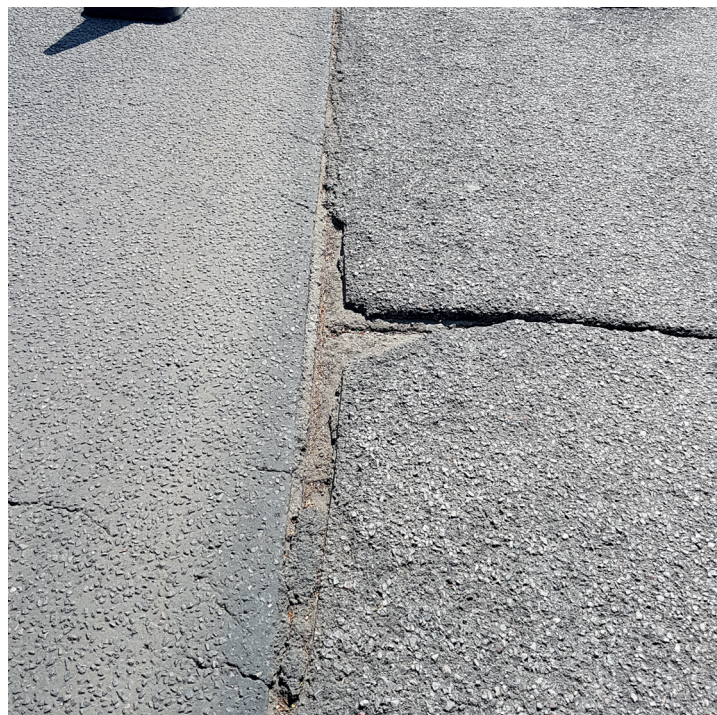
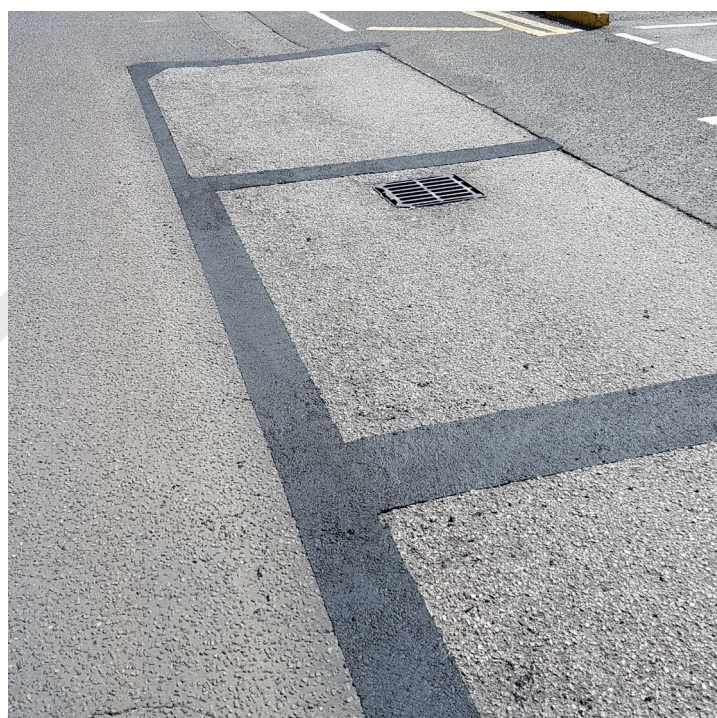
Lakeside Office Park was acquired by Portsmouth City Council in August 2019. The asset was originally developed in 1976 and the carparking and roadway areas included significant volumes of concrete, which have since been overlaid using asphalt systems. Where vertical joints had not been created in the asphalt, the movement of the old concrete slabs has resulted in surface failures in the asphalt. A full resurfacing programme would be ideal, but wasn't in the two-year maintenance budget, so an alternative solution was needed.

There was clearly movement in the substrate, which caused the asphalt to fail so any repair solution needed to be flexible. The PermaFyx L271 is a durable MMA system that has flexible properties which satisfies this criteria. The deeper sections were filled with a bulked out formulation of 2-6mm and then the area was screeded at a thickness of approximately 3mm to give a full bond across the movement joints. Using the PermaFyx L271 system also ensured a good SRV could be maintained.

PermaFyx L271 MMA Surface Repair with 2-6mm aggregate. Overcoated with a surface layer of base resin, which has 1.4-2.5mm aggregate.
