# PERMAFYX L271 CASE STUDY

## PORTSMOUTH COUNCIL LAKESIDE CAR PARK

Portsmouth Council, Lakeside Office Park, Northharbour, PO6 3EZ

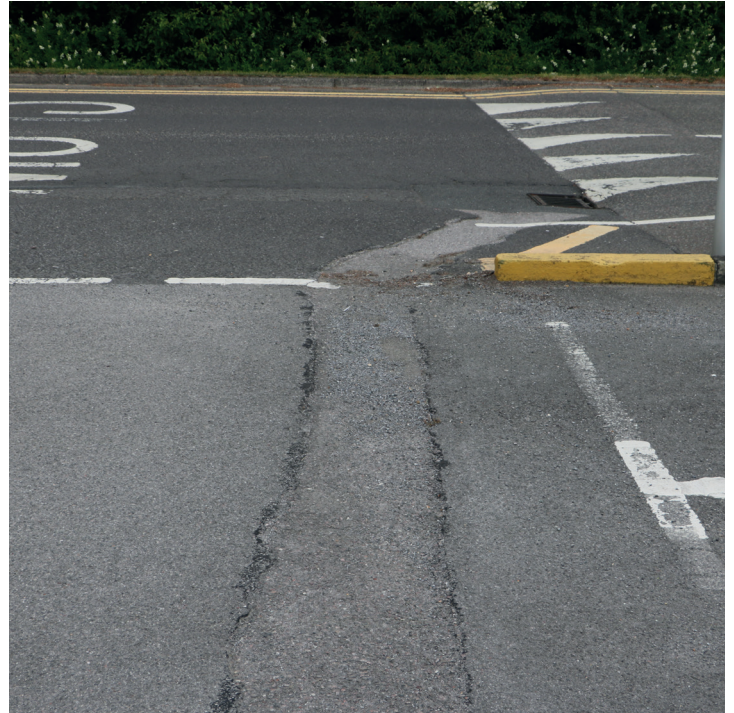
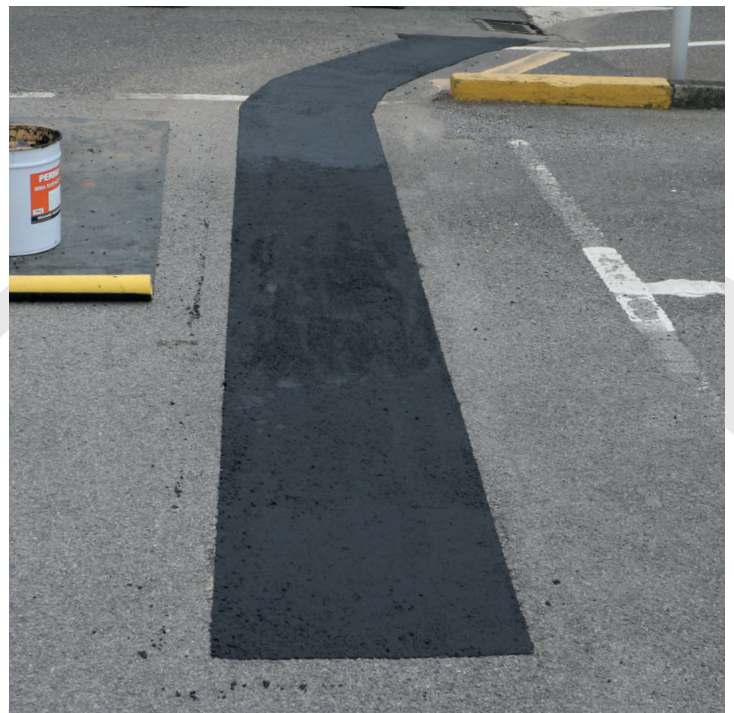
Following drainage works undertaken in the carpark area, the reinstatement was subject to compaction settlement, asphalt had been used below recommended temperatures, and the surface texture had started to deteriorate. The carpark is subject to 4000 vehicle movements per day and minimising disruption to the clients facility was critical.

Pictures of the finished result really speak for themselves. The client reported back saying, 'We know that the Meon products always work' and this application satisfied all expectations. 6 months later the repair is holding up extremely well.

With the substrate dry and edges swept, PermaFyx L271 was selected as a suitable system to remedy the situation. By filling the deeper sections with a 2-6mm blend and then overcoating the whole area using a 2.5mm blend against a taped edge enabled a quick, quiet and durable repair to be made.

PermaFyx L271 MMA Surface Repair with 2-6mm aggregate mixed in. Overcoated with a surface layer of base resin, which has 1.4-2.5mm aggregate.
