PERMAFYX L271 CASE STUDY

TRAFFORD COUNCIL FOOTWAY REPAIR

Trafford Council, Regent Road, Altrincham, WA14 1RP

Applied on 8th October 2020

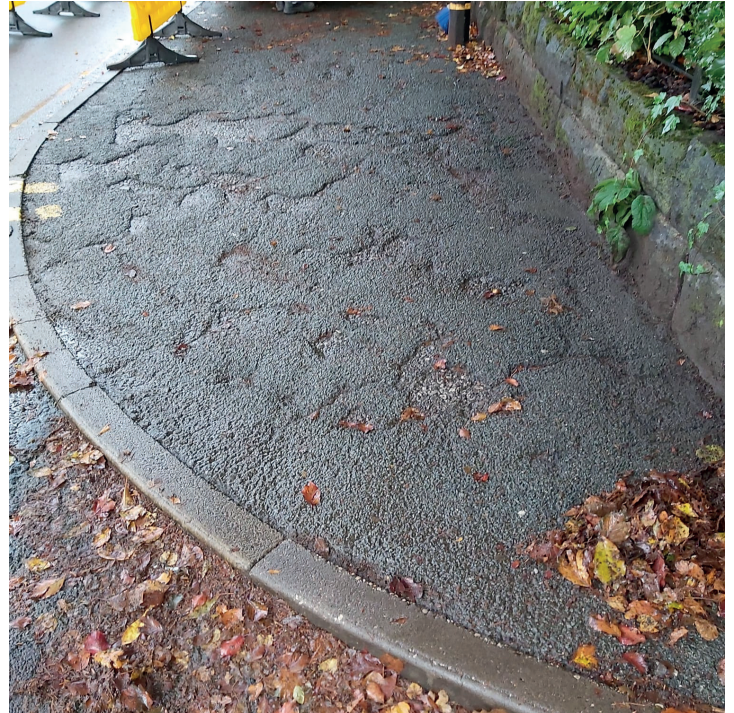
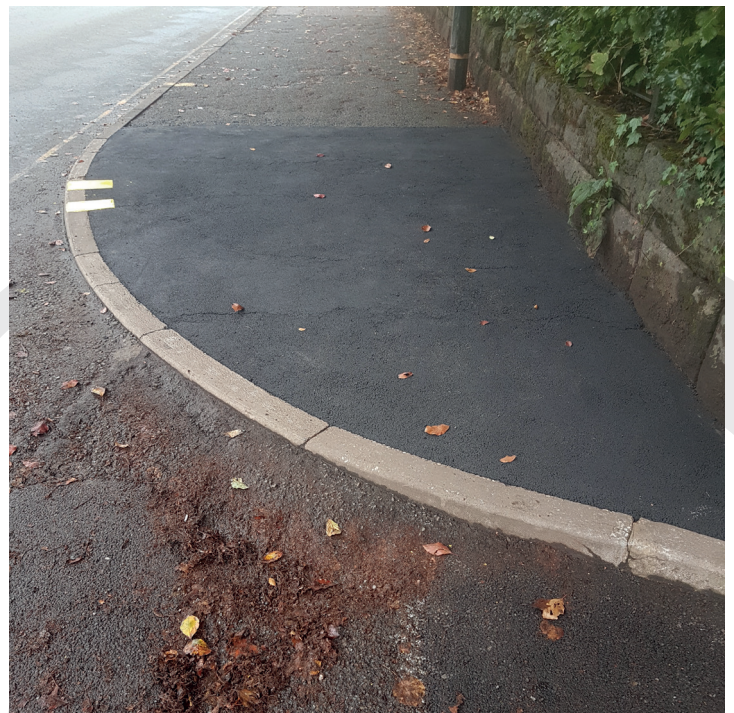
A failing footway surface in a sensitive urban area was becoming a trip hazard for pedestrians. The client was looking for a system that could be applied directly over the existing surface without the noise and physical disruption of excavation.

The PermaFyx L271 met all requirements set out by the client and was successfully applied without disrupting nearby school activities. The application was made on a wet morning which meant the substrate had to be dried using a turbine surface dryer prior to any material being laid. The deeper voids were filled using a 2-6mm mix and then the complete area was overcoated using a 1-3mm mix to give a safe, flat and durable surface that could be trafficked within 30 minutes.
