RAF DALTON ULTRACRACK L275

MAGMA CASE STUDY

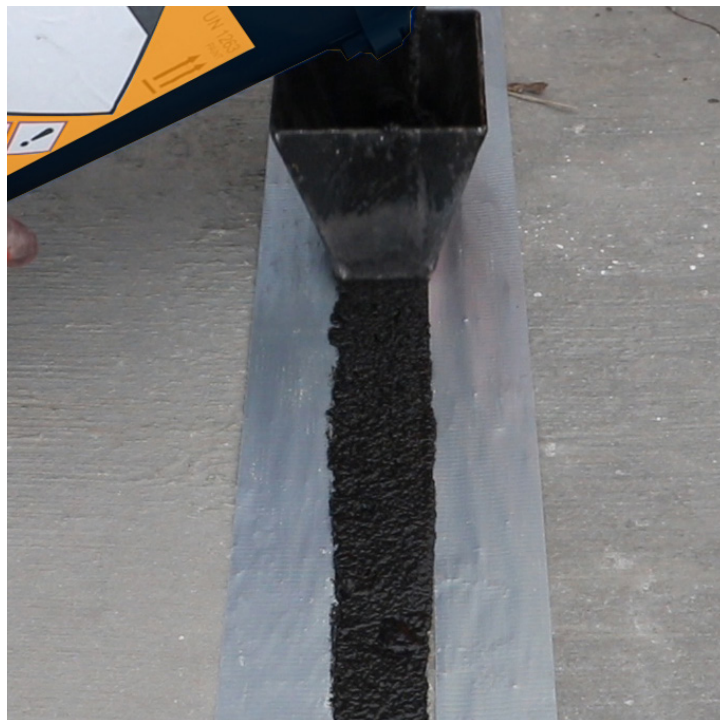
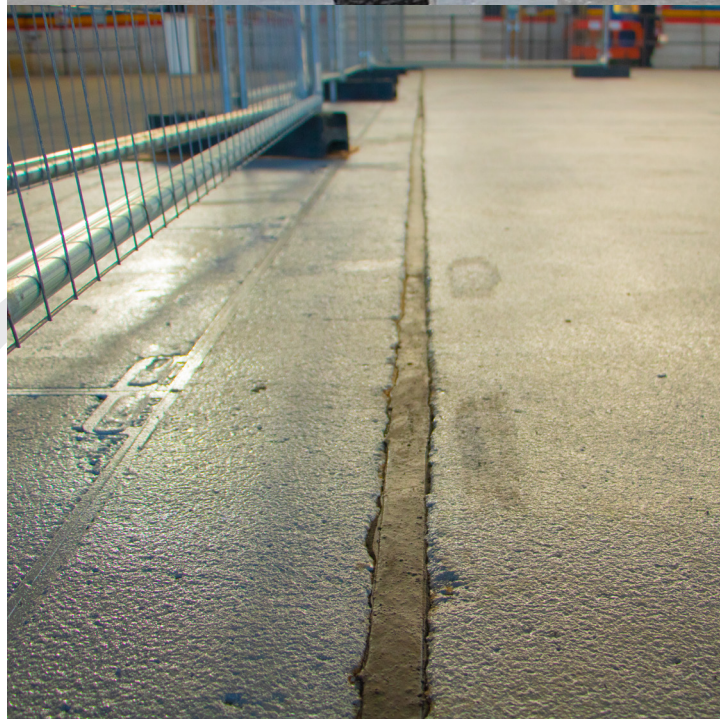
The contractor New Looks Oxon were undertaking major works to one of the hangars at RAF Dalton, including a complete repainting of the concrete floor. The joint filler between the concrete slabs had sunk so they wanted to replace them with a product which was very durable to withstand heavy traffic from military vehicles. It also needed to be flexible to allow for expansion and contraction between the concrete slabs. As the hangar was used for vehicle maintenance there were flammable materials stored there so a hot applied filler was not an option.

Meon was able to offer UltraCrack L275, a cold applied MMA joint filling product with high adhesion and flexibility once cured. The application process is simple with a resin and powder component which mix together and is then applied into the joint using a hand mould. This product is very durable and also offers a certain level of anti-slip once cured so there is no risk of slipping, especially when it gets wet.

New Looks Oxen were able to provide RAF Dalton with a well revitalised hangar. The hangar has been back in use since February and so far there are no defects in the joints thanks to the durable, impact resistant material standing up to heavy military vehicles passing over.
