WEST STREET READING TOWN CENTRE

MAGMA CASE STUDY

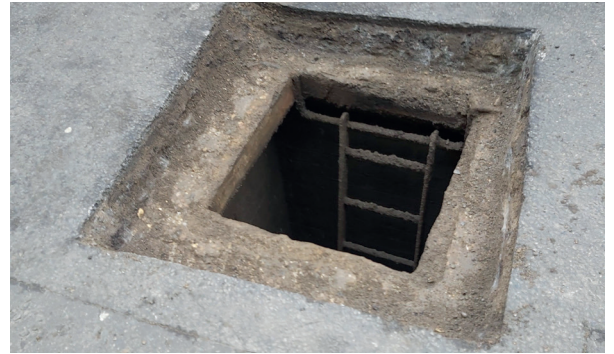
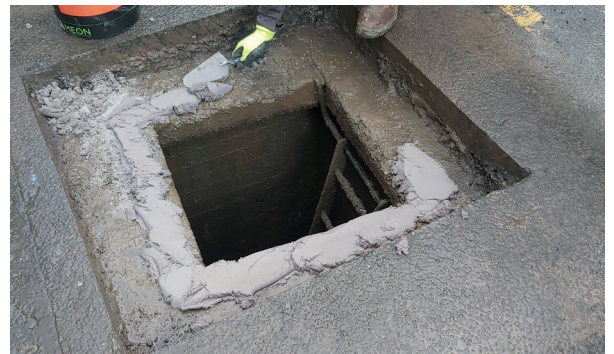
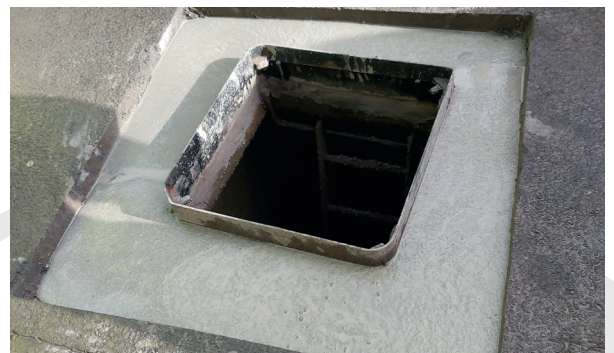
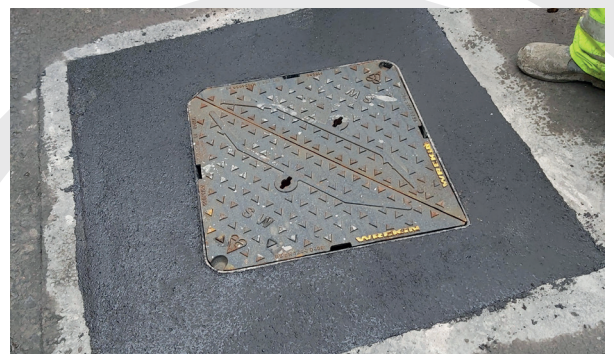
Having seen the examples on view, the team selected the Magma permanent ironworks reinstatement system to resolve their issues, being impressed with rigidity and ease of installation. They quickly identified a site to use for a trial. The site involved the reinstatement of a 600 x 600 x 150mm access chamber cover in the wheel tracks of a bus route. The solution was chosen because it could be installed without any hot-works and all materials and equipment could be transported to site within one vehicle.

The installation was completed within a 3 hour time frame which included removal of the existing cover and preparation for the new frame. The site could be open to traffic within 3 hours of the initial mortar placement. A senior highways engineer supervising the install confirmed he was impressed with the speed of installation, ease of material preparation and the final visual appearance.

HardMaster W620 CD534 Polymer Modified Bedding Mortar
HardMaster W615 Rapid Strength Flowable Concrete
PermaFyx L271 Surfacing Material Systems
