SPECIALISTS IN
WAREHOUSES

SURFACE REPAIR

EXPANSION JOINTS

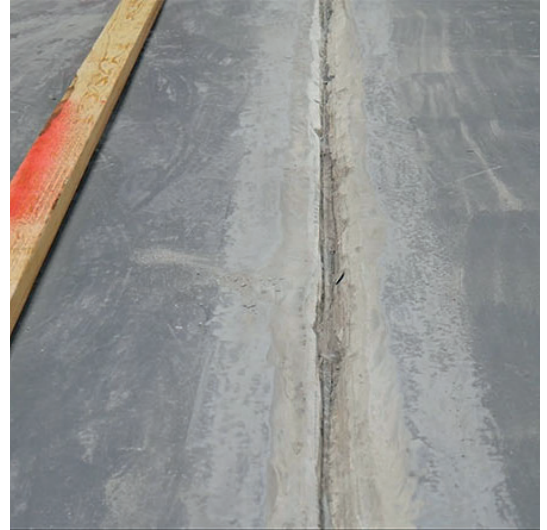
The solution is to use the UltraCrack L275 rapid curing expansion joint repair system. This system is based on a well proven cold plastic repair system which has been modified to allow for expansion and contraction, whilst still maintaining it's rapid curing properties and high durability. The use of this system means that areas can be repaired and returned to service in as little as 45 - 60 minutes.

Failing expansion joints in high traffic areas, both in external service yards and also internal warehouse floor areas.

The problem is that when expansion joints fail they then no longer support the edge of the concrete slabs, leading to cracking along the edge and corner of the slabs. This very quickly becomes a health and safety hazard and also leads to the damage of forklifts and other MHE.

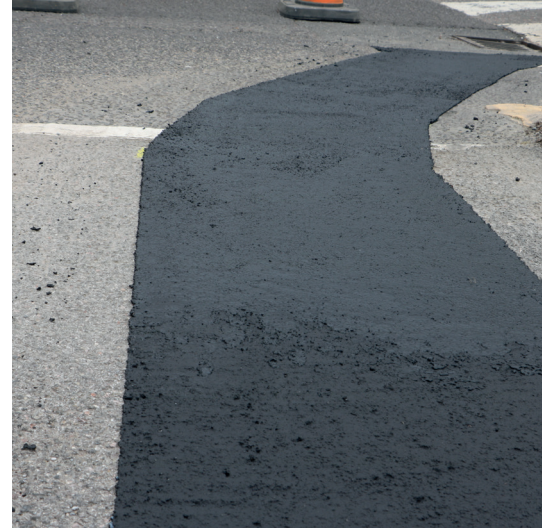
The solution is the use of the PermaFyx L271 one system. This is a rapid curing repair system that allows return to service within 30 - 45 minutes. It provides the permanency of a hot lay solution without any requirement for hot works at all. There is also no requirement for cutting or breaking out the surface, which not only creates noise and dust hazards, but also lead to the need for disposal of arisings created. The use of PermaFyx L271 removes all of these challenges whilst using a very simple tool kit, which is well within the scope of site maintenance teams.

Potholes and surface damage on asphalt and tarmac surfaces. This kind of damage is frequently found within supermarket car park areas, and also on the entrance roads to warehouses and distribution centres.

The problem is that these areas of damage are typically located in high traffic areas and often caused by stress such as being in a turning area, or failure caused by ground movement and substrate failure. Cold lay asphalt solutions, whilst being quick and simple to apply, are not designed to withstand these stresses.

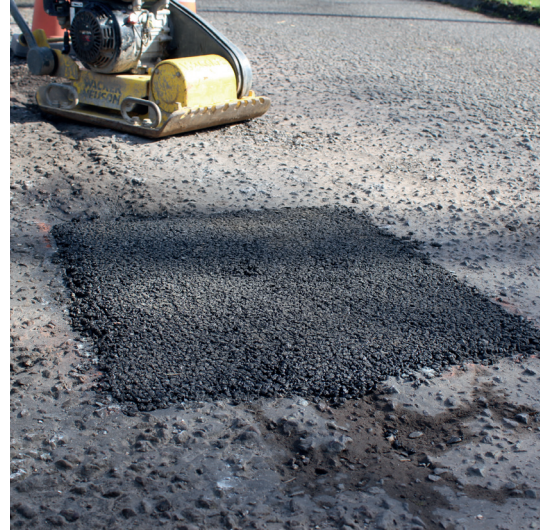
A solution is to use the HardMaster range of rapid curing concrete repair products and PatchMaster for pothole repair. This product range reaches a high strength within a few hours allowing the area to be quickly reopened to traffic and minimising disruption to the site. These products offer good bonding to the existing surface and can also be used in conjunction with expansion joint repair system, to completely reinstate damaged areas at a fraction of the cost of a complete break out and repair.

Repairing potholes and surface damage in busy service yards.

The problem is that traditional methods of repair to concrete surfaces have either utilised short life cold lay asphalt solutions, which need to be frequently replaced, or the taking the area out of service for several days to completely break out and reinstate the slab area.
