# N40 KINSALE ROUNDABOUT

## SPECTRUM CASE STUDY

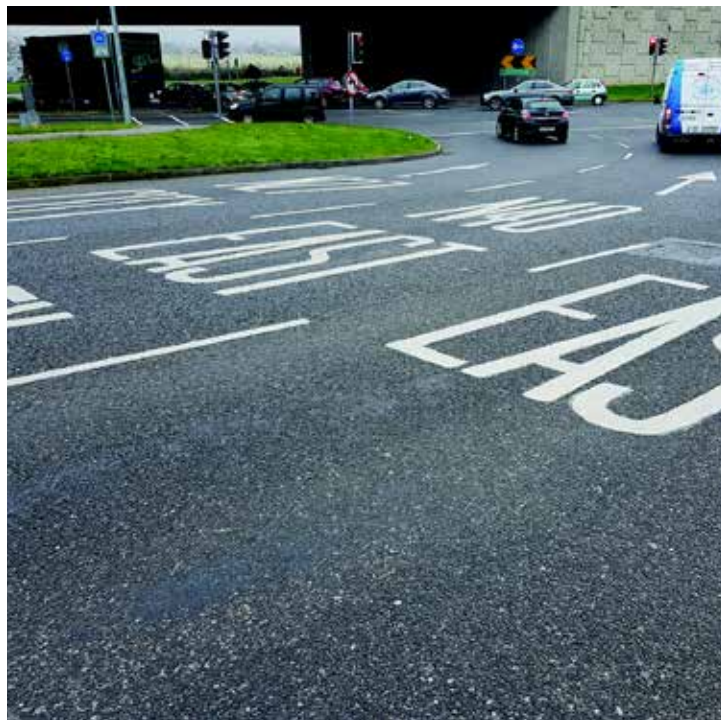
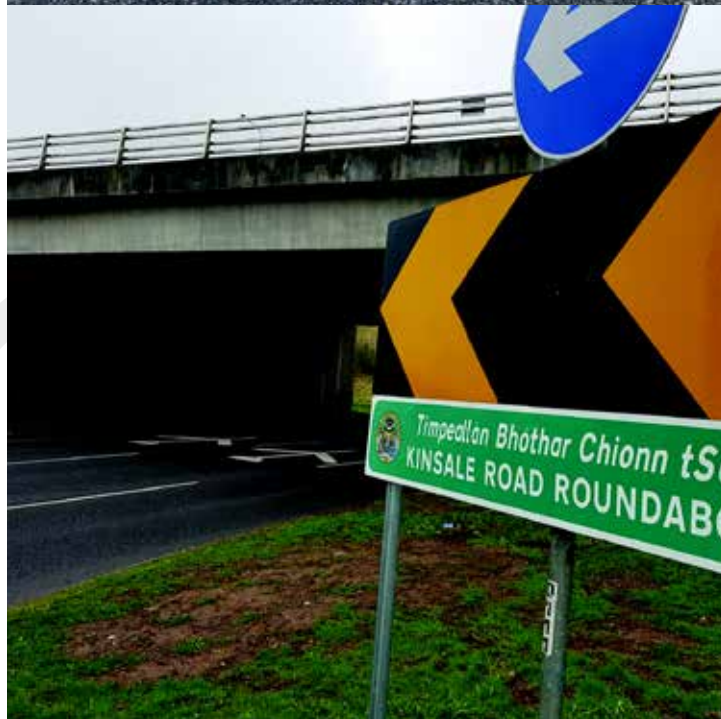
All directional markings, symbols, arrows, pedestrian crossings, stop lines and lane lines were refreshed by Highway Markings Ltd in October 2017, using Meon's UltraLine MMA, which was applied over the existing worn thermoplastic markings after surface preparation & cleaning had been carried out.
