CASE STUDY

**COMPLEX IRONWORKS REINSTATEMENT
WITH ZERO COMPACTION OR HOT WORKS**

WALES&WEST
UTILITIES

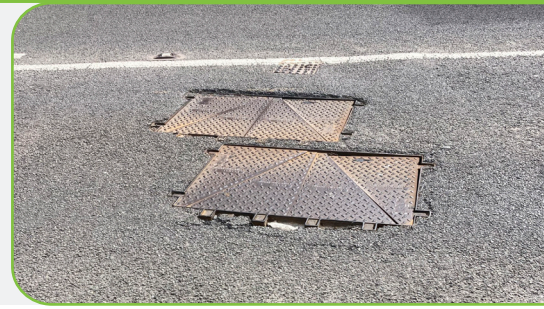
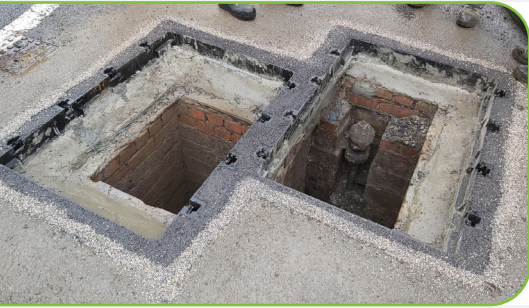
PROBLEM:

Wales & West are responsible for the maintenance of many Ironwork assets. They are proactive in improving their efficient service, by being open to new innovative solutions. A twin, double cover Ironworks had previously received some maintenance works months earlier, but it had further deteriorated and was now rattling, causing disruption for the nearby residents. One of the biggest challenges faced with this repair was the covers were positioned less than 150mm apart, meaning no compaction could be applied within this zone, causing an inherent weak point. The impact of ineffective repair solutions for Ironworks, can increase the ongoing cost, use more resources and develop to become a greater problem.

Meon supported Wales & West with the installation and suggested using our HardMaster, Rapid Set Concrete Bedding and Back Fill System, topped off with our revolutionary Asphalt Repair Solution, PermaFyx L273. By using the HardMaster W620 Bedding Mortar and HardMaster W621 Flowable Backfill Concrete, the narrow channel between the 2 covers was no issue and PermaFyx L273, requiring zero compaction, was the crowning touch. The repair was sealed with UltraCrack L270, to help prevent the ingress of water into the repair, maximising its durability and longevity. All the systems used are cold applied, so no hot works equipment was required for completion of the repair.

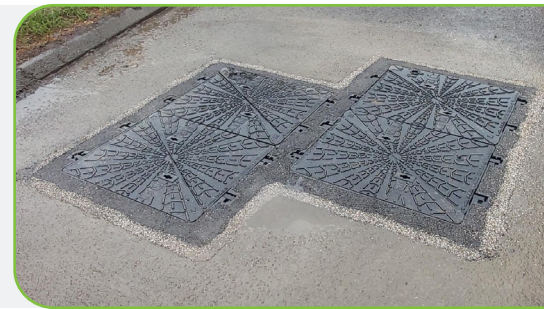
RESULT:

Local residents were able to benefit from a safe, effective and efficient Ironwork repair. The finished result is a very secure, well protected Ironwork, with a quick service time, the repair was open to traffic in just 90 minutes. The chemical reaction bond strength, achieved with our Cold Applied Rapid Set Concrete and Asphalt Repair Solutions requires zero compaction, hot works or heavy equipment, allowing for ease of application and minimal disruption to the local road network. Due to its high strength and durability, this ironworks will outlast several more years than traditional repair systems.
