## NextGen Boiler – Stuck impeller on Wilo Circulator

It has been brought to our attention that installers have experienced a couple of instances with a stuck impeller on the Wilo circulator. The control panel pump symbol

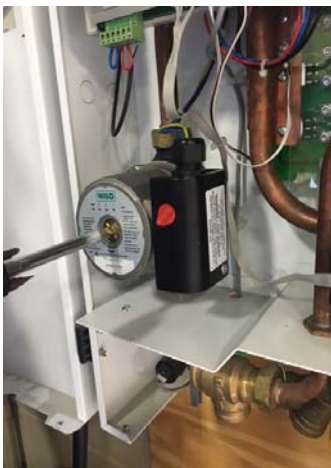
Figure 1

**Step 2- Use a slotted screwdriver to remove the brass vent plug located in the center of the Wilo circulator. (Fig. 1) Note that you will observe a small amount of water coming out of the circulator.**

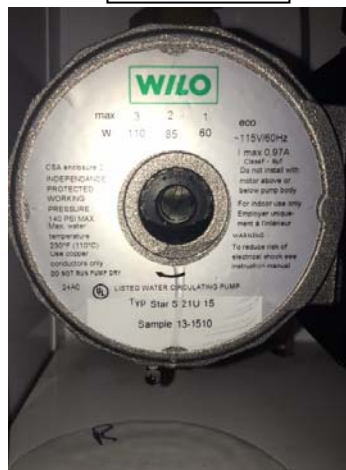
Figure 2

**Step 3-Locate the impeller with the screwdriver slot within the interior portion of the pump. (Fig. 2)**

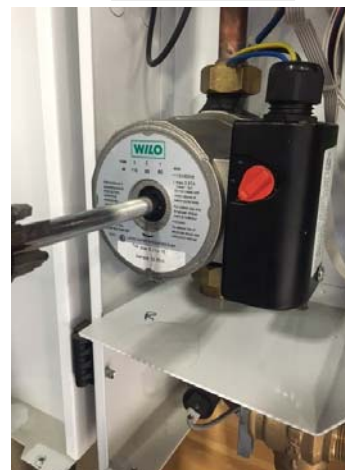
Figure 3

**Step 4-Use a slotted screwdriver to turn the impeller a couple of revolutions. (Fig. 3) Replace vent plug.**
