Why down pipe plugs may not seal adequately.

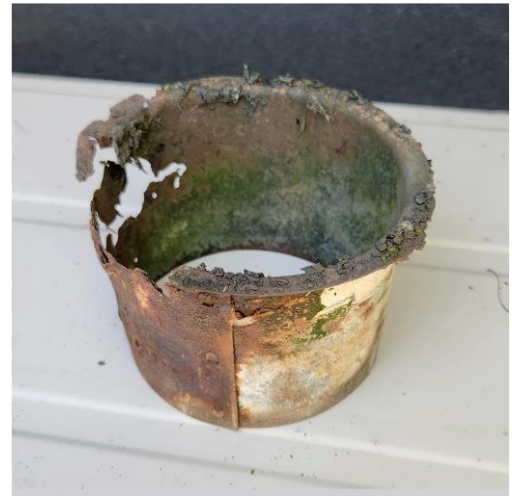
Fig 1

Downpipes are usually attached to the gutter via a “pop”
The downpipe plug may not seal if the “pop” has degraded & rusted, as in the case of fig1. The photo is a pop that has been removed from a gutter.
In this case the plug cannot seal because the side of the pop has rusted away.

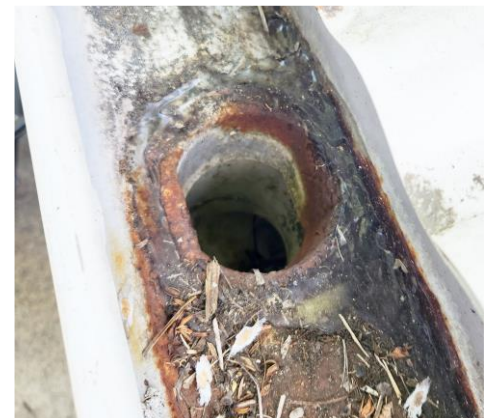
Fig 2

Before choosing a plug, we recommend you inspect the pop to make sure it is in a serviceable state. An example of a pop that is still serviceable but showing signs of degradation is in fig 2. If your gutters pop is in this state it would be wise to have a plumber inspect them & replace if necessary.
