INSTALLATION INSTRUCTIONS

OYS-EBK AV8 Emergency Brake Cable Kit for Model A and Early Ford Hot Rods

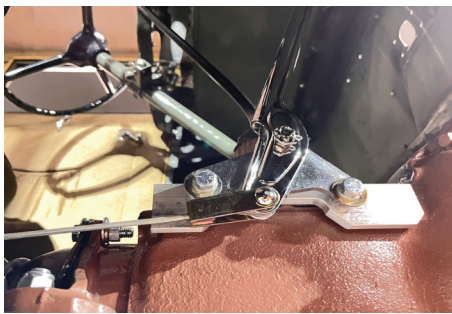
Attach primary sleeved brake cable to the emergency brake lever using the u-shaped mount, clevis and cotter pin. Ensure that that the emergency brake is ratcheted all the way to the OFF position.

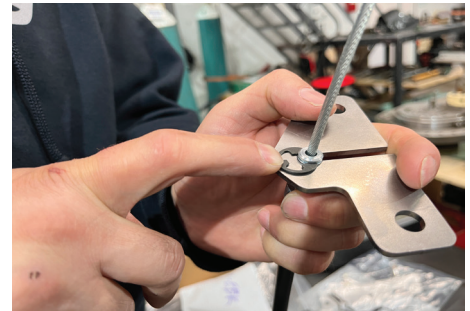
Insert the primary sleeved brake cable into the transmission crossmember cable mount provided. The cable end slides down and through the mount. Attach spring retaining clip into groove on the sleeved brake cable

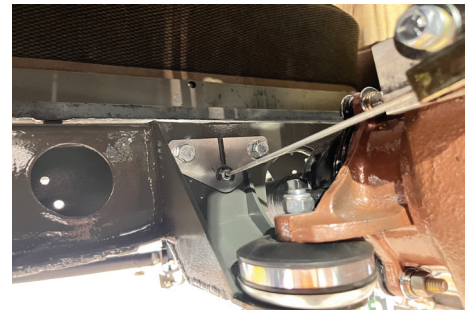
Mount the cable to your Old Yankee Speed AV8 transmission mount using the two upper left holes on the transmission mount and pass the primary cable through the e-brake access hole. If you don't have the AV8 mount, drill appropriate mounting and cable access holes into your crossmember, and secure the primary e-brake cable mount to your crossmember. NOTE: you will need to use the provided primary cable mount because the this the correct thickness for the spring clip

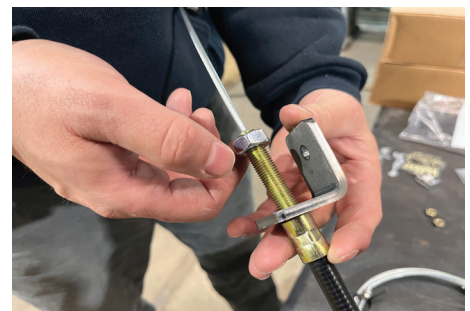
A.) If using a Model A driveshaft, find the location on the transmission side of the driveshaft where the taper of the torque tube gets larger and taper flattens out. This is where you'll secure the primary cable driveshaft mount tab. Next, drill and tap a hole for a 5/16"-18 bolt and lock washer (provided) and attach mount to the torque tube. Do not use a larger than 1/2" length bolt because it will interfere and damage the inner drive shaft. We recommend using a high temp RTV on the drive shaft bolt to avoid any leaks.

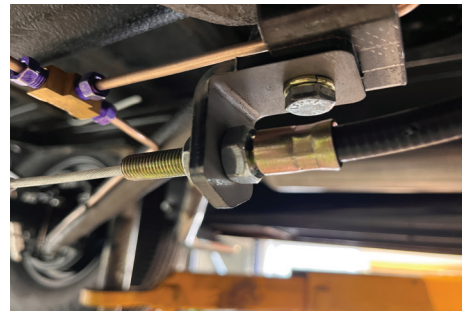
B.) If using an Early V8 Ford driveshaft, attach the primary cable tab mount to the U shaped V8 driveshaft mount, using 5/16" hardware (provided) then secure the mounts to the radius road mount location. No drilling of the torque tube is needed.

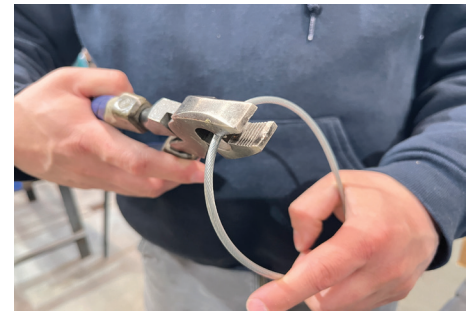
Now attach the primary cable to the torque tube drive shaft by inserting the threaded tube end through the primary cable, using the provided 3/16" nut to adjust tension on the emergency brake cable.

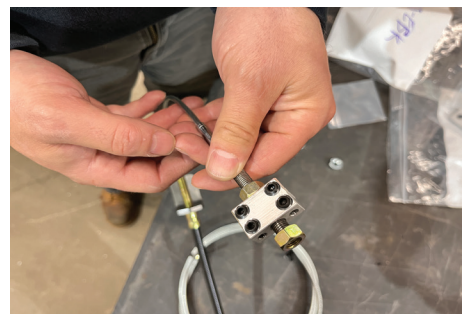
Attach secondary cable to your Early Ford emergency brake system through the backing plates. Once attached to both wheels, pull the one piece cable taught and center it to the primary cable and mount. Mark the center of the secondary cable and cut it into two sections, one for each wheel. We recommend wrapping the cable in masking tape where you will be making the cut to help with cable fray.

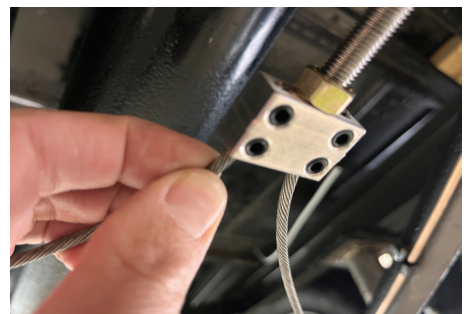
Then attach the threaded cable tension distribution block to the threaded primary cable end using the two 3/6" locking nuts provided. Leave the nuts loose for now. Attach the distribution block to the last 3rd of the threaded tube, leaving enough room for future cable adjustment.

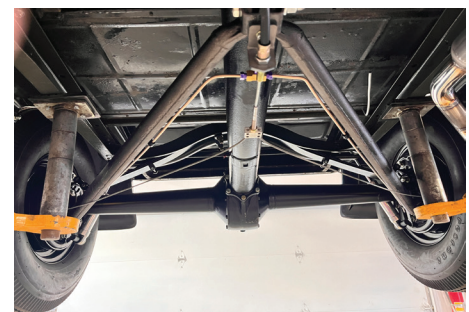
Next insert all three cables into the distribution block and pull the cables tight. Once all cables are tight, tighten set screws to secure cable in distribution block. If needed, fine tune tension on distribution block by threading the tube in further. Then tighten both sets of lock nuts on both sides of both drive shaft mounts. NOTE: cable must remain tight to work properly.

Finally, pull emergency brake handle and check that the emergency brakes are working and securing the car in place and not moving. If needed, loosen nuts to use tube fine adjustment to take up any slack on the cables. Once all checks have been completed and cable is working properly, trim excess braided cable from distribution block.
