## Testing Certification

### VISIPLAS Pallet Racking Upright Protector

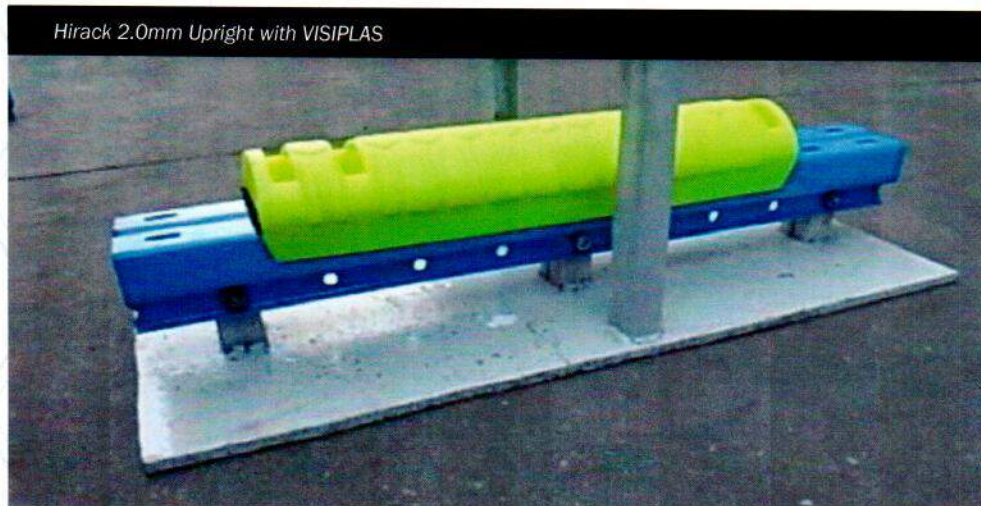
*This photo shows the VISIPLAS fitted to upright prior to impact.*

The VISPLAS protector showed minor rib deformation and evidence of penetration of the ribs into the shock absorbent layer. However the VISIPLAS reformed itself to its original dimensions. The upright section sustained minor damage resulting in 0.7mm average bending of the upright in the direction normal to the aisle, which represents less than 25% of the allowable bending defined in FEM 10.2.04.

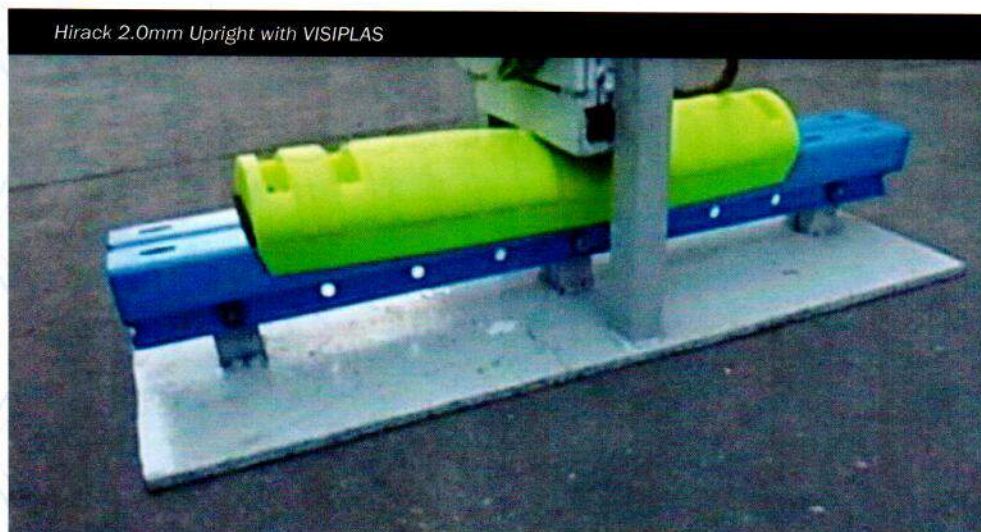
*This photo shows the VISIPLAS during the impact.  
Note the deflection of the VISIPLAS as the impact force is absorbed.*

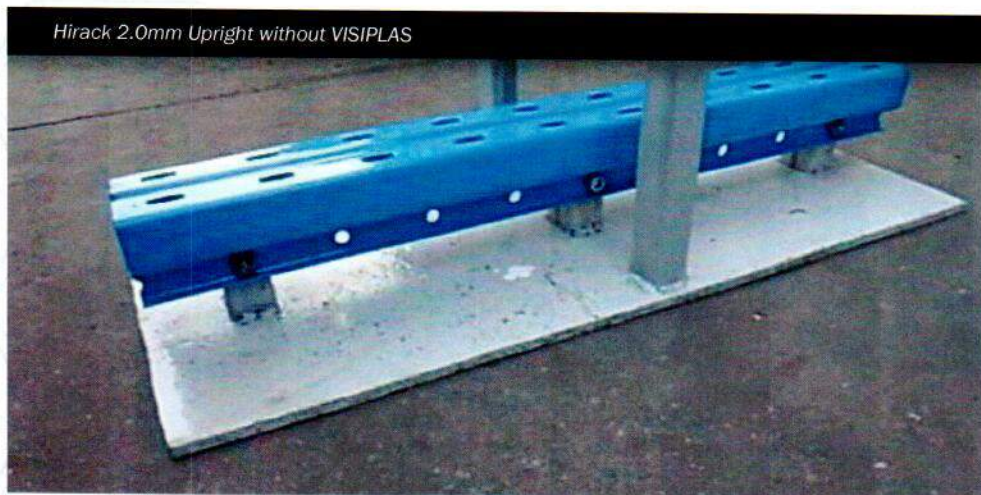
*This photo shows the upright without VISIPLAS prior to impact.*

Test results showed that the unprotected upright section in all cases exceeded the damage level allowed by FEM 10.2.04 and would require replacement. FEM 10.2.04 allows 3mm maximum bending of the upright section in 1.0metre gauge length in the direction normal to the aisle. The average amount of bending for the upright impacted without VISIPLAS was 7.1mm, which is 235% of the allowable.

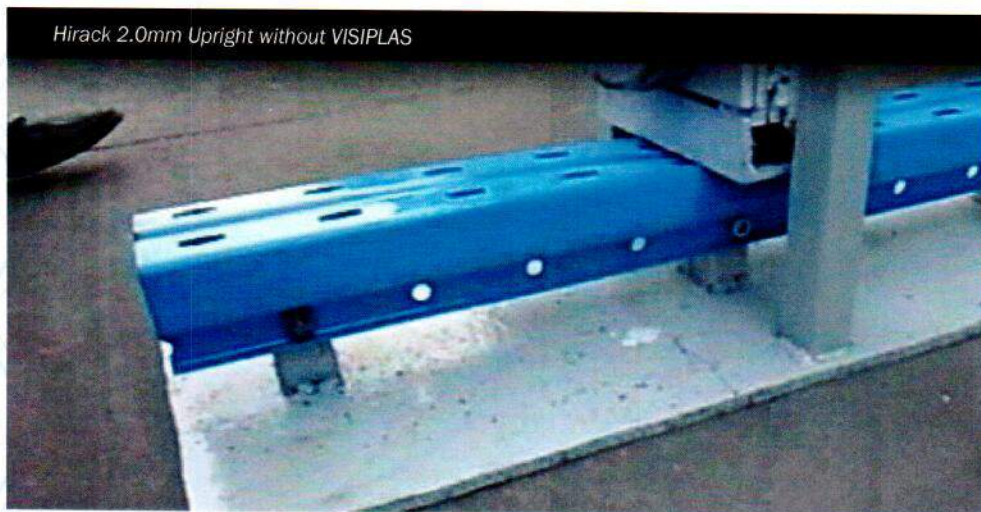
*This photo shows the upright during the impact.*
