Title: 'Rimblades' Alloy Wheel Protector
 Interim No.: MBK-12/1102
Safety Test
 Reissue Date of Reissue: \_\_\_\_\_

From: Millbrook Proving Ground Ltd.

Dates of Evaluation: 19.12.12 until 19.12.12
**Objective:**

To subject production 'Rimblades' alloy wheel protectors to high speed, pothole, medium/high vertical input and kerb strike procedures to test the safety and integrity of the design.

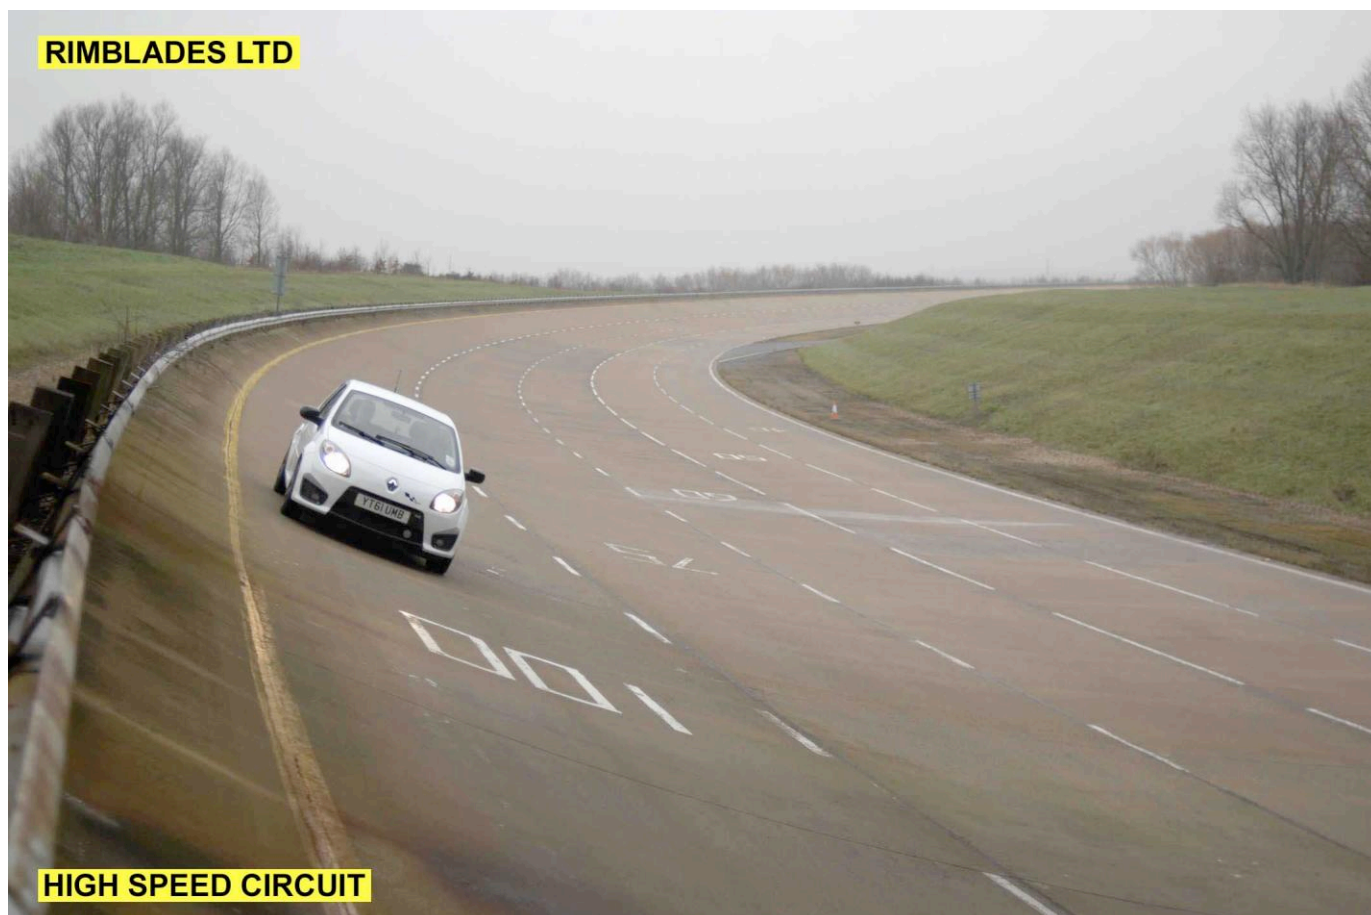
Module conducted on a 2 mile circumference circular banked track.

After the module, all wheel protectors were checked for security. If any wheel protector had detached from the adhesive bond or any other safety issues were noted, a verdict of failure would be recorded.

'Rimblades' wheel protectors safely passed and completed this module.

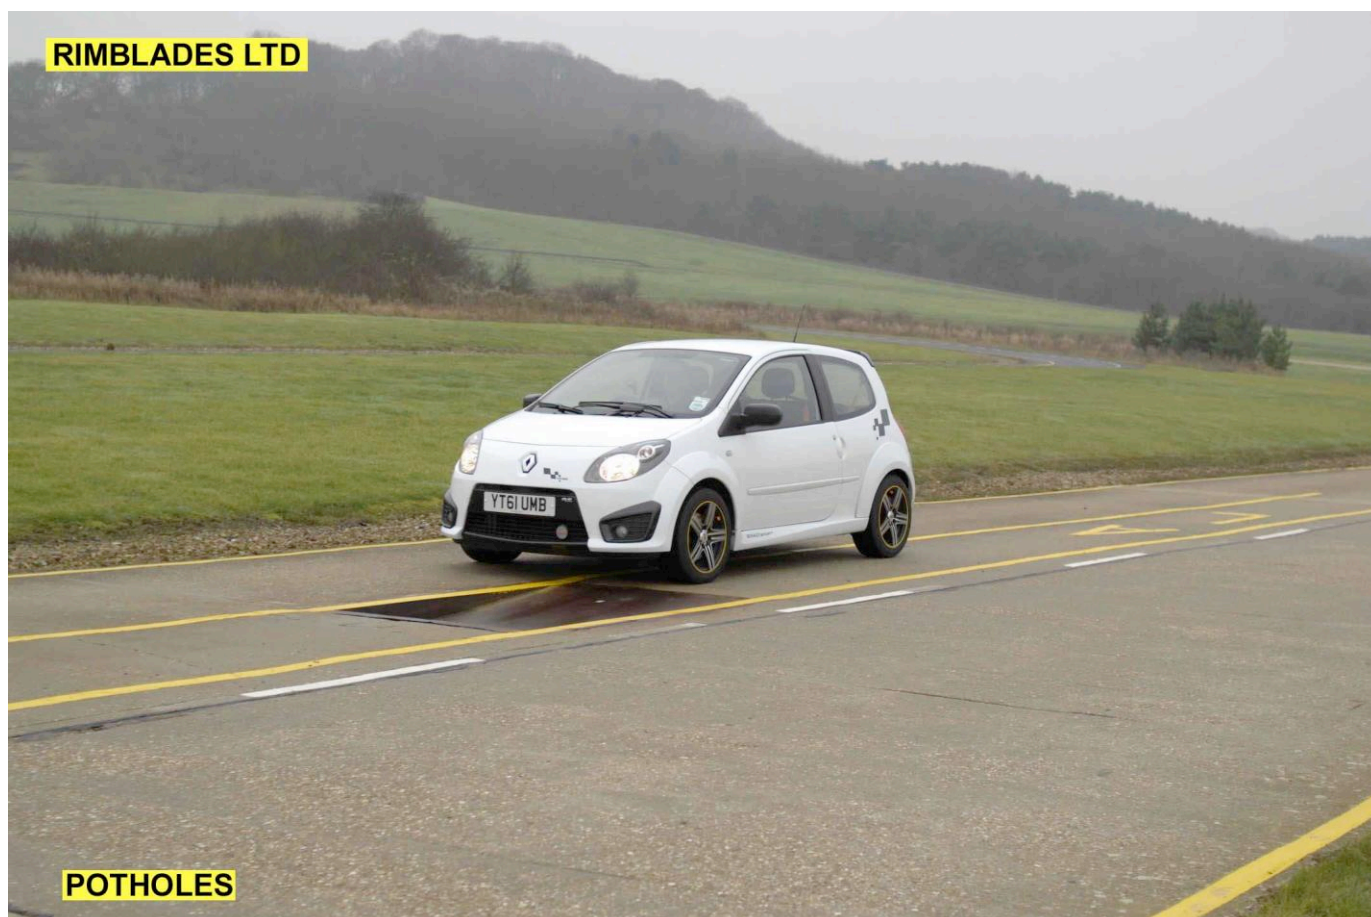
Module conducted on a level, cornered circuit equipped with two purpose-built potholes aligned with each side of the vehicle.

After the module, all wheel protectors were checked for security. If any wheel protector had detached from the adhesive bond or any other safety issues were noted, a verdict of failure would be recorded.

'Rimblades' wheel protectors safely passed and completed this module.

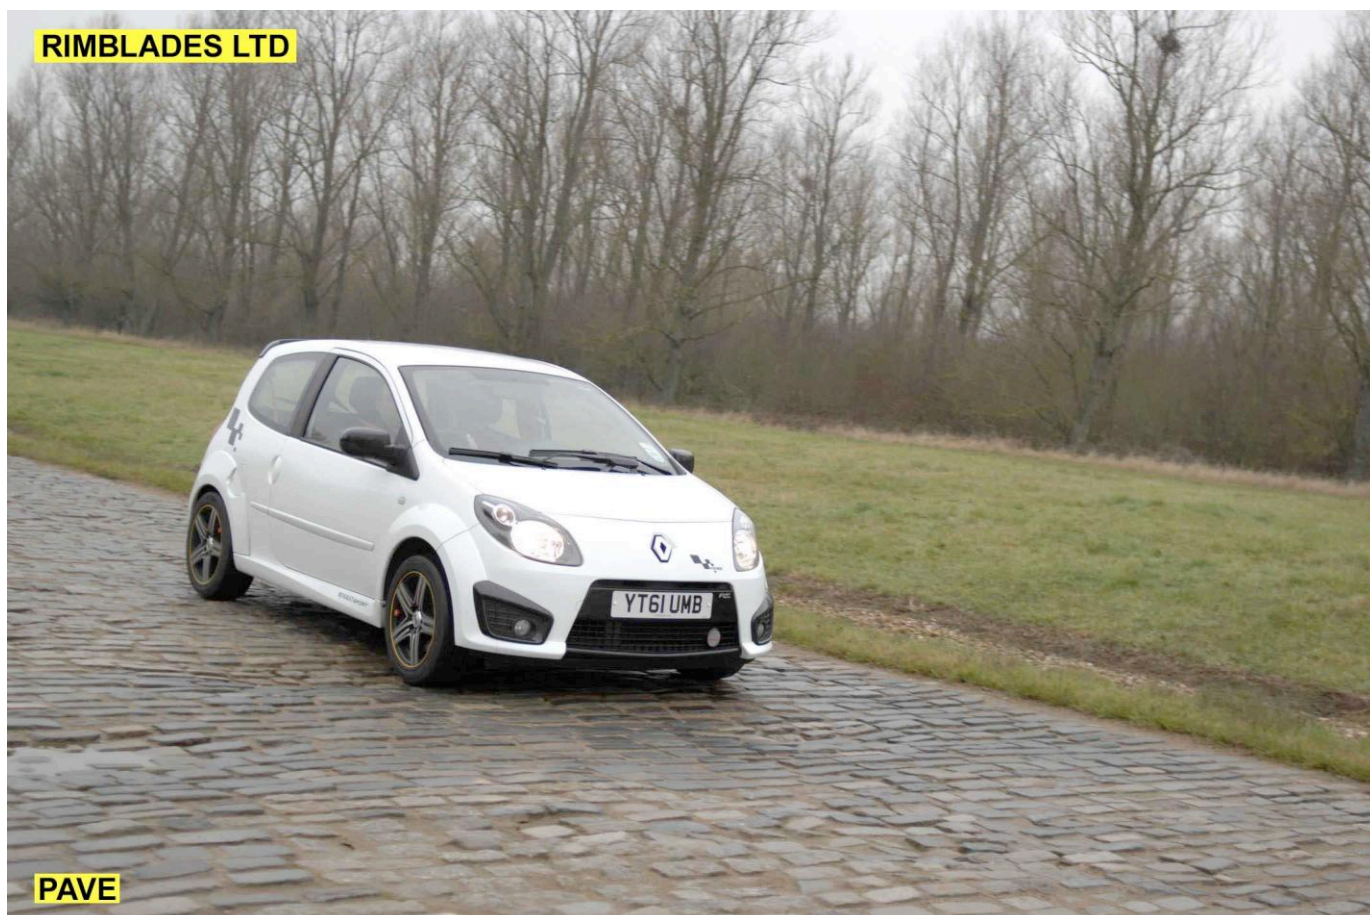
Module conducted on a 1 mile length cobbled rough track (Belgian Pavé).

After the module, all wheel protectors were checked for security. If any wheel protector had detached from the adhesive bond or any other safety issues were noted, a verdict of failure would be recorded.

'Rimblades' wheel protectors safely passed and completed this module.

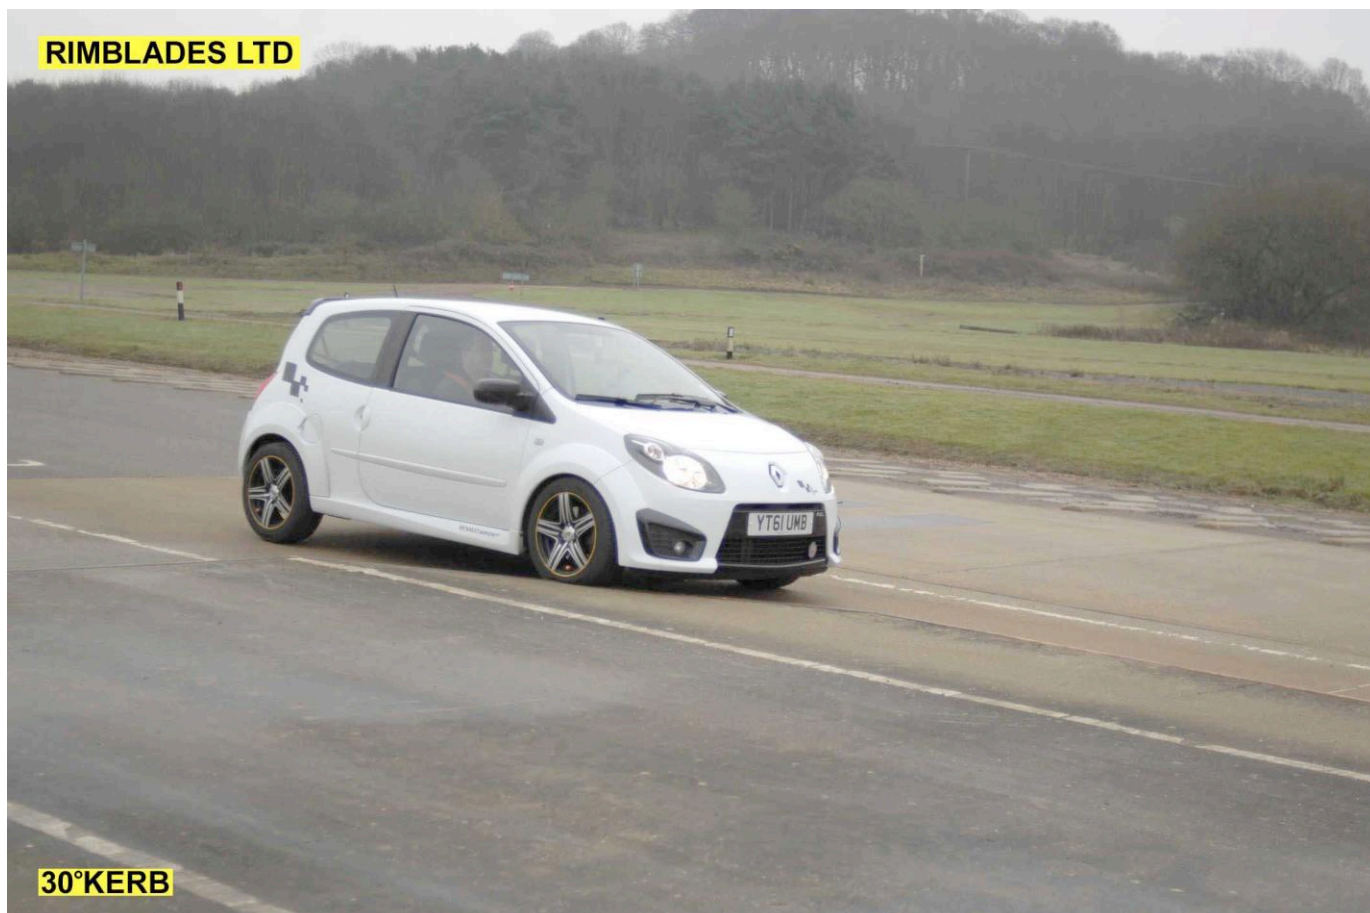
Module conducted on a purpose-built kerb facility. Kerbs measured approximately 100 mm in height.

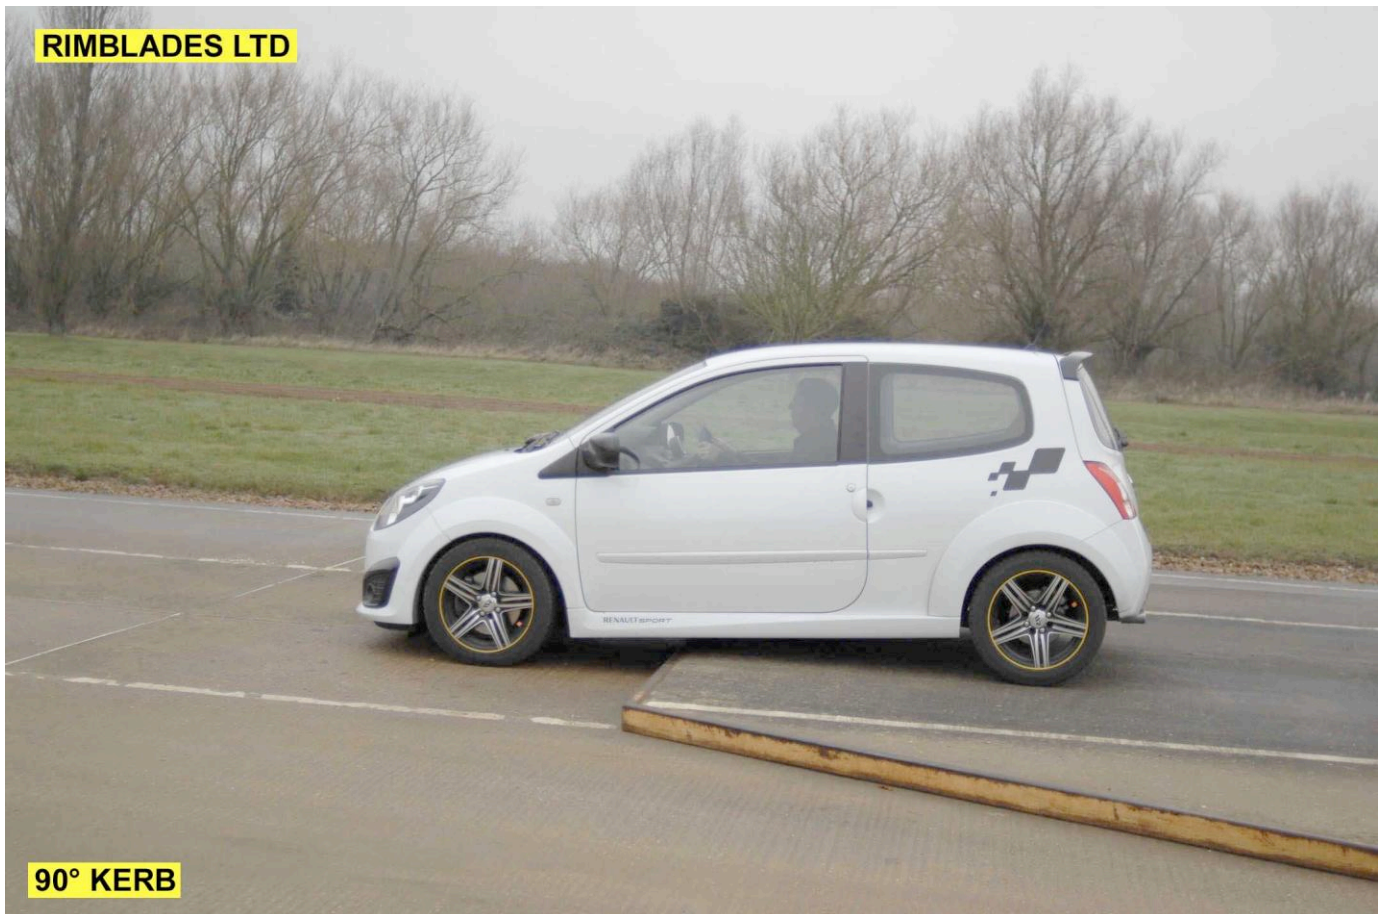
After the module, all wheel protectors were checked for security. If any wheel protector had detached from the adhesive bond or any other safety issues were noted, a verdict of failure would be recorded.

'Rimblades' wheel protectors safely passed and completed this module.
