ECOBoard Standard - A sustainable MDF alternative

TS Making Team - Testing ECOboard Results

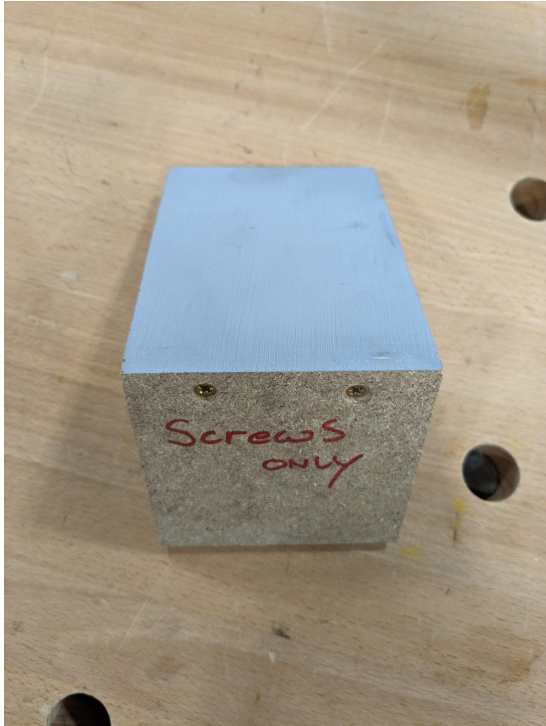
Screwing, pinning and joinery

Screws only, no glue. Stronger join than MDF. Painted over the butt joint, no visible join

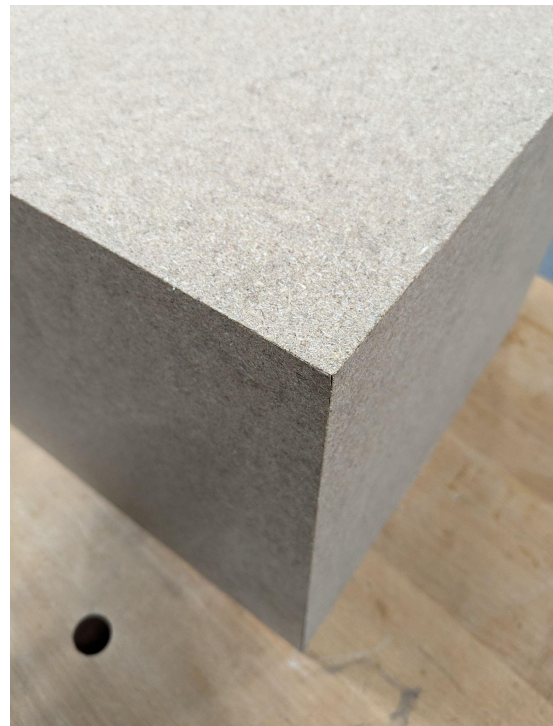
Mitred box joints

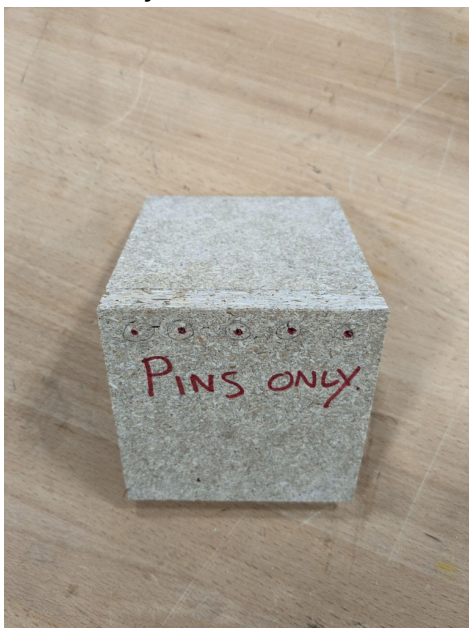
Pins only, no glue

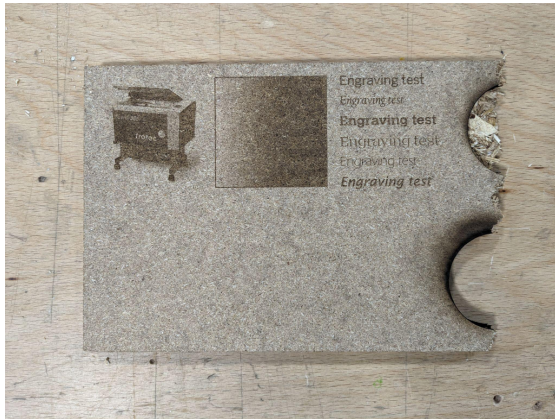
Laser engraving

Engraves well, though background is less uniform than MDF.

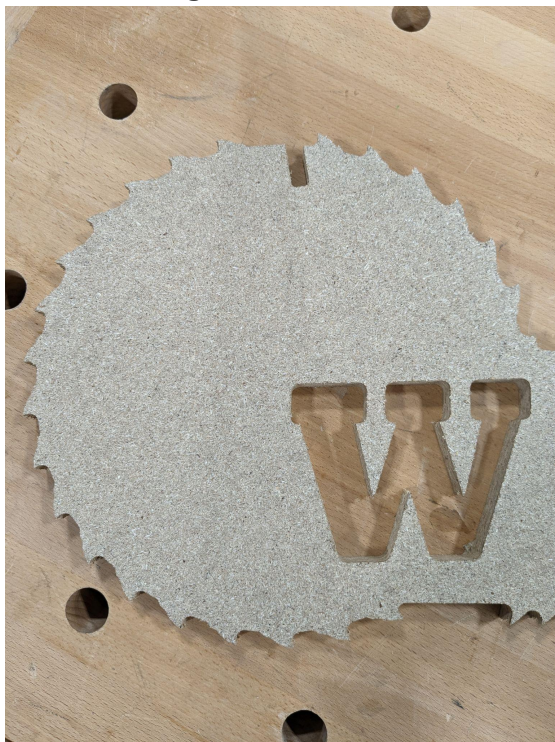
CNC Routing

Routes well leaving a defined and crisp shape on the surface. Edges are more textured than MDF

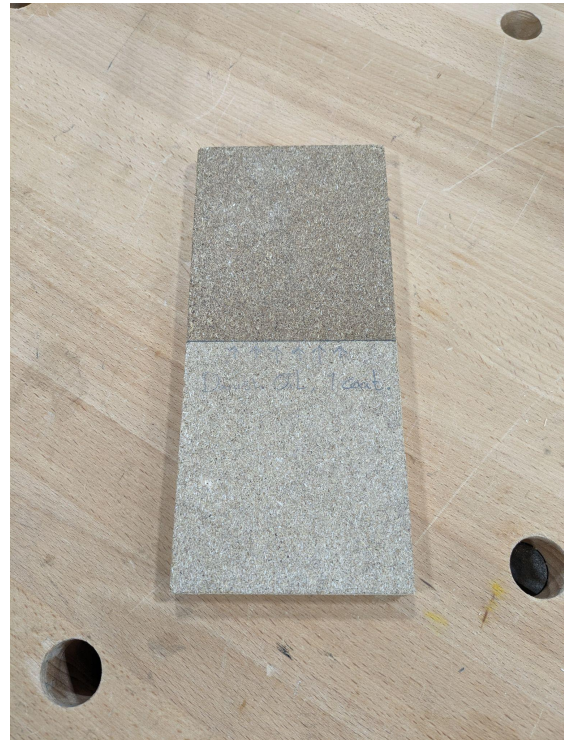
Top half, 1 coat of Danish oil. Bottom half natural.

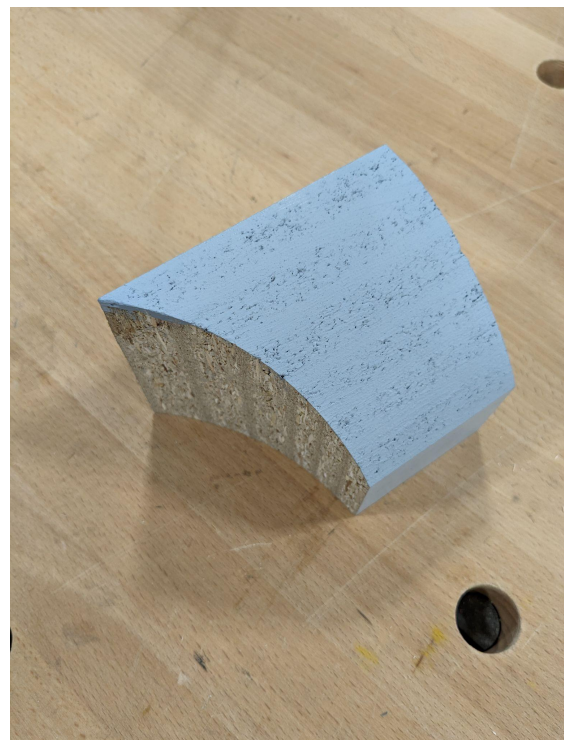
Laminated curved section painted with one coat grey acrylic paint and no filler.
